# Airworthiness Directive Schedule

## Aeroplanes

### Alpha Aviation Design HR200 and R2000 Aircraft Series

27 August 2015

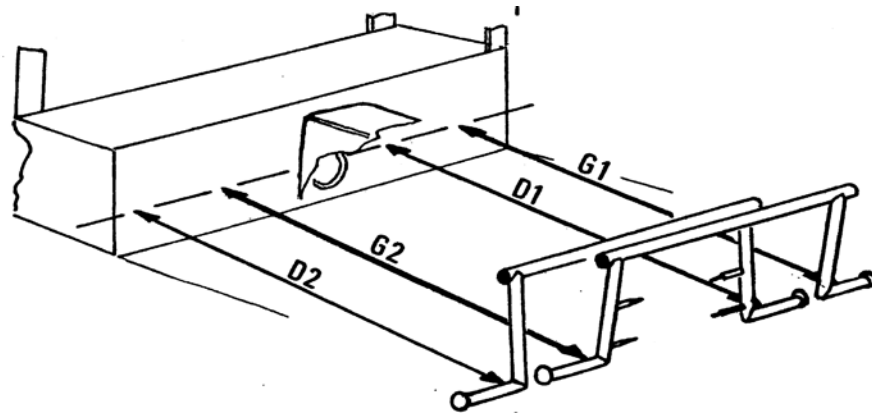
**Figure 1**

Check the geometrical shape of both the rudder bars in accordance with Fig 1. Maintain the rudder bars in the neutral position and measure distances G1, G2 and D1, D2 (the distance between the foot tubes and the front face of the frame box located under the seats). The difference between G1 and G2, or D1 and D2 is the distortion.

- a. If  $D1 = D2$  and  $G1 = G2$  (+/- 5mm), there is no significant distortion and no action is required, re-inspect at intervals not to exceed 500 hours TIS.
- b. If the distortion is between 5 and 10 mm re-inspect at intervals not to exceed 100 hours, until replaced by rudder bars P/N 27.40.31.010 and P/N 27.40.31.020 per AA-SB-27-003.
- c. If the distortion is equal to or greater than 10mm, replace both rudder bars per AA-SB-27-003.

Replace the left rudder bar P/Ns 27.23.05.010 and the right rudder bar P/N 27.23.05.020 with reinforced rudder bars P/N 27.40.31.010 and P/N 27.40.31.020 respectively, per Alpha Aviation Service Bulletin AA-SB27-003.
