Airworthiness Directive Schedule

Yakovlev/Aerostar 3, 18, 50, 52 and 55 Series

27 October 2016

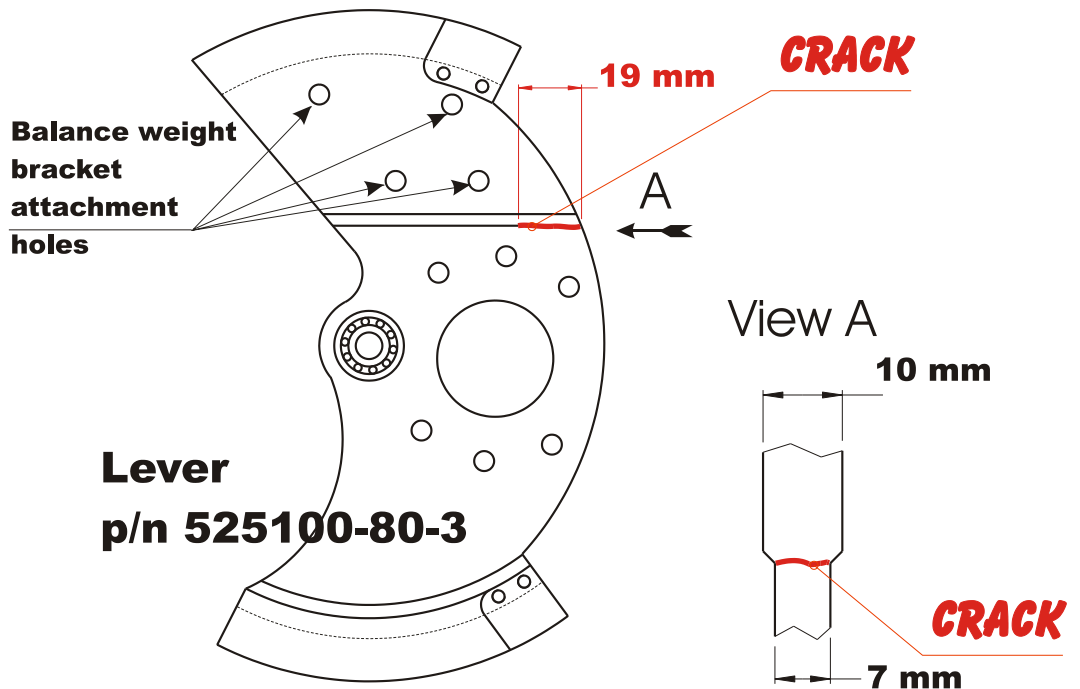
Note: This AD is prompted by a report of finding a 19 mm crack in the elevator control pulley P/N 525100-80-3 (referred to in the Romanian parts catalogue as a “lever”). The failure of this component could result in loss of elevator control.

Inspect lever P/N 525100-80-3 for cracks using a dye penetrant method. Inspect in the area below the attachment of the balance weight bracket at the point where the section reduces from 10 mm to 7 mm.

If the lever is found cracked, replace affected parts before further flight.

Inspect the primary stops of the lever for damage and wear. If any defects are found, or if the rubber pads are excessively worn, replace affected parts before further flight.
