Airworthiness Directive Schedule

Aeroplanes

De Havilland DH82 Series (Tiger Moth)

26 April 2018

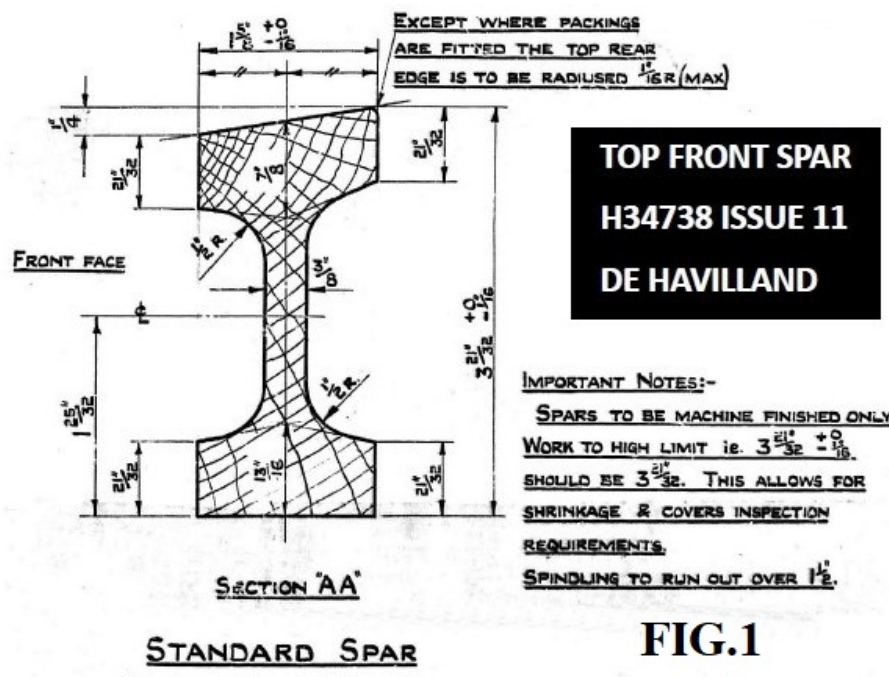
Figure 1 - De Havilland Design:

Note 1: DCA/DH82/129B revised to introduce a one-time inspection of the wing spars. If the spar section properties conform to the original de Havilland design shown in Figure 1, or if the wing spar section properties (minimum radius and dimensions) are no less than that shown in Figure 2, then no further action is required, and the previous flight limitations can be removed.

1. If an affected wing or aileron spar is found installed, then aerobatics or other flights involving high load factors, including flight in turbulent conditions are prohibited until requirement 2 of this AD has been accomplished.
2. If an affected wing or aileron spar is found installed, accomplish the following:
 - 2.1. If an affected aileron spar part number is found fitted, then conform the spar to the approved type design per the original de Havilland design, or replace the affected aileron spar, before further flight.
 - 2.2. If an affected mainplane/wing spar is found fitted, then inspect the forward and the aft faces of the affected spars in four places, and determine if the spar section properties (i.e. area, shape) conform to the approved type design per the original de Havilland design shown in Figure 1.

If the wing spar section properties conforms to the original de Havilland design shown in Figure1, then no further action is required, and the previous flight limitations can be removed.

If the wing spar section properties do not conform to the original de Havilland design shown in Figure1, then accomplish requirement 3 of this AD, before further flight.
3. Inspect the affected wing spar and compare the spar section properties with the Croydon spar profile shown in Figure 2.

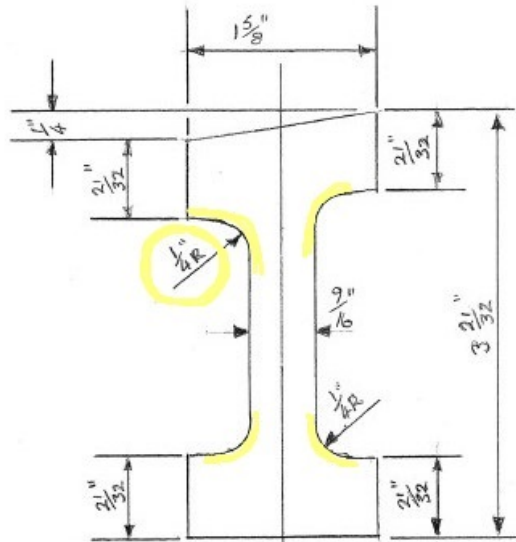
Figure 2 – Croydon Spar Profile:

If the wing spar section properties (minimum spar web radius and dimensions) are found not less than that shown in Figure 2, (i.e. the inside radii of the spar cut-

outs are found not less than 0.25 inches as shown in Figure 2), then no further action is required, and the previous flight limitations can be removed.

If the wing spar section properties (minimum spar web radius and dimensions) are found less than that shown in Figure 2, (i.e. the inside radii of the spar cut-outs are found less than 0.25 inches as shown in Figure 2), then remove the affected spar from service, and replace with a serviceable part, before further flight.

**TOP FRONT SPAR
H34738 C
CROYDON**

Note 2: Report any machined spars with section properties less than that shown in Fig.2 to the CAA by completing a CA005 Defect Report form. Please provide the spar part and serial numbers, and a copy of the release documentation. The form can be obtained from CA005@caa.govt.nz. The completed form can be emailed to the CAA at http://www.caa.govt.nz/Forms/CA005D_Form.pdf
