Airworthiness Directive Schedule

Aeroplanes

Piper PA-32 Series (Cherokee 6, Saratoga, Lance and Seaplane)

28 January 2021

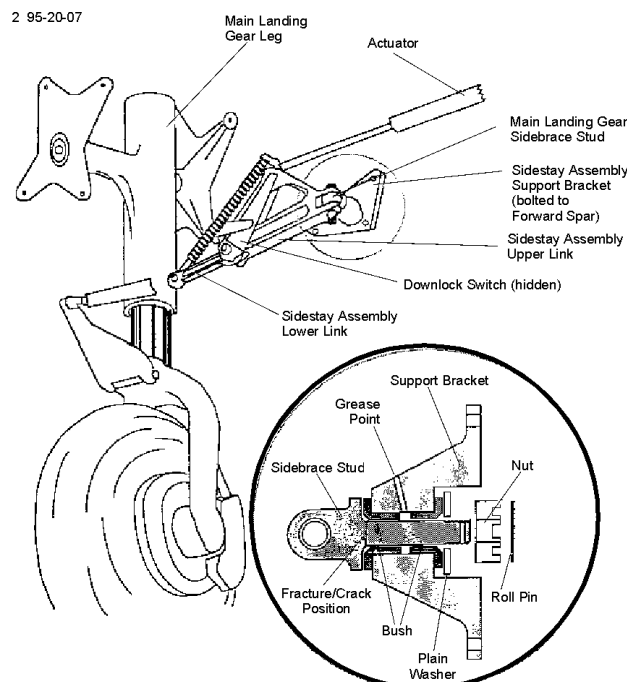
Requirement: To prevent main landing gear (MLG) collapse due to possible main gear sidebrace stud cracks which if not detected and corrected could result in loss of aircraft control during landing, accomplish the following:

Remove both the left and right main gear sidebrace studs from the aircraft per the instructions in the landing gear section of the aircraft MM. Inspect both the main gear sidebrace stud for cracks using Type I (fluorescent) liquid penetrant or magnetic particle inspection methods. Figure 1 of this AD depicts the area where the sidebrace stud is to be inspected.

Note: This figure is provided to depict the area of the sidebrace stud to be inspected. This is not intended to represent the configuration of all models affected.

For any main gear sidebrace stud not found cracked, before to further flight reinstall the stud per the instructions in the Landing Gear section of the applicable MM, and reinspect and replace (as necessary) per this AD.

For any main gear sidebrace stud found cracked, before to further flight replace the cracked stud with a serviceable part per the instructions in the Landing Gear section of the applicable MM and accomplish one of the following, as applicable:

- Reinspect and replace (as necessary) per the repetitive requirements in this AD, or
- For affected PA32R-300 aircraft the 9/16 inch main gear sidebrace studs (P/N 95299-00, 95299-02 or 67543 as applicable) are no longer manufactured: Install a new main gear sidebrace stud bracket assembly P/N 95643-06, 95643-07, 95643-08 or 95643-09 as applicable. No repetitive inspections will be required by this AD for when this bracket assembly is installed on both the LH and RH sides, or

- Ream the existing two-piece bushings P/N 67026-6 to an inside diameter of .624 inch to .625 inch, chamfer the head side of the bushing to accommodate the radius in the shank of the main gear sidebrace stud and install the 5/8 inch stud P/N 78717-02. No repetitive inspections will be required by this AD when this action is accomplished on both the LH and RH bracket assemblies. If the bushings cannot be reamed while installed in the bracket (i.e., the bushings are loose), then install a main gear sidebrace bracket assembly P/N 95643-06, 95643-07, 95643-08 or 95643-09, as applicable.
