Airworthiness Directive Schedule

Components & Equipment

Aircraft Seats and Harnesses

27 February 2025

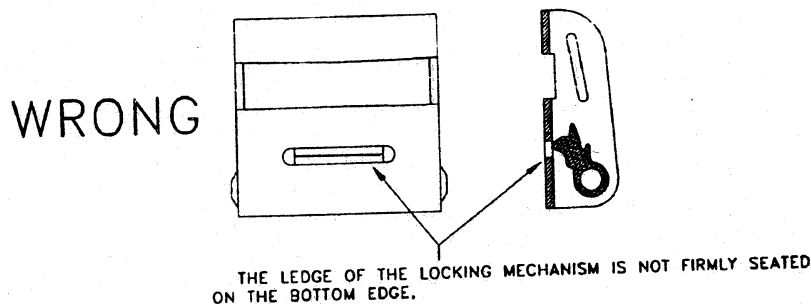
Requirement: To prevent failure of the seat restraint system due to the buckle assembly locking mechanism not engaging properly, which could result in the restraint system failing to properly secure the occupant during turbulence or landing, accomplish the following:

After the lever is completely closed, examine the slot in the bottom of the buckle. The locking mechanism should be firmly seated against the edge of the slot as shown in Figure 1.

If the locking mechanism does not seat properly, replace the buckle with an airworthy buckle.
