Continuing Airworthiness Notice – 51-004

MD 369HS and Kawasaki 369HS Helicopters – Upper Vertical Fin Crack

30 January 2023

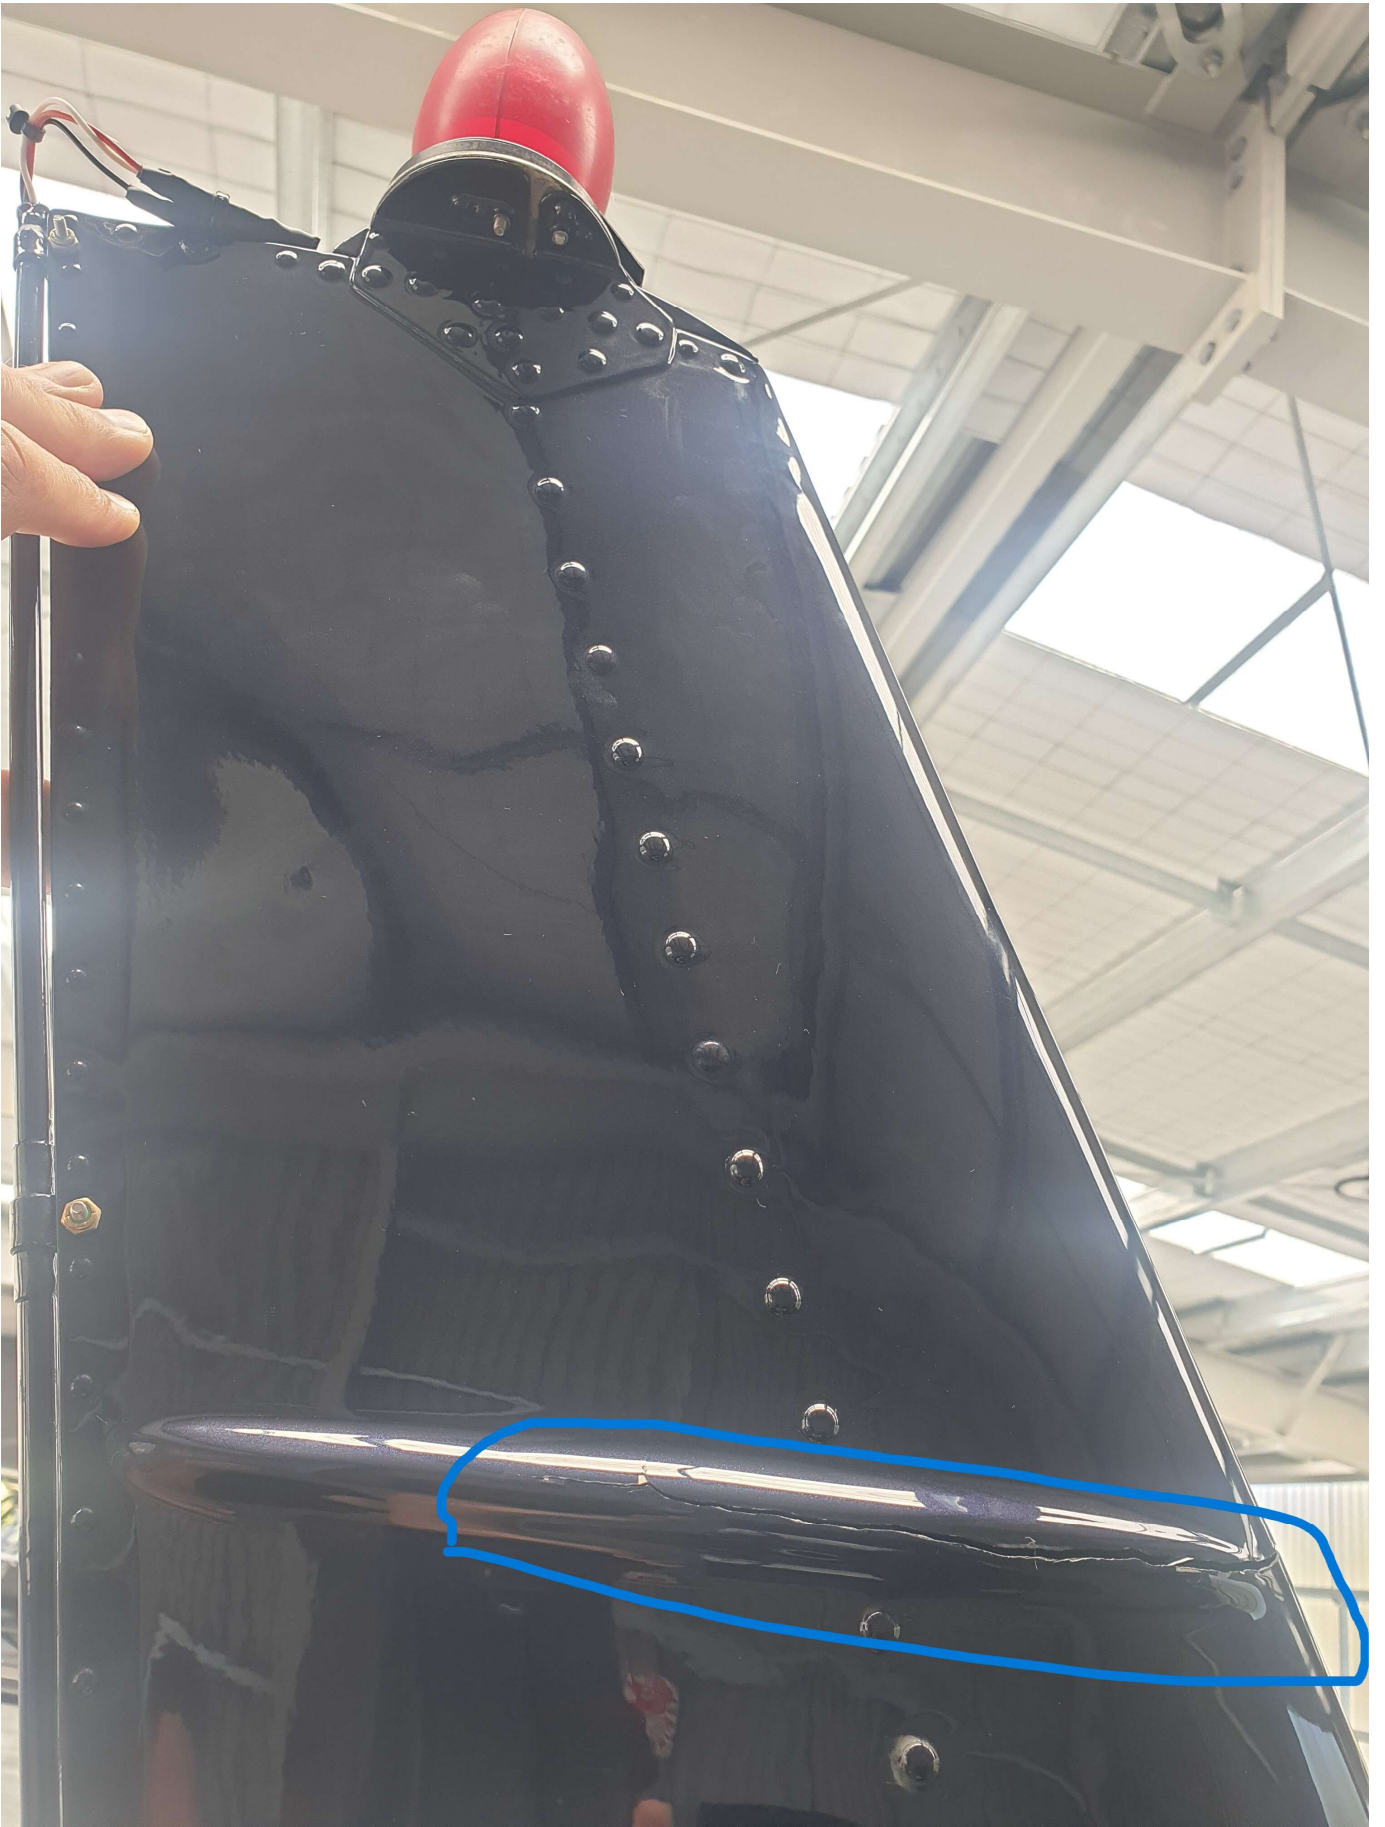
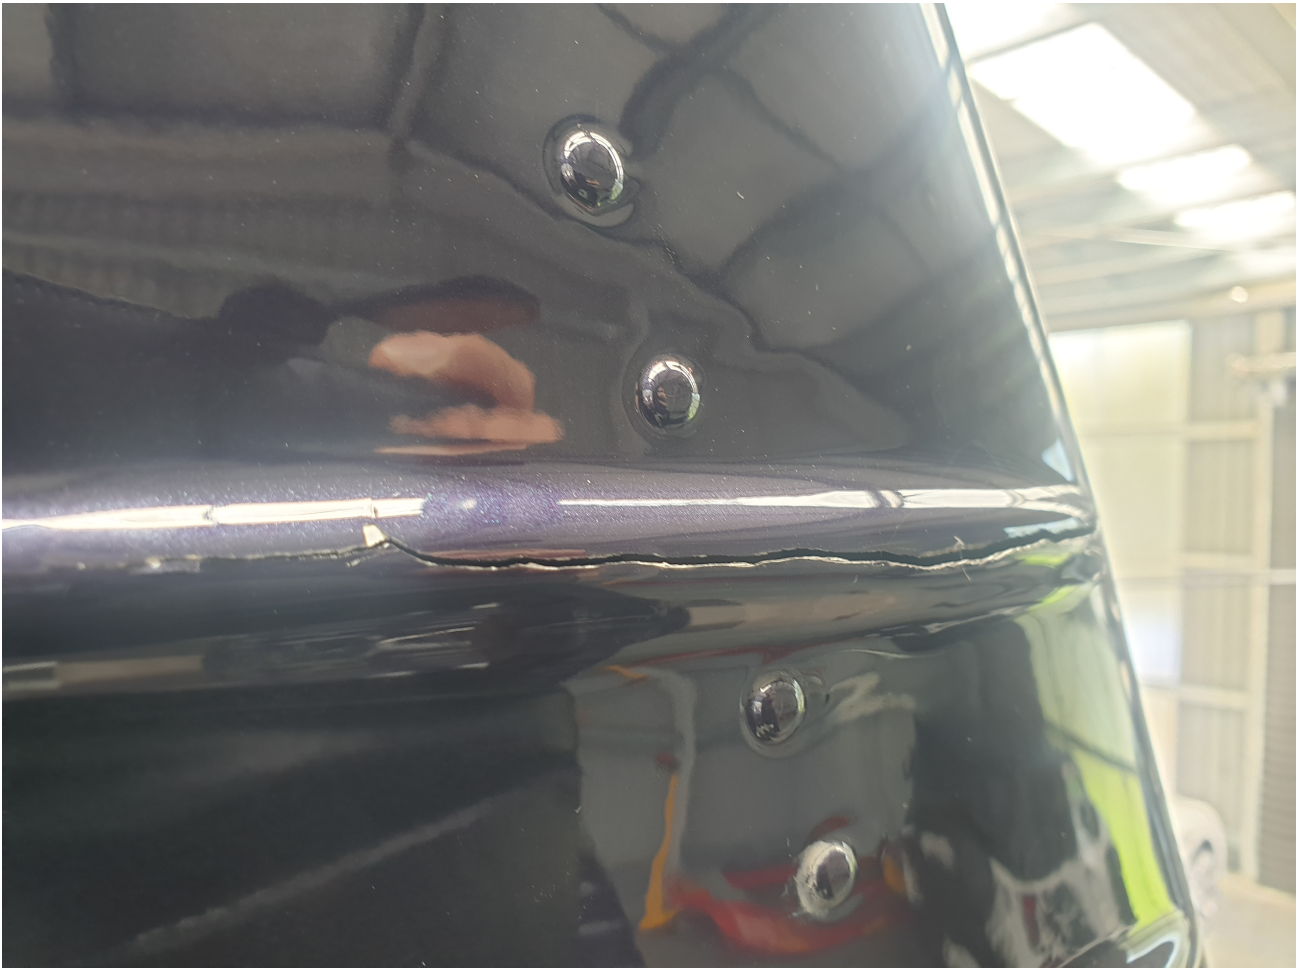
This CAN is prompted by a recent report from a New Zealand 369HS helicopter operator who found a significant crack in the upper vertical fin of their helicopter whilst conducting a routine cleaning of the helicopter. Based on the helicopter maintenance history, the crack seems to have developed in a noticeably short time frame.

The crack appears to extend from the leading edge of the upper vertical fin to approximately two-thirds of the chord length, and it is understood that the fin spar is also cracked.

CAA are engaging with the manufacturer to find the root cause.

The CAA recommends that operators of MD 369HS and Kawasaki 369HS helicopters pay particular attention to the affected area during pre-flight inspections. If any cracks are suspected, operators should seek the advice of their maintenance provider before further flight.
