Continuing Airworthiness Notice – 65-001

MD369 Helicopters - Tail Rotor Gearbox (TRG) Duplex Bearing Distress

23 August 2024

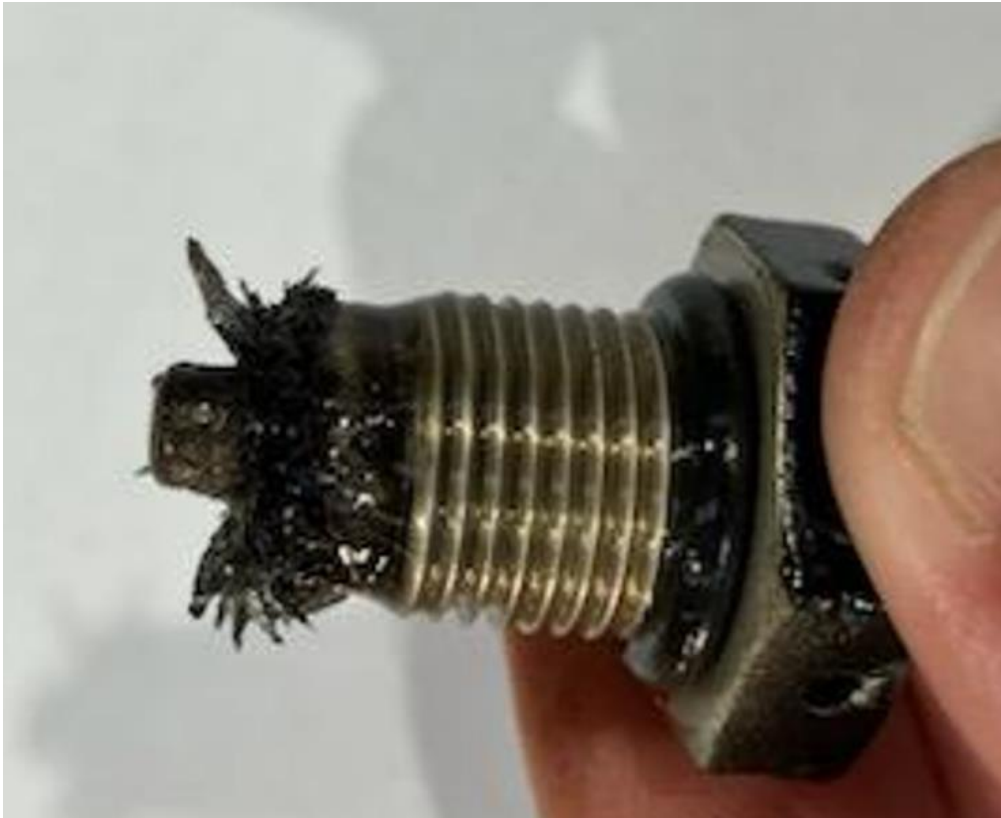
Whilst these defects were identified following activation of the chip detector system in three instances, in one case CAA understands that the chip detector did not activate. The pilot reported a 'ticking' sensation through the control pedals. A subsequent inspection confirmed TRG duplex bearing distress.

In all cases, an initial field investigation identified significant amounts of metal on the magnetic chip detector. (Refer to Figure 1 below).

Figure 1 - Magnetic chip detector from damaged TRG.

Operators are advised to treat any chip detector activation as legitimate.

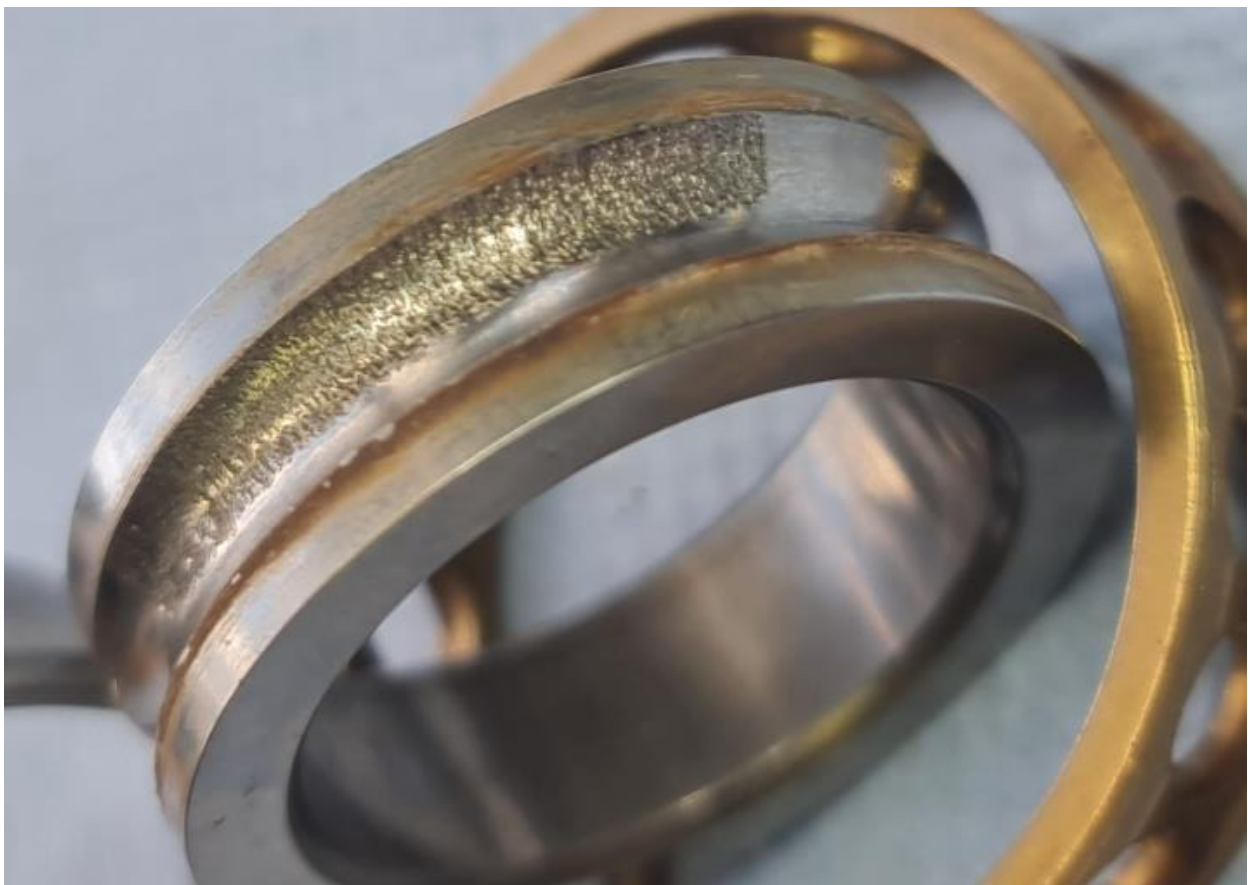
Significant TRG duplex bearing distress has been identified in a number of MD369 TRGs during service.

Further investigation (i.e. a shop visit) identified significant damage to the TRG, originating from the duplex bearing. (Refer to Figure 2 below).

CAA understands that the flight time following the chip detector activation was very short, indicating that the bearing has the potential to degrade extremely quickly in operation.

Figure 2 - Damaged duplex bearing.
