Continuing Airworthiness Notice – 56-001

Aeroprakt A-32 (Vixxen) Aircraft – Windscreen Cracks

17 June 2020

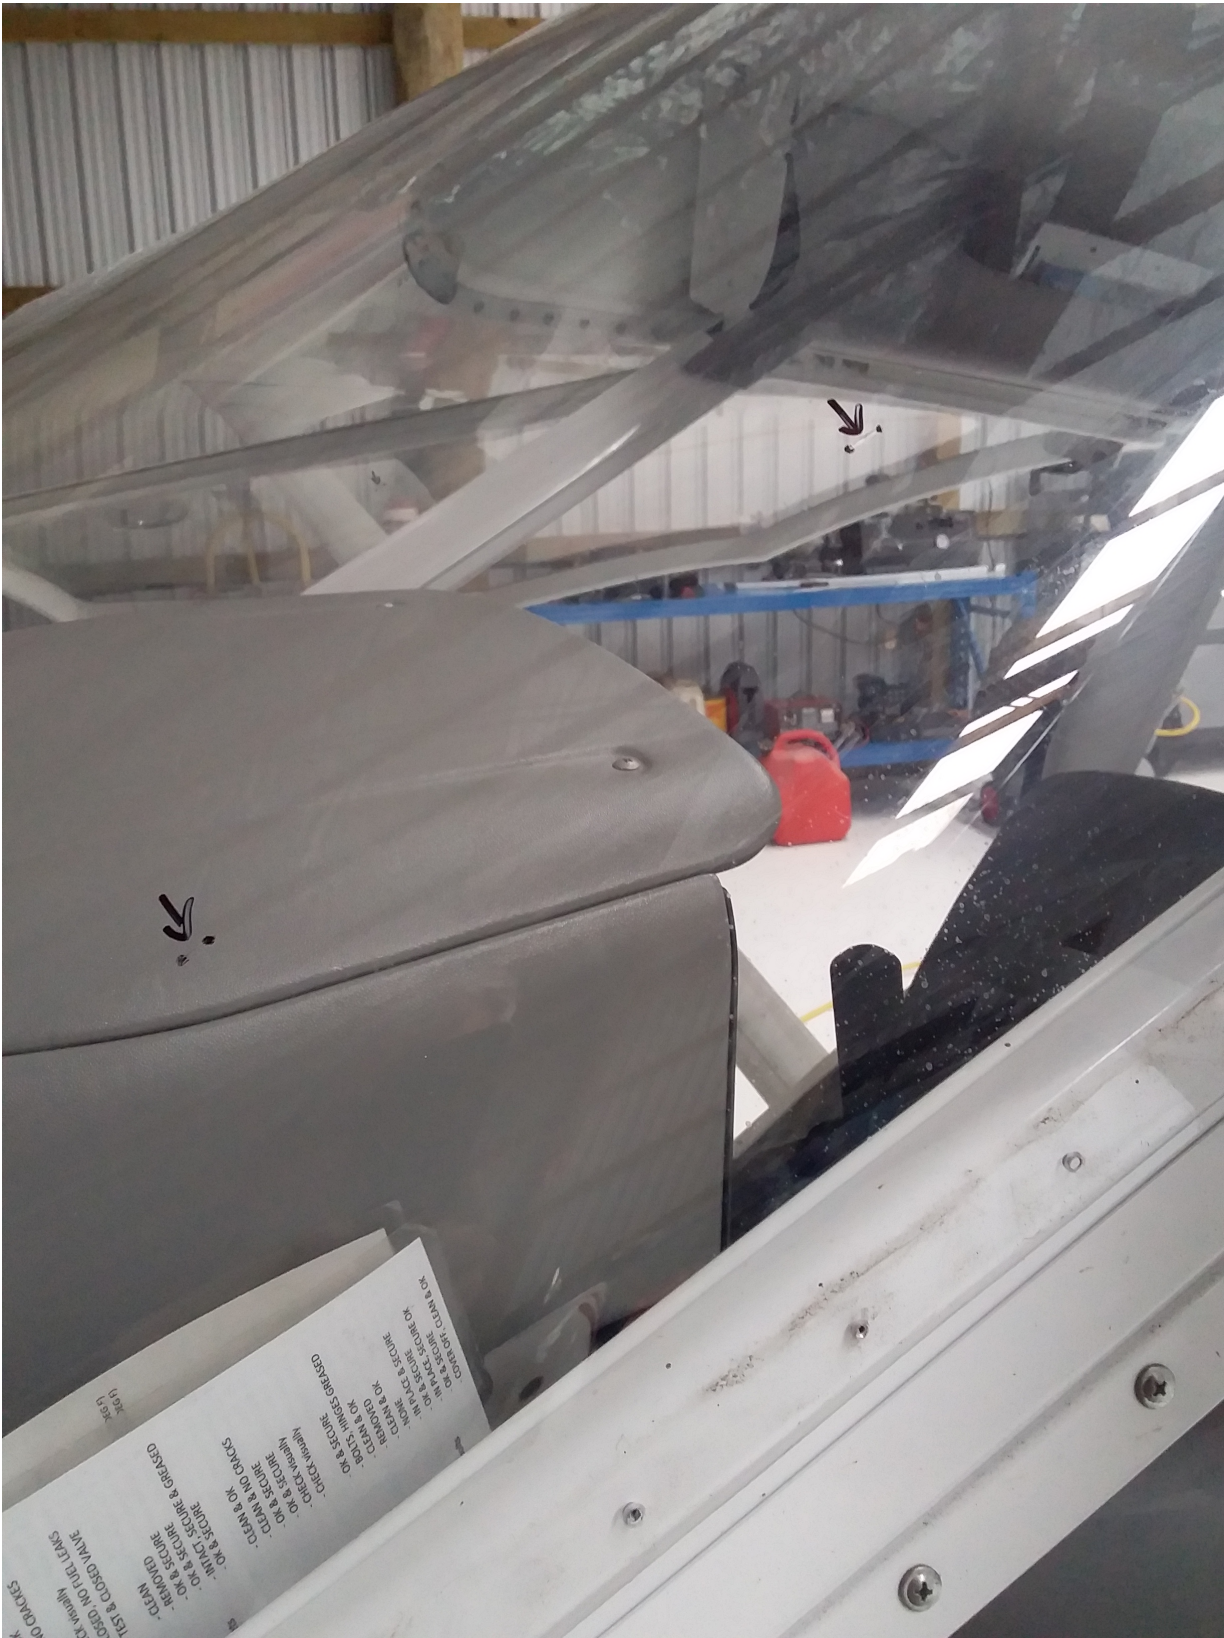
Photo 1: Windscreen LH side – Upper and lower cracks found in an A-32 windscreen. (The location of the two small cracks are between the dots and marked with black arrows).

Note: On this particular aircraft cracks were also found in the same area in the upper RH side of the windscreen, including under the RH side glass attachment strip, when the RH side strip was removed.

If an indication of a crack is found, then replace the windscreen, before further flight and report findings to the CAA.

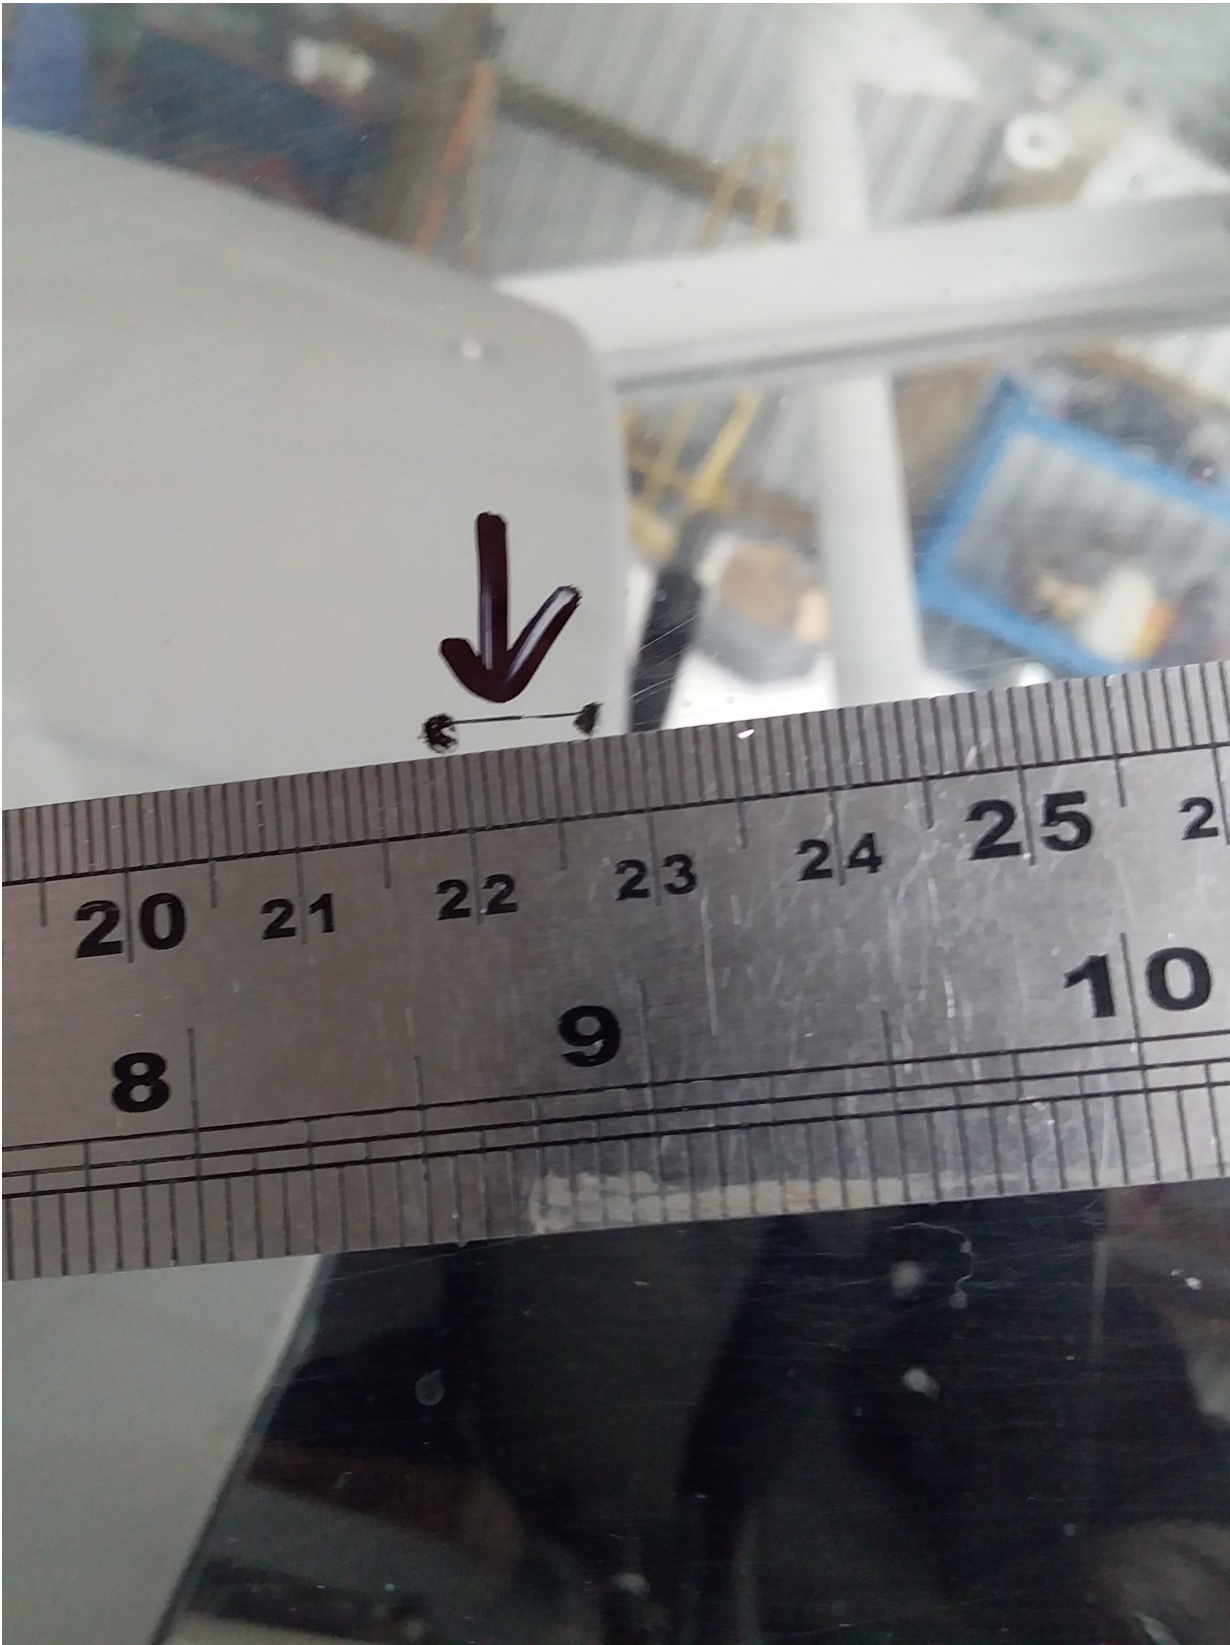
Photo 2: Windscreen LH side – Closeup of upper crack found in the A-32 windscreen. (The location of the small crack is between the dots and marked with a black arrow).
