Airworthiness Directive Schedule

Engines

Continental IO-470 Series and O-470 Series

28 September 2023

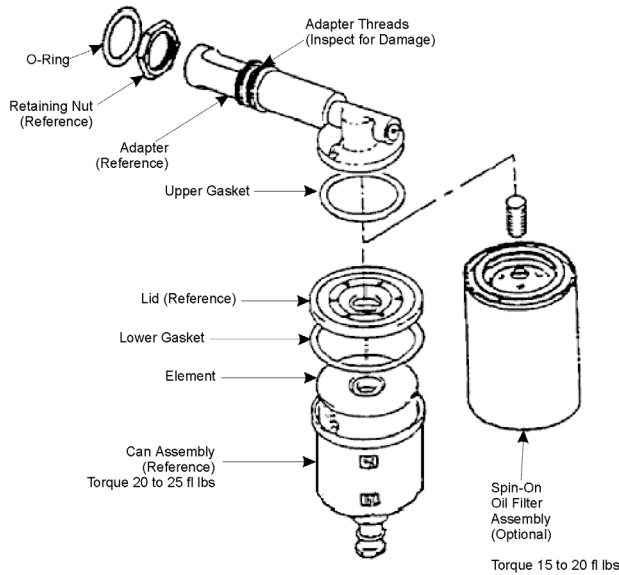
DETAIL A

2. For oil filter adapter assemblies that do have torque putty between the engine filter adapter assembly, nut, and oil pump housing, inspect the torque putty for misalignment, evidence of oil leakage, or cracks.

If any misalignment, evidence of oil leakage, or torque putty cracks are found, prior to further flight, accomplish the requirements specified in paragraph (1) of this AD, including all subparagraphs.

- (a) Inspect the adapter locking nut installation for evidence of oil leakage.
- (b) Check the torque of the adapter nut installation and ensure that the torque value is within the limits of 50 through 60 foot pounds.
- (c) If evidence of oil leakage is found or the torque is not within the 50 through 60 foot pound limit, prior to further flight, remove the adapter and filter assembly, and:
 - (i) Inspect the threads of the adapter assembly and engine for signs of damaged or cracked threads; and
 - (ii) Replace any adapter assembly and engine oil pump housing (if necessary) that have evidence of thread damage or cracks.
- (d) Apply torque putty between the engine filter adapter assembly, nut, and oil pump housing as specified in the diagram.
- (e) Reassemble the engine oil filter assembly.

Snap-On crows foot P/N AN8508-34A have ground down the ends for clearance
