# Airworthiness Directive Schedule

## Engines

### Continental IO-550 Series and TSIO-550-K Series

28 September 2023

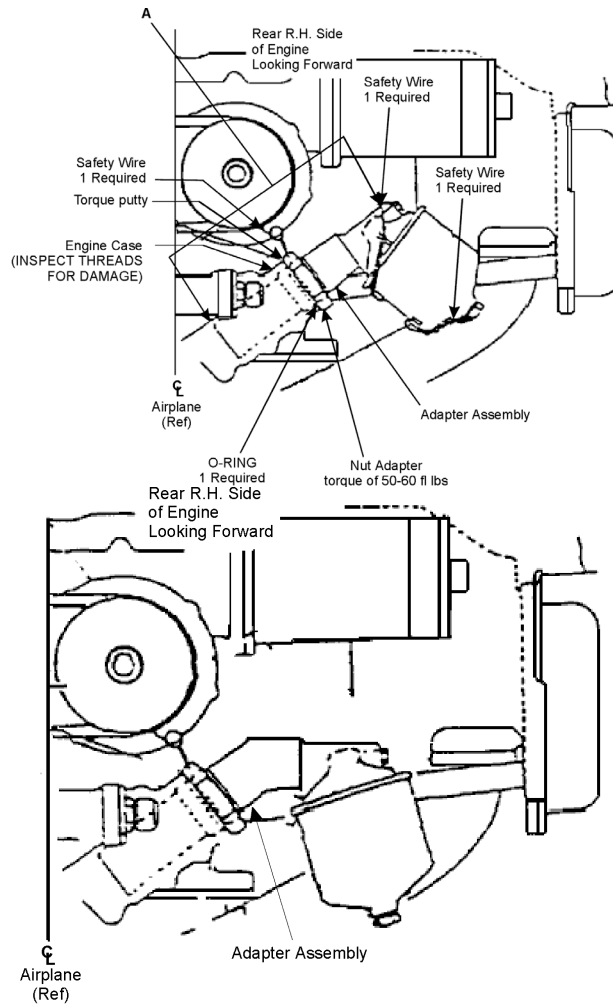
1. For oil filter adapter assemblies that do not have torque putty between the engine filter adapter assembly, nut, and oil pump housing, accomplish the following:

2. For oil filter adapter assemblies that do have torque putty between the engine filter adapter assembly, nut, and oil pump housing, inspect the torque putty for misalignment, evidence of oil leakage, or cracks.

Manufactured by Teledyne  
Continental Motors  
Not Applicable to This AD

- (a) Inspect the adapter locking nut installation for evidence of oil leakage.
- (b) Check the torque of the adapter nut installation and ensure that the torque value is within the limits of 50 through 60 foot pounds.
- (c) If evidence of oil leakage is found or the torque is not within the 50 through 60 foot pound limit, prior to further flight, remove the adapter and filter assembly, and:
  - (i) Inspect the threads of the adapter assembly and engine for signs of damaged or cracked threads; and
  - (ii) Replace any adapter assembly and engine oil pump housing (if necessary) that have evidence of thread damage or cracks.
- (d) Apply torque putty between the engine filter adapter assembly, nut, and oil pump housing as specified in the diagram.
- (e) Reassemble the engine oil filter assembly.

If any misalignment, evidence of oil leakage, or torque putty cracks are found, prior to further flight, accomplish the requirements specified in paragraph (1) of this AD, including all subparagraphs.
