Airworthiness Directive Schedule

Helicopters

Airbus Helicopters AS 350 Series

27 March 2025

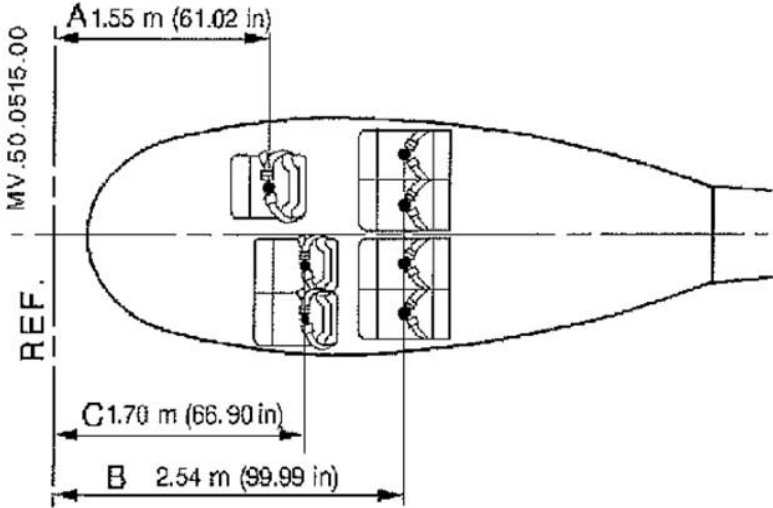
Figure: Airbus Helicopters recommended CG position of forward two-place seat

2. Remove CAA Limitations Section, (1 page), dated 14 December 2015 and insert 1 page dated 30 June 2016.
