Airworthiness Directive Schedule

Helicopters

Robinson R22 Series

31 October 2024

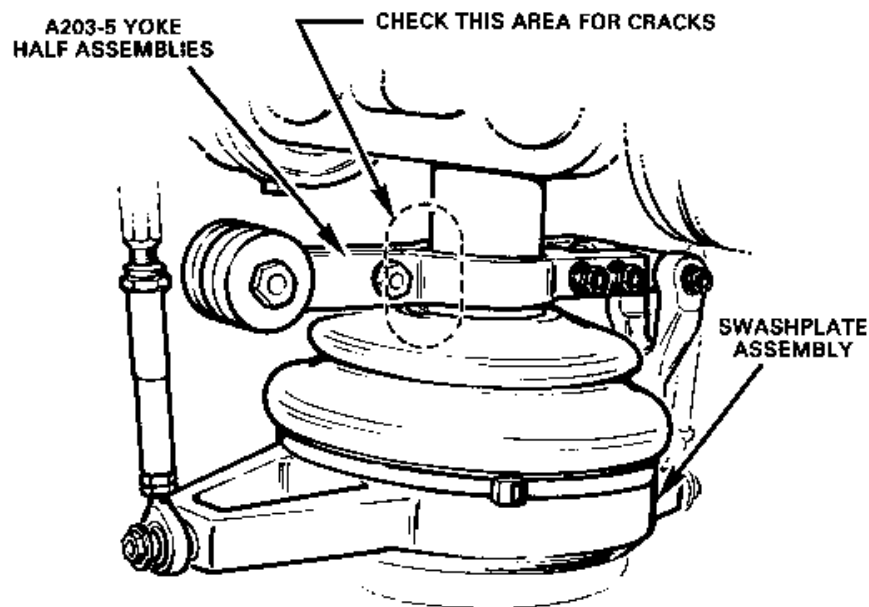
1. Inspect each yoke for cracks. The diagram shows the area to be inspected. If a yoke is found cracked, before further flight, replace the yokes with airworthy yokes, P/N A203-7. Both yokes must be replaced with P/N A203-7.

2. Determine the Lot identifier of each yoke. If the Lot identifier is from 24 through 43, if it is a letter code, or if it is illegible, replace yokes, P/N A203-5, with airworthy yokes, P/N A203-7. Yoke, P/N A203-7, cannot be installed with yoke, P/N A203-5.

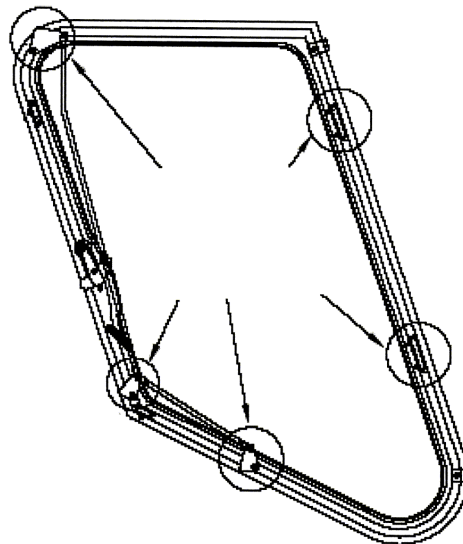
1. Visually inspect each pilot and copilot door assembly integral frame for cracks in the locations indicated in the figure below:

If a crack is found in any door assembly integral frame, replace LH door assembly P/N R-22-101-51 or P/N R-22- 101-53, and R/H door assembly P/N R-22-101-52 or P/N R-22- 101-54, per Tech-Tool Plastics, Inc. Installation Instructions TTP-1R, Revision A, and per the sections titled "Door Weather Seal Installation" and "Cotter Pin Installation" in Tech-Tool Plastics, Inc. Service Bulletin TTP2005-01, Revision A, prior to further flight.
