Airworthiness Directive Schedule

Helicopters

Robinson R44 Series

19 December 2024

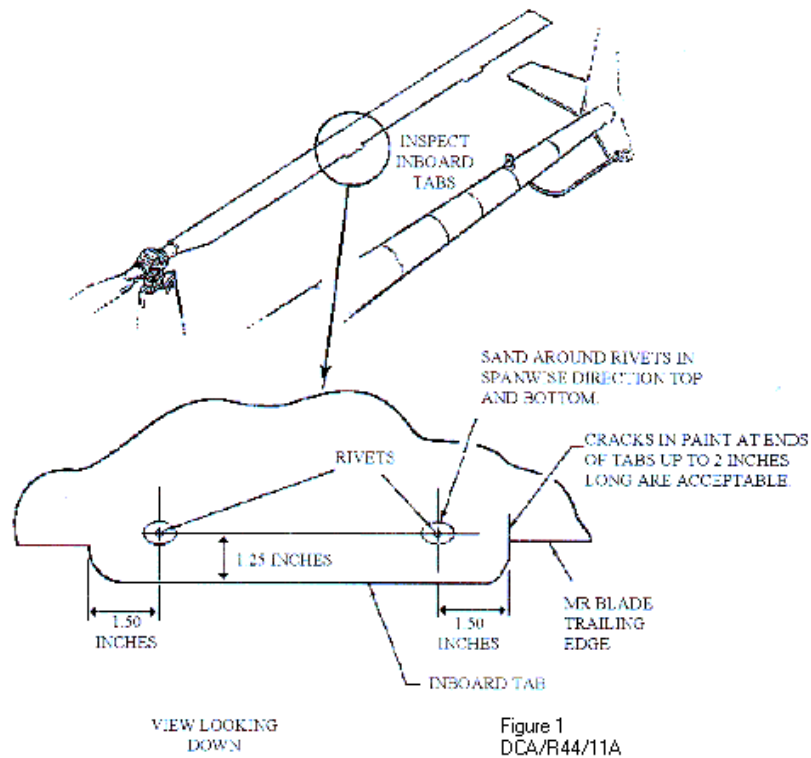
2. Using a 5-power or higher magnifying glass, visually inspect both upper and lower main rotor blade skin surfaces around the inboard trim tab rivets (4 locations) for cracks. If a crack is found, replace the main rotor blade with an airworthy main rotor blade before further flight.

3. Install a set of main rotor blades, P/N C016-2. This constitutes terminating action for the inspections required by this AD.

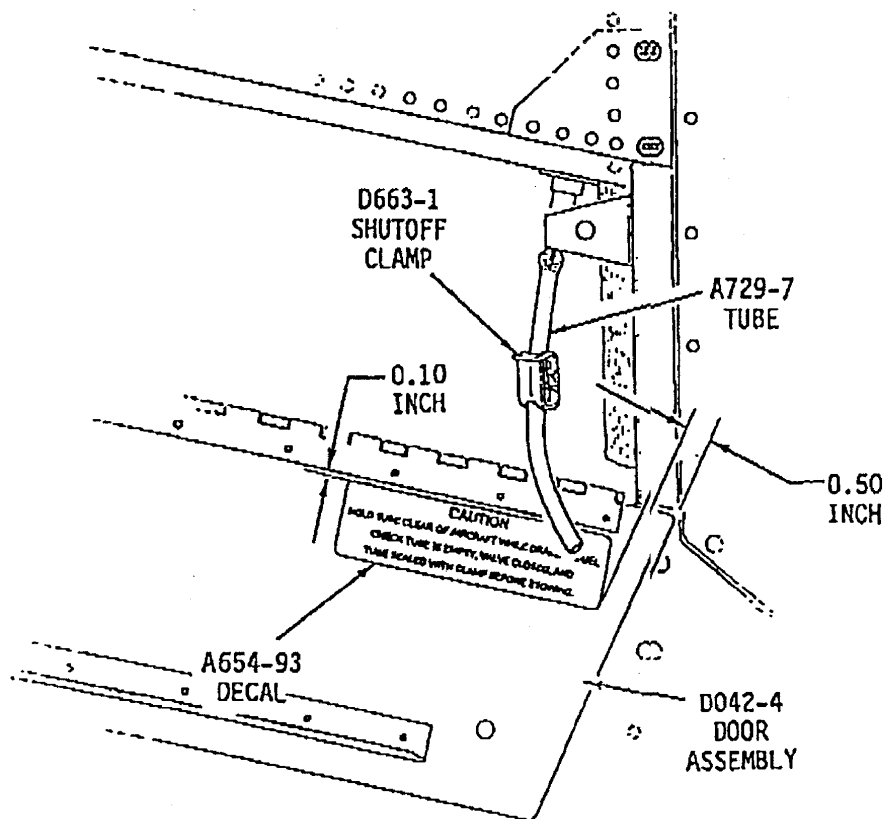
FIGURE 1
AD 99-13-11

Requirement: To prevent fuel leaks from the auxiliary fuel tank sump drain, which could cause a fire and subsequent loss of the helicopter, accomplish the following:-

Install placard decal, P/N A654-93, as shown.

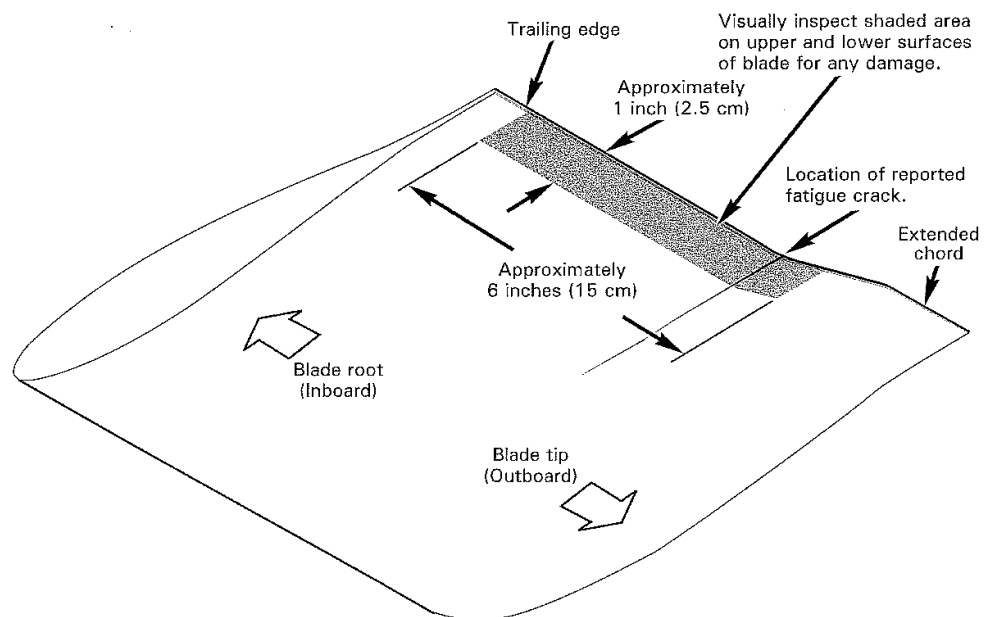
Figure 1 – Section of MRB P/N C016-7 (View of blade lower surface)

1. Inspect the upper and lower surfaces of each main rotor blade in the area shown in Figure 1. Inspect for any damage which may initiate a fatigue crack. A stepladder may be required to inspect the blades.

If the inspection reveals any damage or unusual marks, then the blades must be inspected by a maintenance engineer before further flight.

If any unusual rotor system vibration is detected in flight, land immediately and inspect the main rotor blades in the area shown in Figure 1. If the inspection reveals any damage or unusual marks, then the blades must be inspected by a maintenance engineer before further flight.

2. Modify the main rotor blades per the instructions in Robinson Helicopter Company R44 Service Bulletin SB-89 dated 30 March 2015.
