Airworthiness Directive Schedule

Helicopters

Sikorsky S-76 Series

24 June 2021

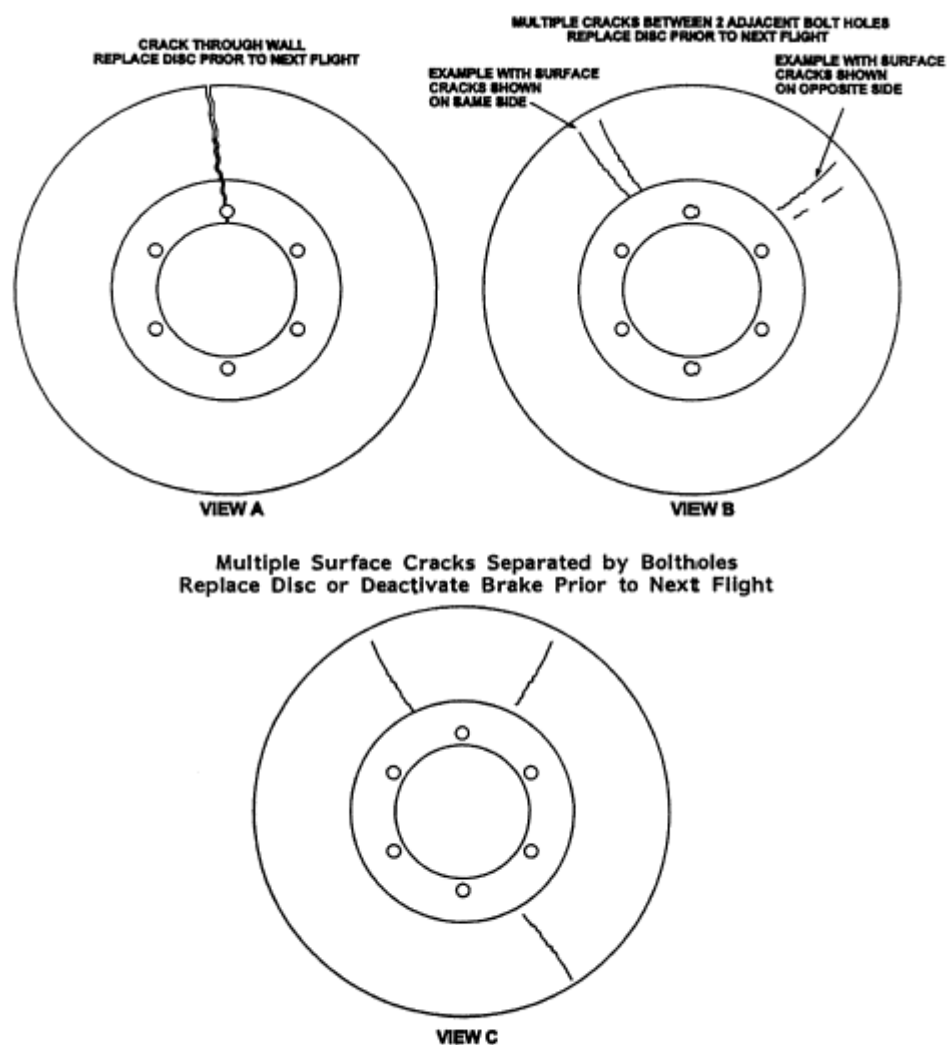
**RBD INSPECTION LIMITS
FIGURE 1.**

2. Visually inspect each RBD, P/N 76363-09103-104, for a crack, and perform the following actions. See Figure 1.

- a. If you find a crack through the entire RBD thickness as shown in Figure 1, View A, replace the RBD with an airworthy RBD, other than P/N 76363-09103-104, before further flight.
- b. If you find two or more surface cracks between adjacent boltholes as shown in Figure 1, View B, replace the RBD with an airworthy RBD, other than P/N 76363-09103-104, before further flight.
- c. If you find a surface crack or surface cracks separated by the boltholes as shown in Figure 1, View C, replace the RBD with an airworthy RBD, other than P/N 76363-09103-104, or deactivate the RBD before further flight.

3. Replace PHC RBD, P/N 76363-09103-104, with an airworthy RBD by 31 May 2003. Any replacement RBD, P/N 76363-09103-104, is not airworthy. (FAA AD 2003-04-15 refers)
