Feedback

Canadian Aviation Service Difficulty Reports

The following content was published between April 2, 2020 and July 7, 2020. The full accessible version of each article is available on the Feedback [website](#).

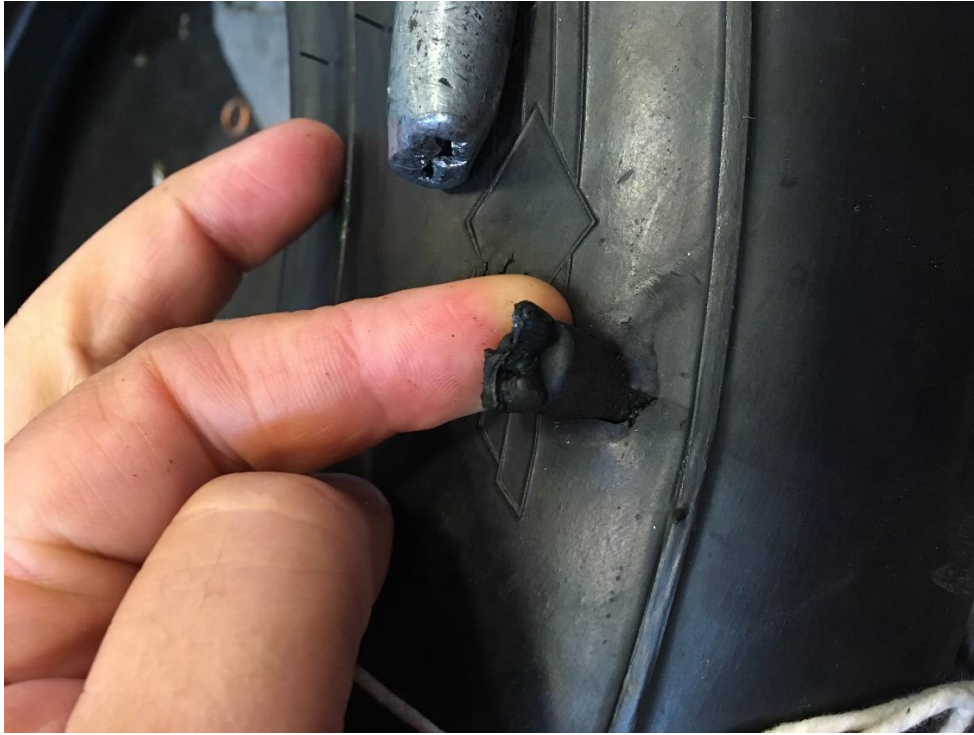
It appears that during manufacture of the tire, a piece of metal fell into the mold and was molded into the tire sidewall. The tire manufacturer's post-inspection requirements (Quality Control) did not detect the foreign object inside the tire sidewall. The defect was not discovered until the tire was inflated by maintenance personnel after installing the tire. The supplier and tire OEM were advised of this event by the operator and Transport Canada Continuing Airworthiness.

Fig 3: Indications metal was molded into tire

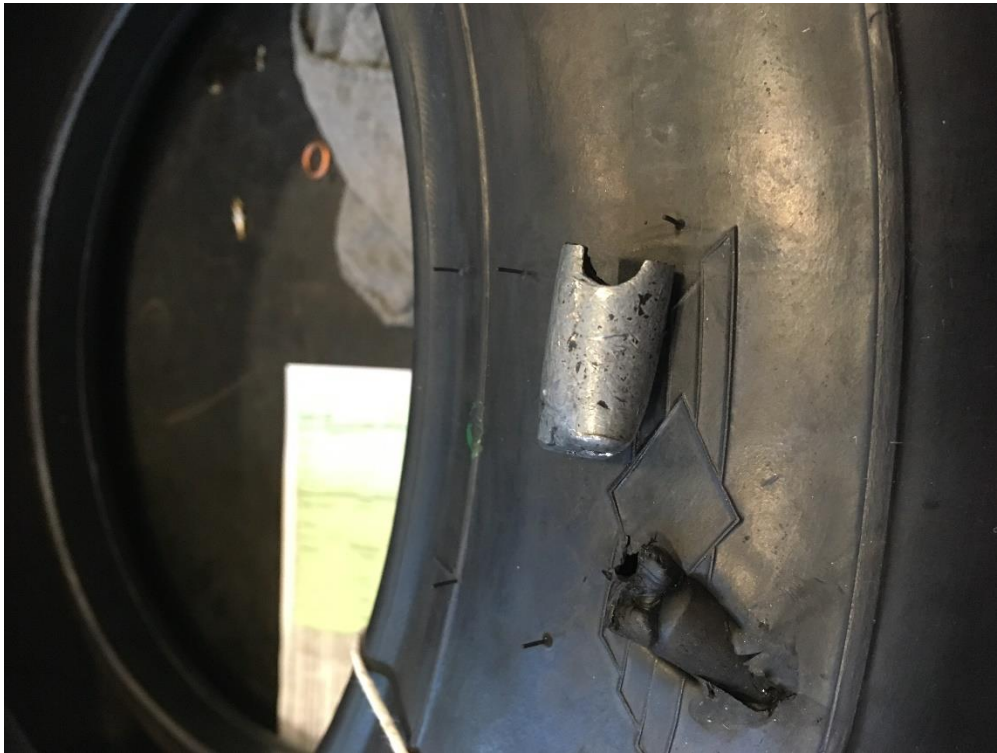
Fig 4: Metal removed

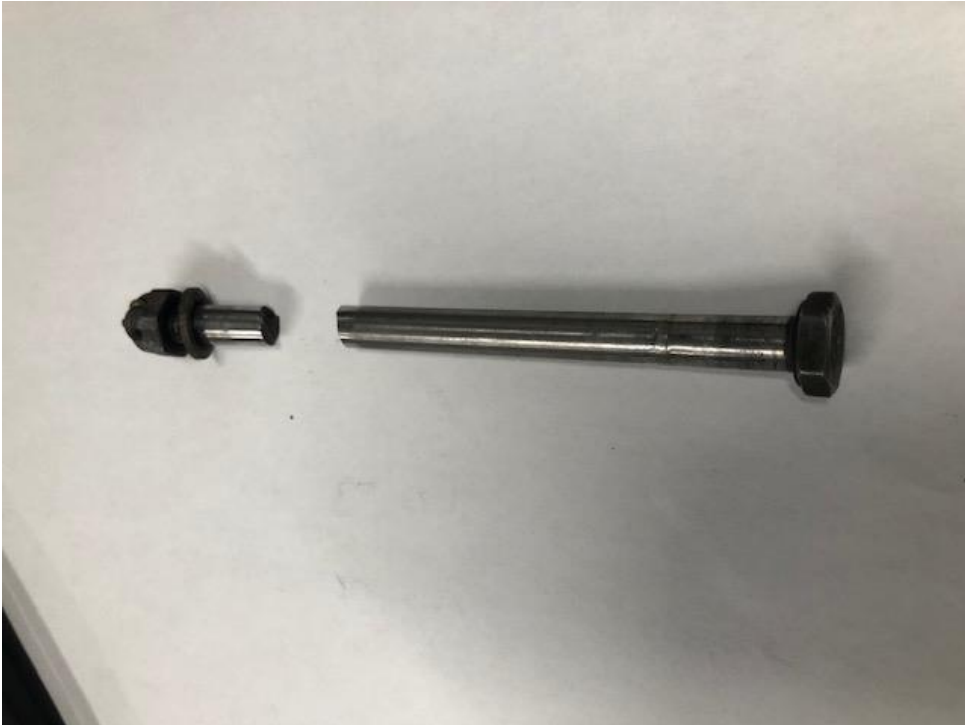
Pic 2: Sheared bolt
