Airworthiness Directive Schedule

Propellers and Propeller Governors

Hartzell Series

27 May 2021

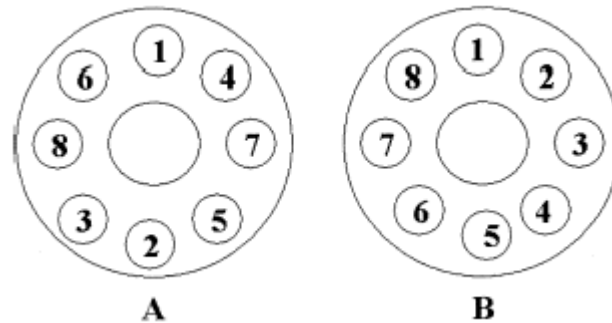
Requirement: To prevent propeller attaching bolt failures or improperly secured propellers, which could lead to separation of the propeller from the aircraft, accomplish the following:

If the torque of any one of the bolts is found to be less than 100 ft.lbs, remove all eight bolts and washers and replace with P/N B-3339 bolts and P/N A-2048-2 washers, or other equivalent manufacturer approved bolts and washers, per requirement 2 of this AD.

(d) Torque all attaching bolts with a torque wrench and an appropriate adapter, to 40 ft.lbs, and then to 80 ft.lbs, following sequence "A" (shown below). Final torque all attaching bolts using sequence "B" (shown below) to 100 ft.lbs to 105 ft.lbs. Safety wire lock all attaching bolts in a manufacturer approved manner.
