In-flight Breakup

Van's Aircraft Incorporated RV-7 ZK-DVS

Te Kopuru, Northland

CAA final report 17/8080

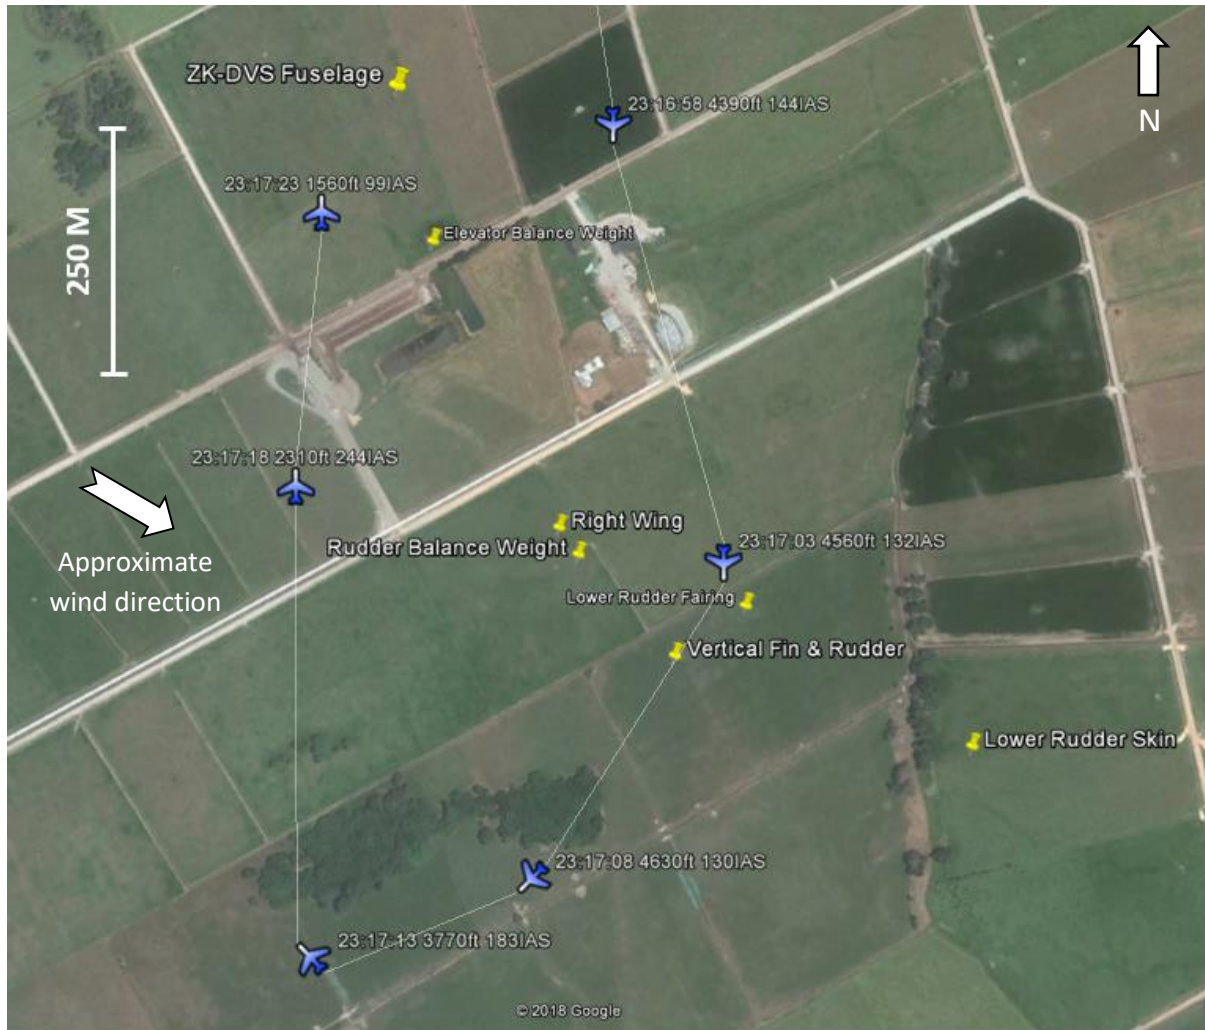
Figure 1: Wreckage distribution and aircraft position reports from EFIS

The main wreckage site contained the engine, propeller, and the aircraft fuselage. Attached to the aircraft fuselage were the left wing, the horizontal stabiliser, and the lower rudder attachment frame, attached only by the rudder control cables (Figure 2). The vertical stabiliser and top half of the rudder were located approximately 600 metres south-east of the main wreckage site. The right wing was located approximately 450 metres south-east of the main wreckage site (Figure 1).

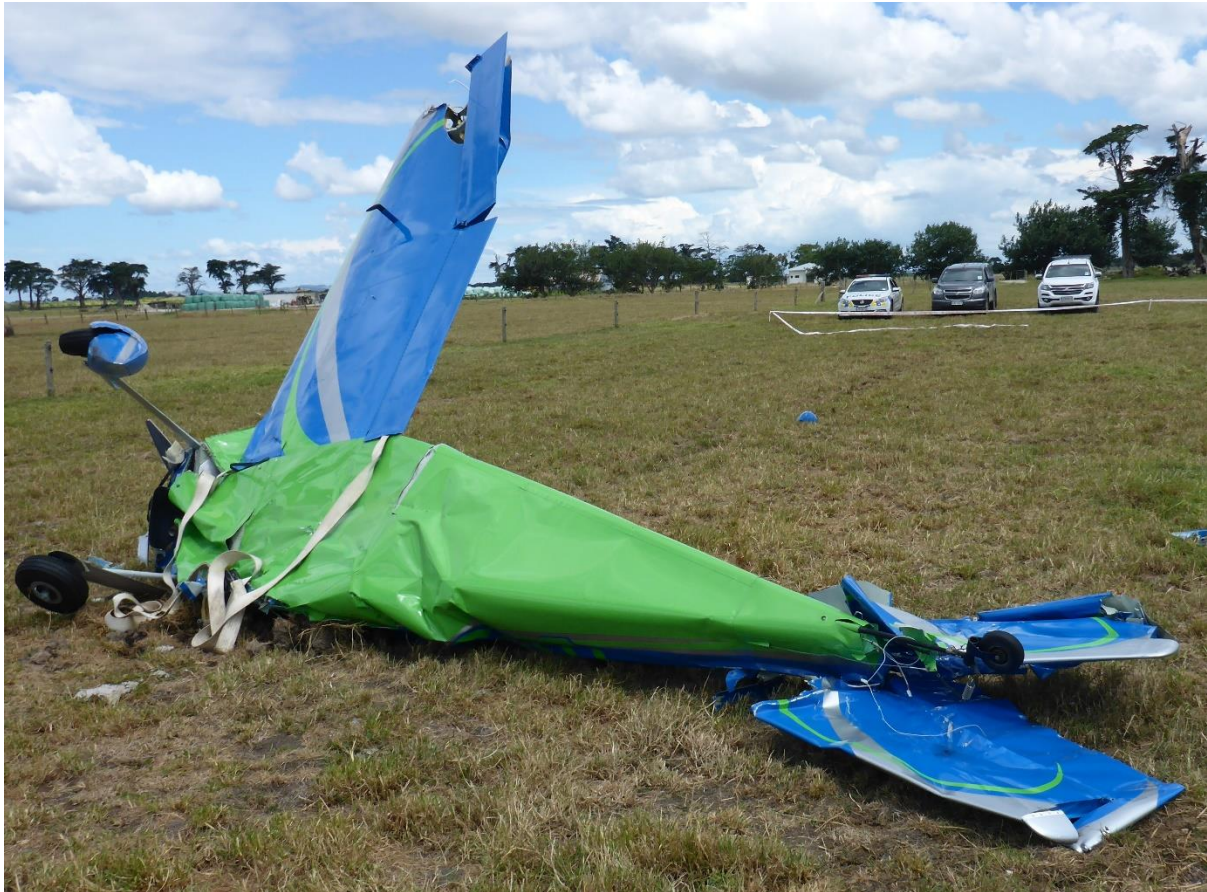
Figure 2: Main wreckage (Source: scene investigation – note: stop around wing used for aircraft wreckage recovery)

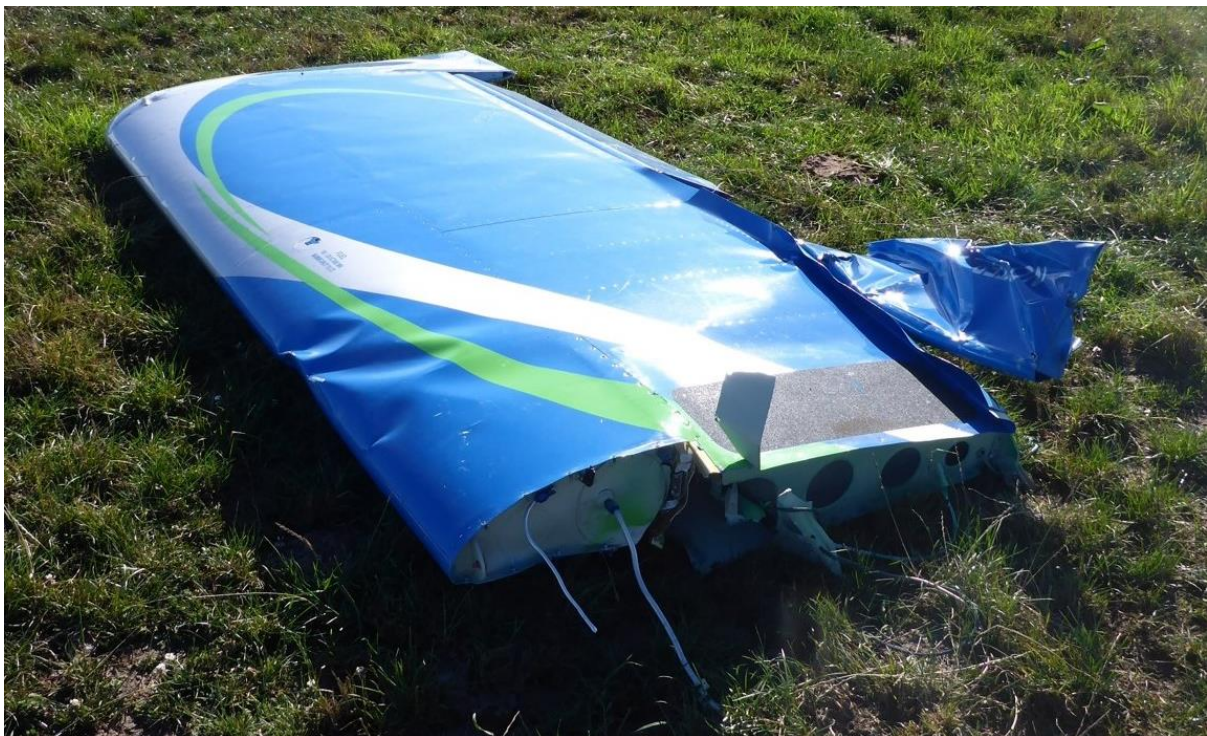
Figure 3: Right wing (Source: scene investigation)

(refer Appendix 2: Accident reports). The damage to the right wing of ZK-DVS was consistent with a downward failure in negative overload (Figure 3).

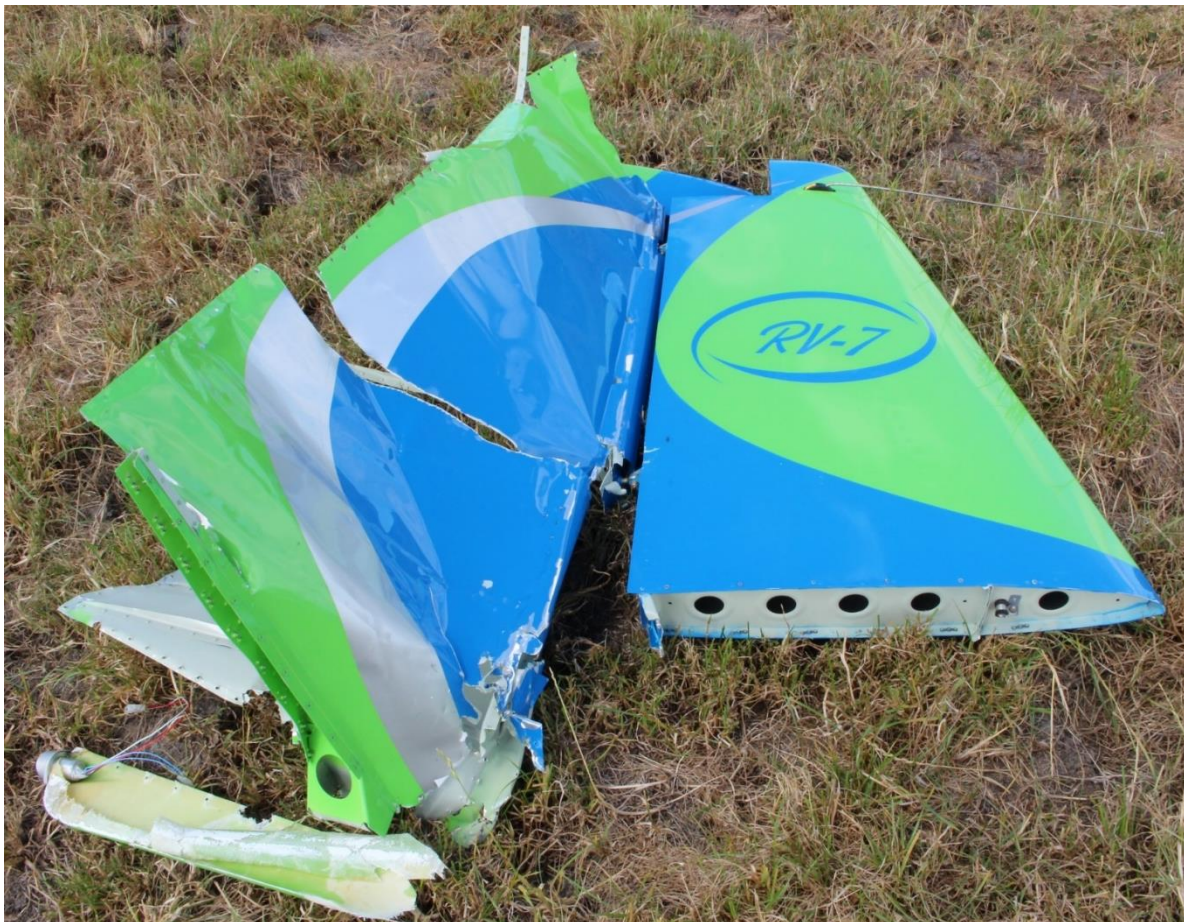
The top half of the rudder was still attached to the vertical stabiliser at the top and centre hinges and had fractured in half just below the centre hinge. The rudder had split open at the trailing edge riveted joint. The skin fracture surfaces were consistent with overstress. There were no indications of progressive failure. Numerous parts of the rudder, including the rudder balance weight and lower skin section, had separated from the main rudder structure (Figure 4).

Figure 4: Rudder and vertical Stabiliser from ZK-DVS (Source: scene investigation – items purposely arranged after recording in-situ)

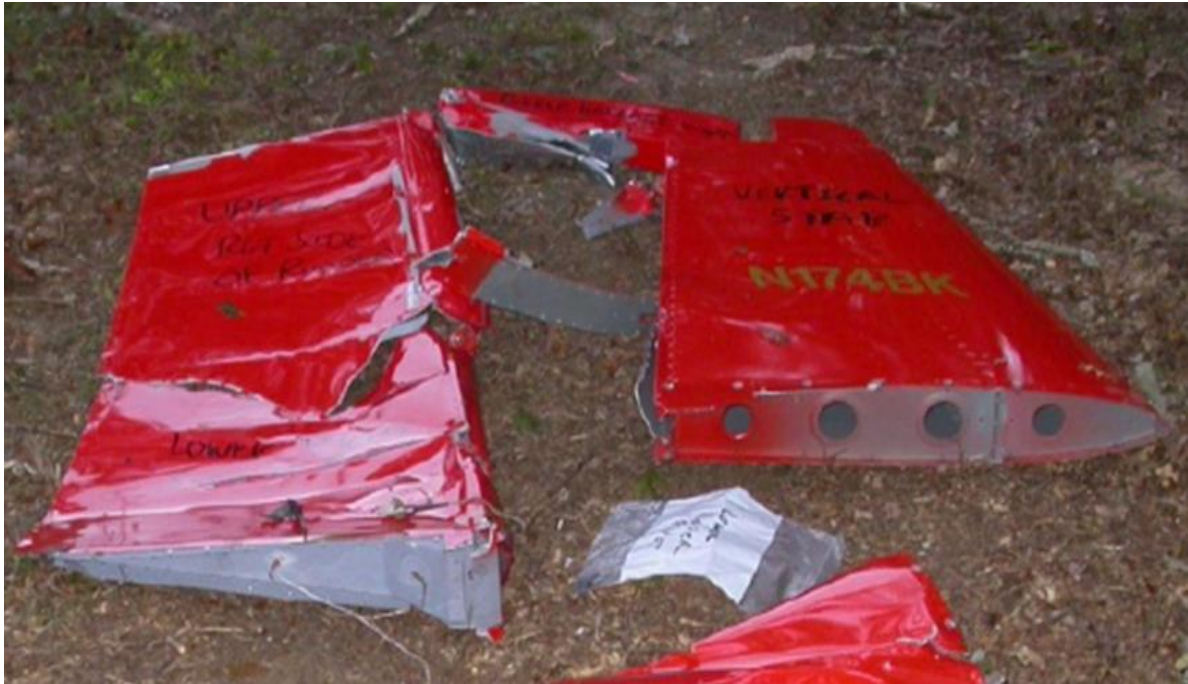
Figure 5: Rudder and vertical stabiliser from N174BK (Source: NTSB)

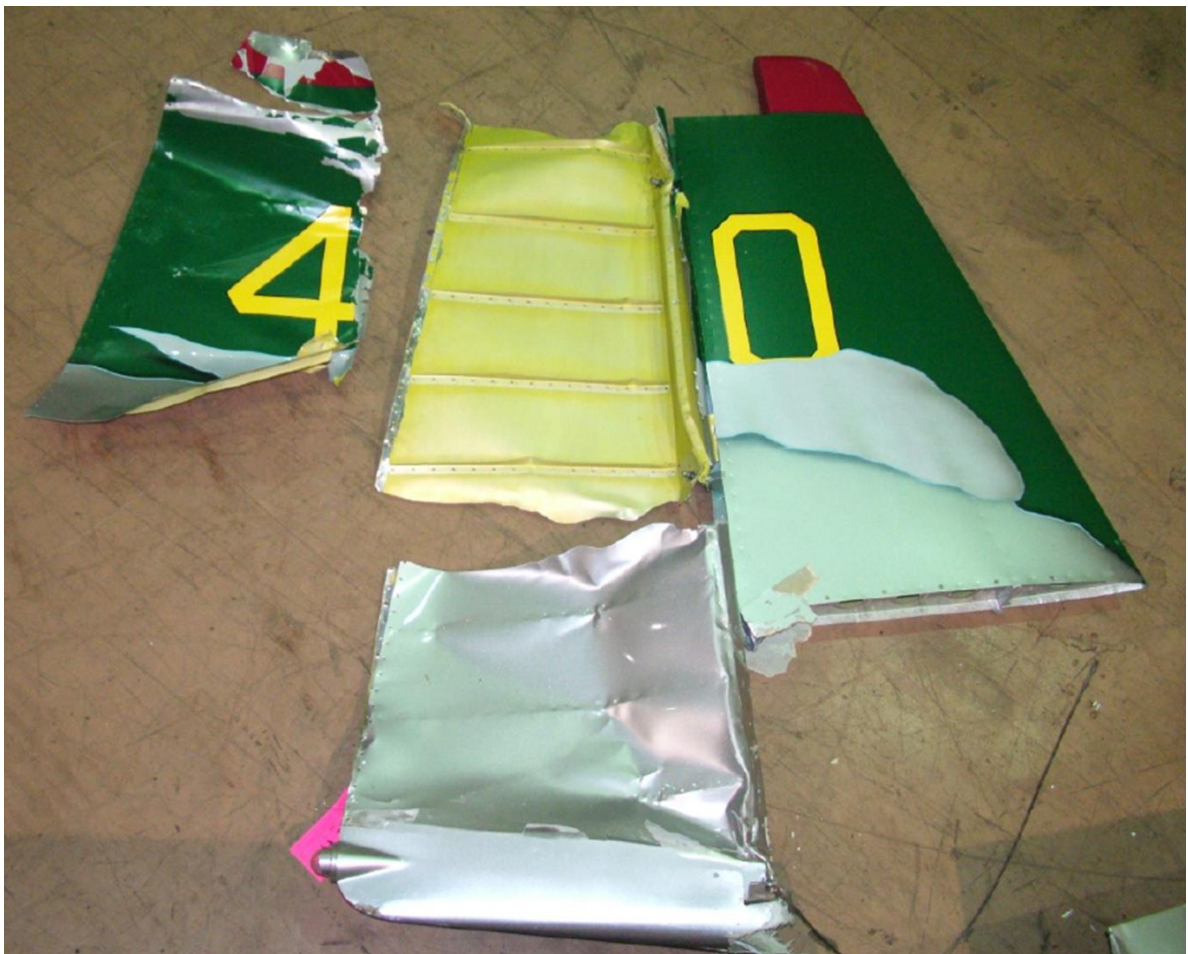
Figure 6: Rudder and vertical stabiliser from C-GNDY (Source: TSB)
