**CAA OCCURRENCE 22/4516**

**Cessna 182H Skylane**

**ZK-MGB**

**Collision with terrain**

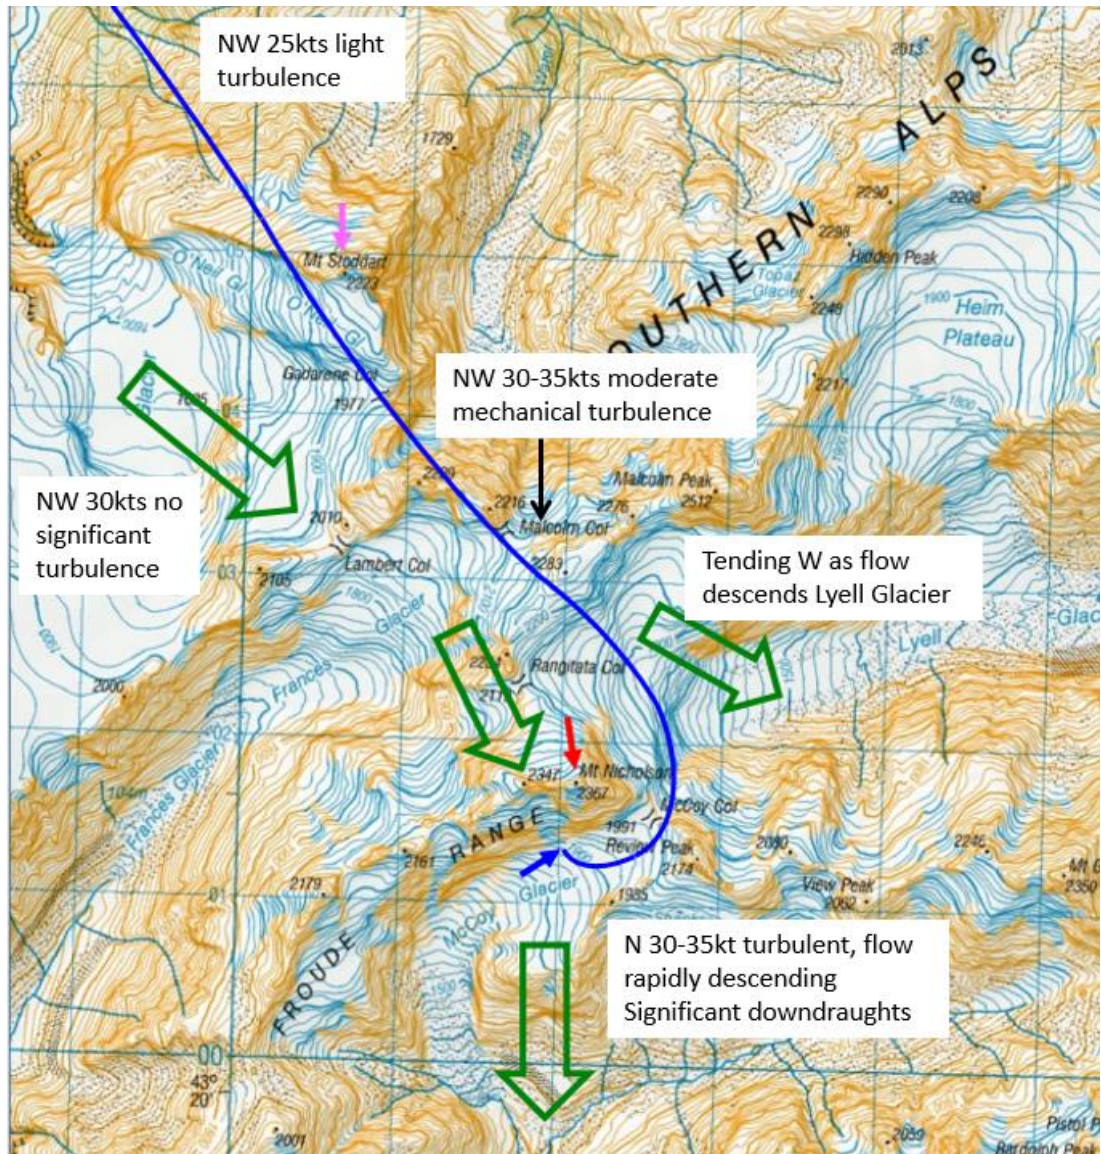
- ZK-MGB likely encountered significant downdraughts, even at altitudes higher than Mt Nicholson. These would have become stronger as ZK-MGB dropped below the ridgeline of Mt Nicholson and the Froude Range. Refer to Figure 6.

**Figure 6: Possible wind flow (green arrows) around Mt Nicholson and the accident site (blue arrow). Approximate flight path (blue line); Mt Nicholson (red arrow); Mt Stoddart (pink arrow). Source: MetService report.**

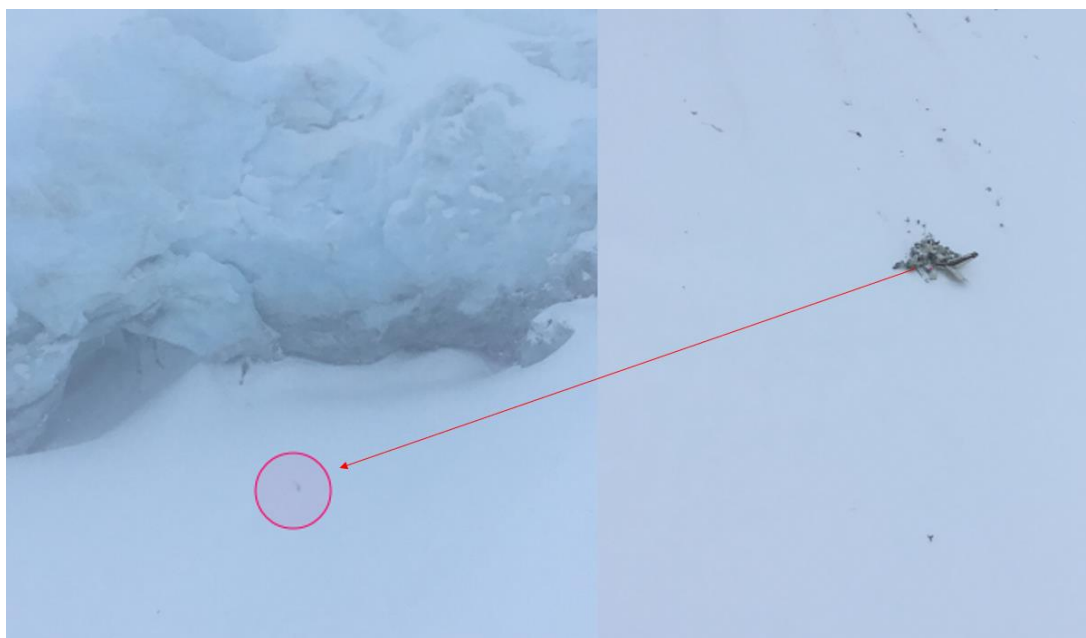
1.12.2 SAR personnel could not locate the initial point of impact but believed ZK-MGB impacted higher up the glacier and subsequently fell over the ice shelf.

SAR imagery showed scattered debris above the ice shelf, which supports their assessment. ZK-MGB was significantly damaged by the accident sequence. Refer to Figure 8.

**Figure 8: Proximity of final resting point of the wreckage to the ice shelf. Source: RCCNZ SAR photos.**

1.12.3 It was not possible to draw conclusions about the impact sequence, but the amount of damage and pattern of debris indicates it was a high-energy impact.

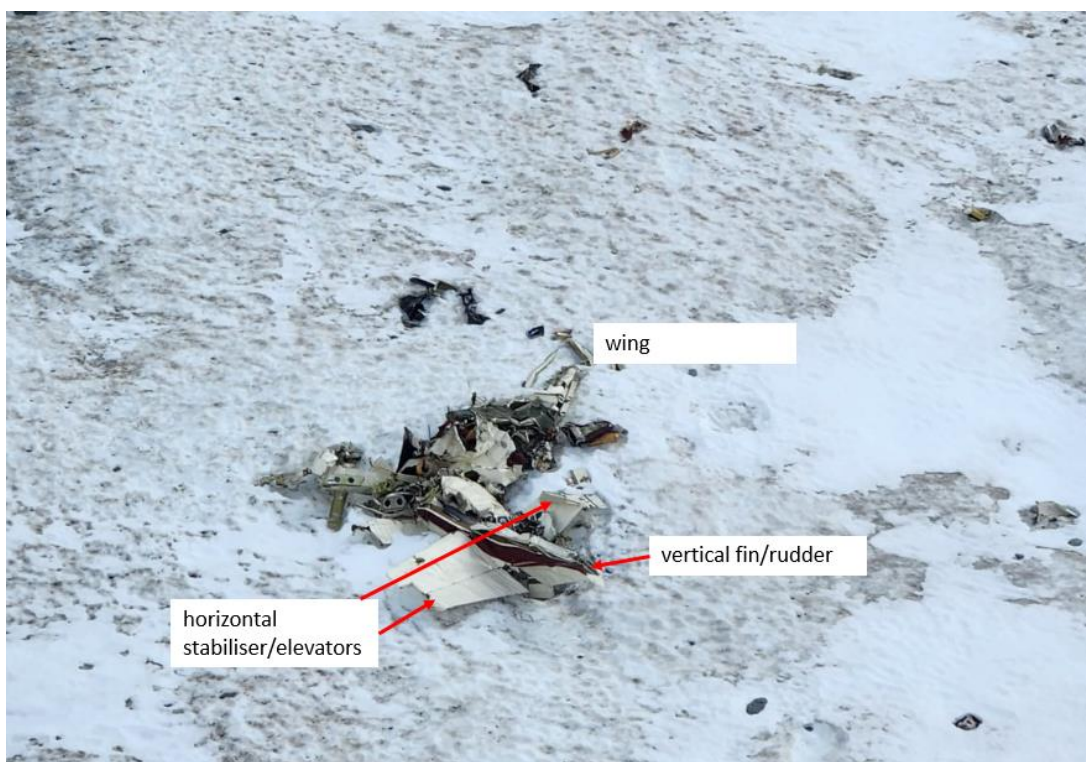
1.12.5 As ZK-MGB was not recovered, no detailed wreckage examination was possible.

Figure 9: ZK-MGB, 04 March 2023. Source: Witness photo (edited) supplied by NZ Police.

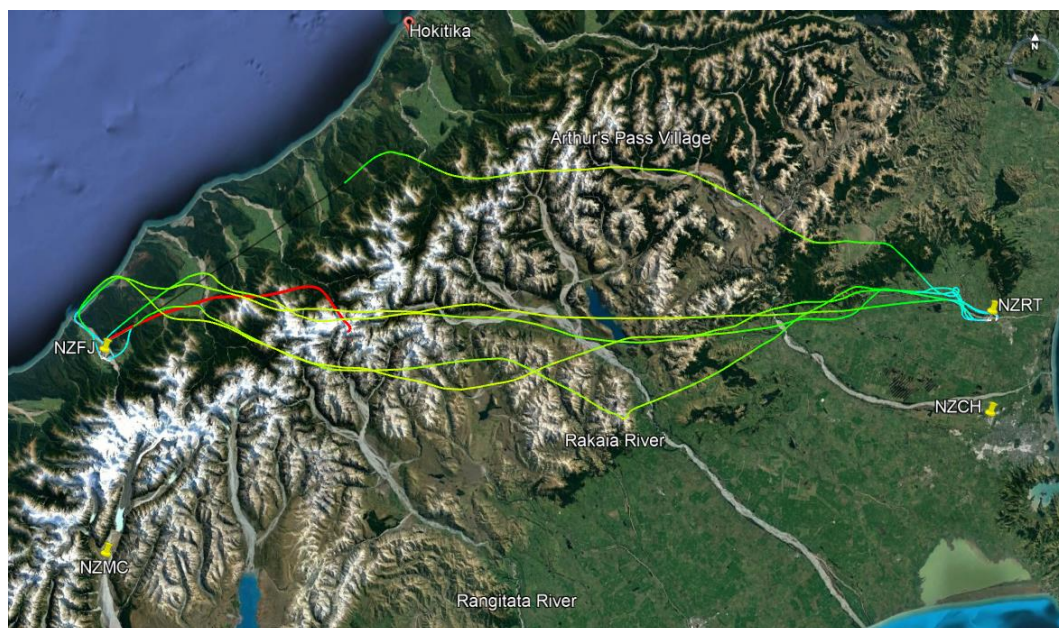
Figure 10: Previous flights between Franz Josef (NZFJ) and Rangiora (NZRT). Accident track in red. Source: ADS-B data overlaid on Google Earth™.

- 1.16.2 The tracks from two flights flown in October 2021 closely matched the track of the accident flight. Another two tracked about 11 km to the south and another to the north via Arthur's Pass.

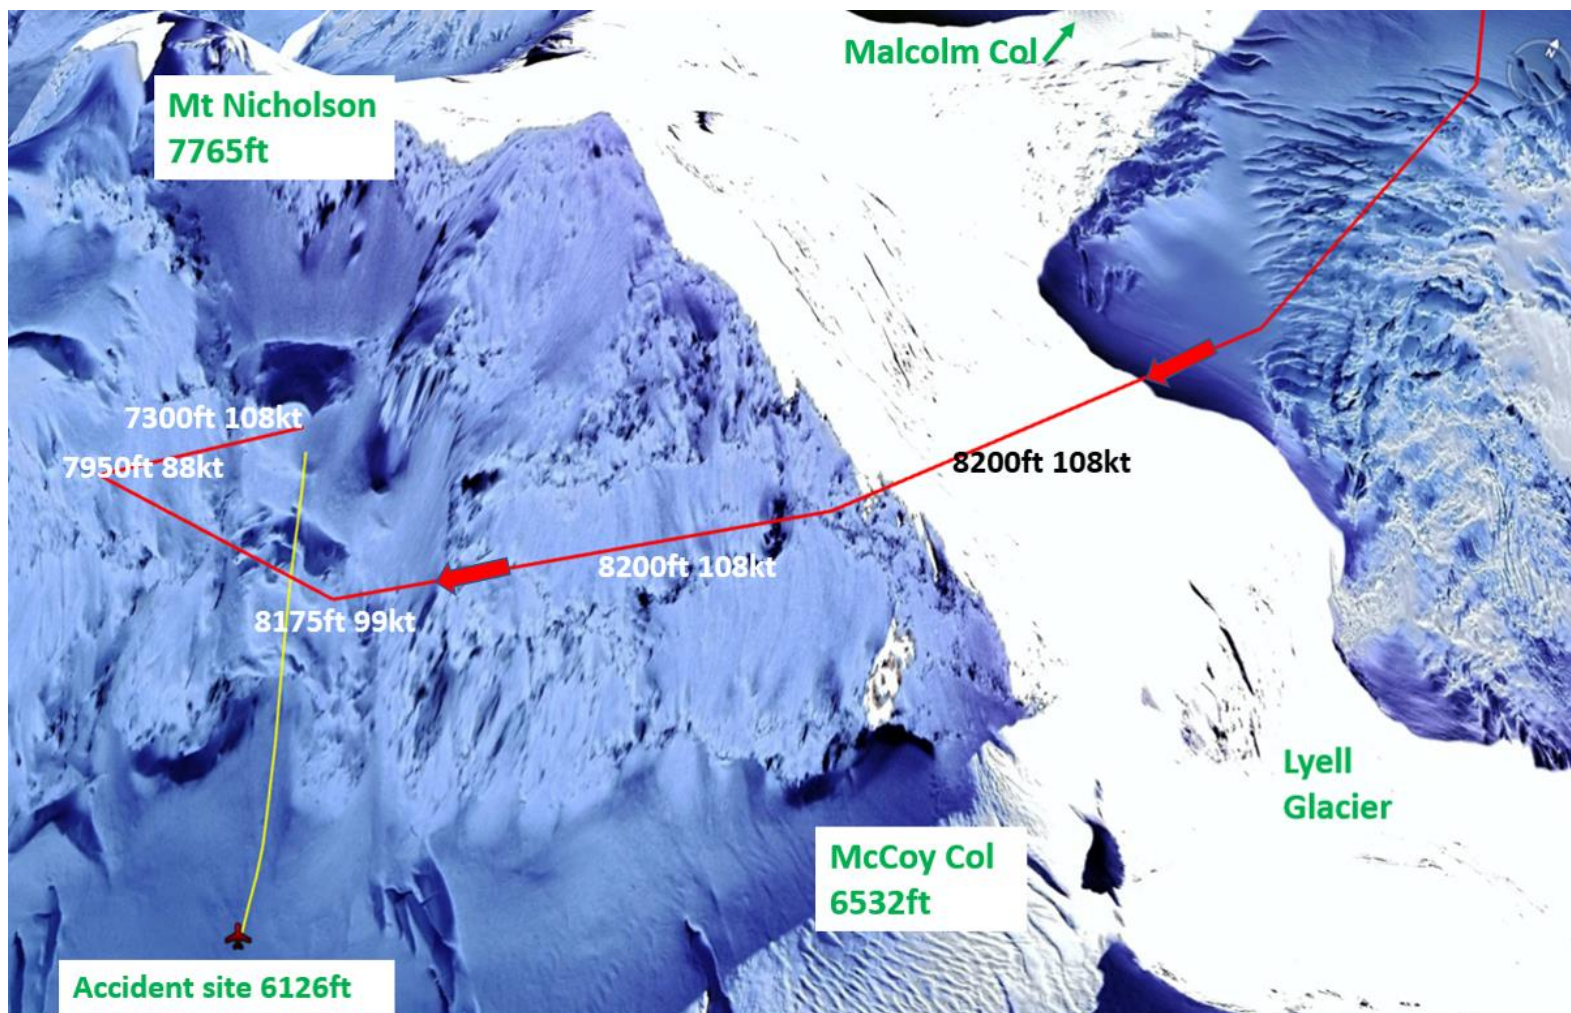
2.7 ZK-MGB crossed the main divide near Malcolm Col. The pilot then turned back towards Mt Nicholson. At this point the ground speed progressively dropped as the wind now flowed across ZK-MGB's track. Refer to Figure 11.

Figure 11: Approximate path (red), altitude, and speeds of ZK-MGB. Yellow line is the approximate path from last track point and accident site. Source: ADS-B Aireon data. Airways New Zealand. Overlay on Google Earth™.

2.8 At 0858 the data shows a high rate of descent developed while ZK-MGB was above the McCoy Col (6,532 ft) at 8,175 ft. Approximately 2,100 ft of altitude was lost in a period of 14 seconds, before the recorded track stops.
