**CAA Safety Investigation Report**  
**Controlled flight into terrain involving ZK-CMV**  
**Cessna 185B Skywagon**  
**Motatapu River North Branch near Wanaka**  
**16 March 2015**

## Executive summary

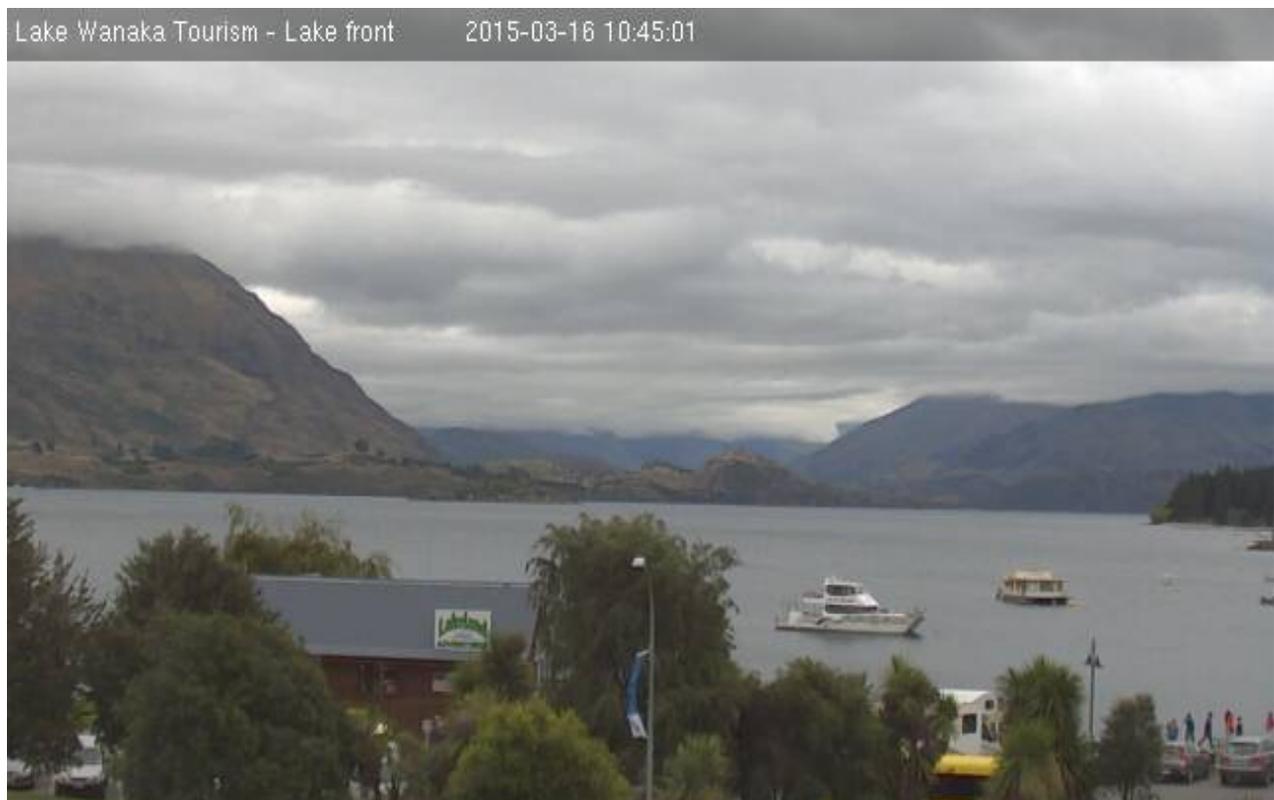
On the day of the accident, the pilots reportedly discussed the weather and their preferred route with their friends with whom they had been staying in Wanaka. However, they did not obtain a MetService weather briefing. According to their friends, both pilots had noted that Roys Peak which rises to 5177 feet amsl and its accompanying ridge above the Motatapu River, was immersed in cloud. (Refer Figure 2)

Figure 2: Roys Peak (left) on the morning of the accident. Cloud base is approximately 3400 feet amsl.

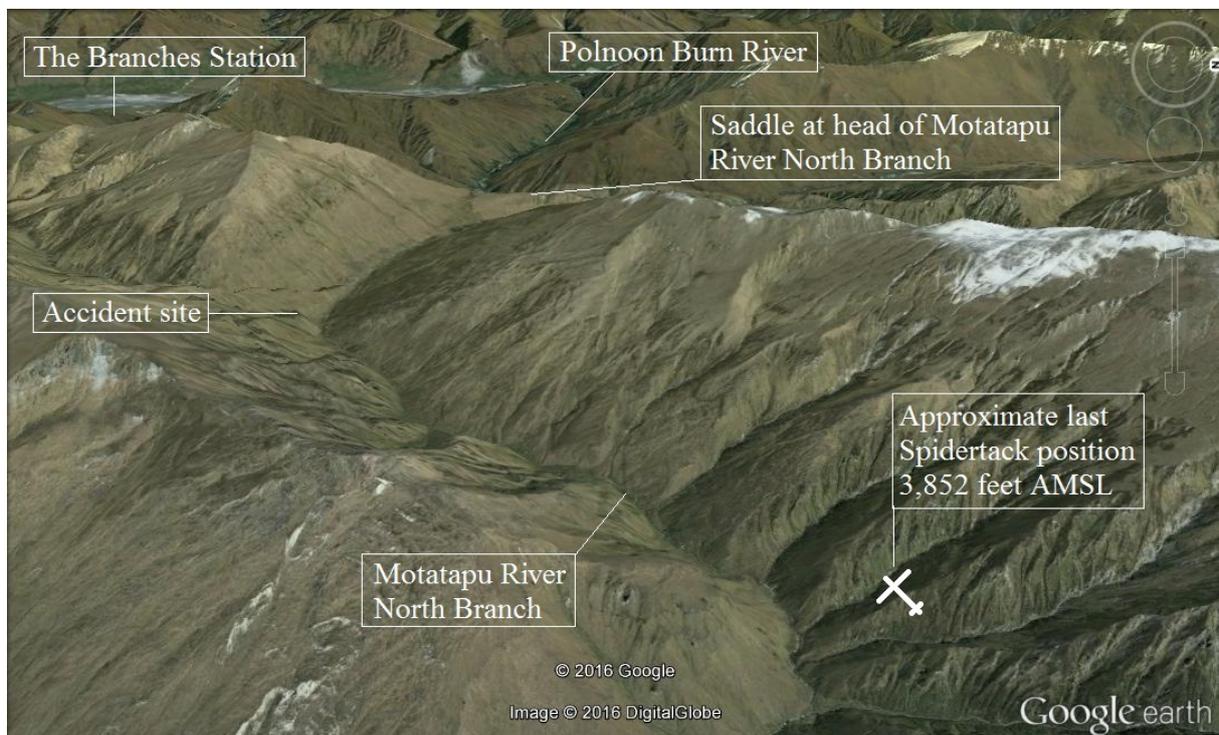
The GPS recorded the aircraft passing Roys Peak at approximately 3200 feet amsl. Shortly after entering the Motatapu River Valley North Branch and for unknown reasons, no further GPS data was recorded. At 1123:30 hours, the aircraft's Spidertracks™ system position report recorded the aircraft continuing its track along the north-western side of the valley at a height of 3852 feet amsl and a ground speed of 129 knots (This is consistent with the aircraft's normal cruise configuration). This was the last Spidertracks™ position report recorded prior to the accident occurring approximately 1.3 nautical miles from the saddle at the head of the Motatapu River North Branch valley.

Figure 3: Overview of last two nautical miles of the flight.

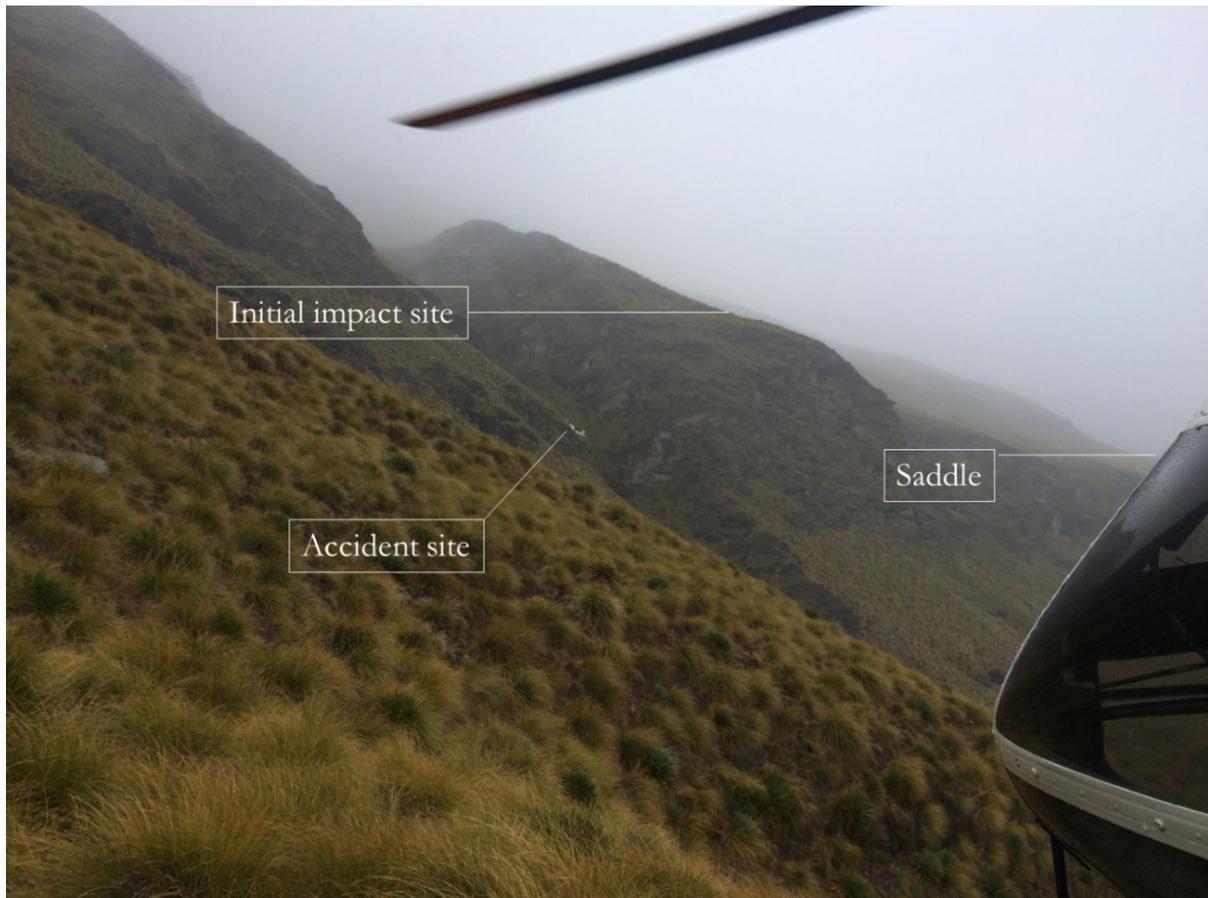
The weather conditions encountered by the helicopter pilot who initially located the wreckage were indicative of those forecast. The pilot reported that there was low level cloud and reduced forward visibility in light drizzle which made flying conditions marginal. A photo taken approximately two hours after the accident shows weather conditions consistent with the forecast in the valley, but having improved from those encountered when the aircraft was first located. (Refer Figure 4).

Figure 4: Weather conditions observed at 1322 hours (approx. two hours after the accident occurred)

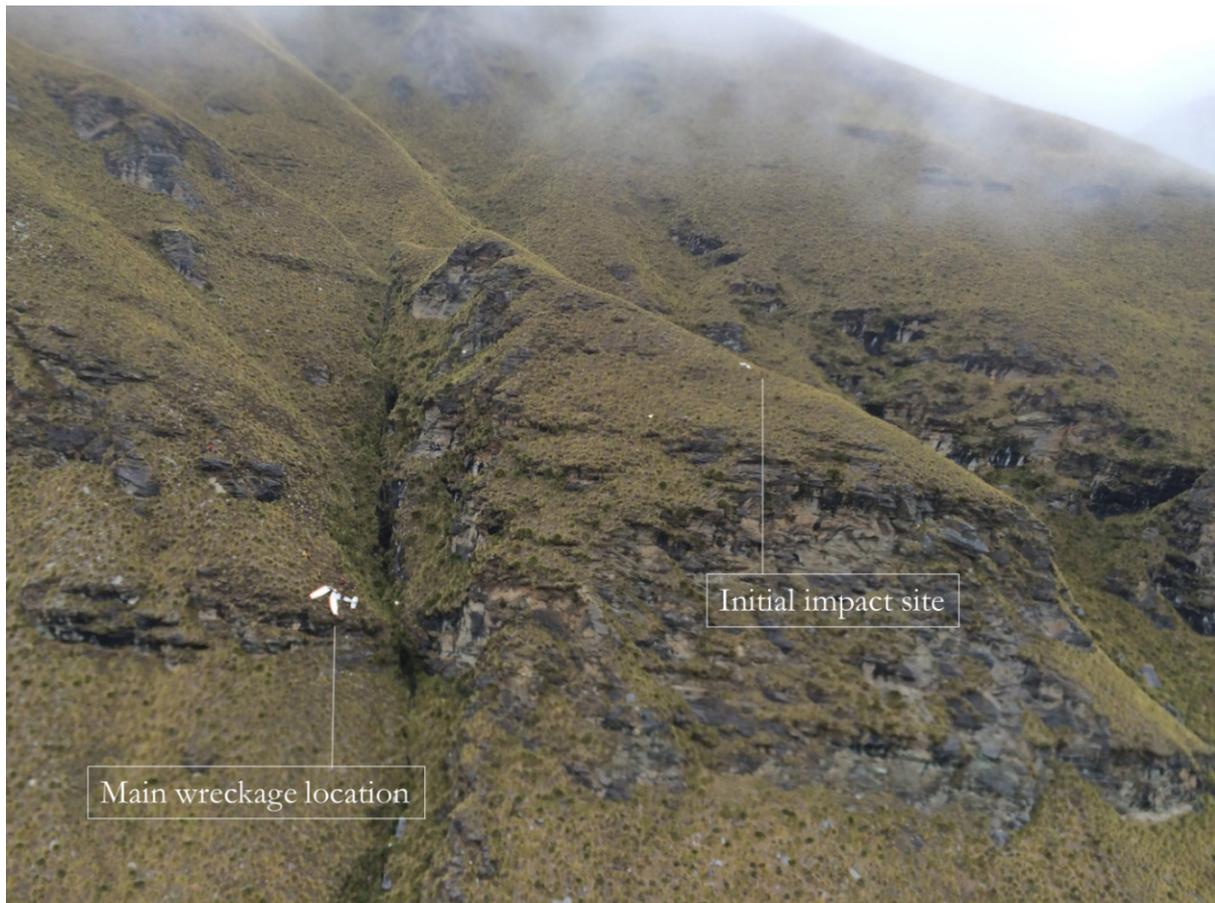
The aircraft initially struck a spur on the southern side of the Motatapu River North Branch valley at approximately 4050 feet amsl during a steep left descending turn. The aircraft then continued across a small gully and came to rest approximately 90 metres away from the initial impact point (Refer Figure 5).

Damage to the left elevator and both control columns indicate that a nose up elevator input was applied by the pilot(s) at the time the aircraft initially struck the spur. All damage to components of the flight control systems was attributed to impact overload failure.

The engine and propeller assembly were removed from the site and examined. The propeller assembly indicated that the engine was producing significant power when the aircraft struck the spur. No damage or defects were identified that would have prevented the engine from developing full power.

Figure 5. Overview of impact and wreckage sites (Photograph taken later the same day).

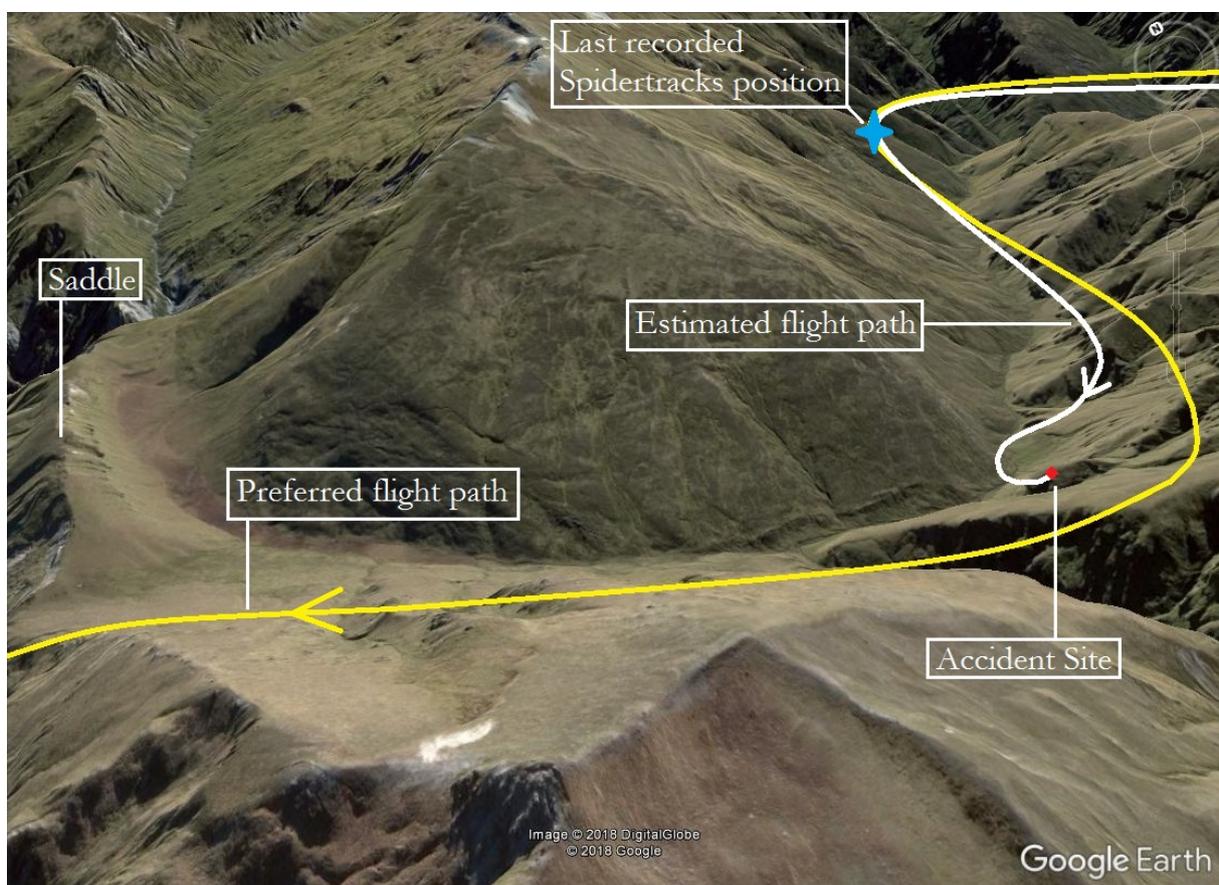
The topographical features of the area surrounding the accident site were mountainous and narrow in the valley. To continue flying up the valley, the pilot would be required to alter the aircraft's heading to the right in order to cross the saddle at the head of the valley. At the lowest point the saddle was approximately 4100 feet amsl. However, it was apparent that instead, the pilots had attempted a reversal turn to the left due to their onward flight path being blocked by cloud.

Figure 6: Preferred (optimal) flight path compared with estimated flight path (For illustrative purposes only).

The optimal positioning for the aircraft in the valley as it approached the right-hand bend would have been on the southern or left side of the valley as illustrated by the yellow line in Figure 6. This positioning then affords the pilots the greatest opportunity to observe the route ahead to the right and if required, turn away if it is impassable.

The fact that the pilots had attempted a left reversal turn would indicate that the aircraft was not positioned on the left side of the valley in the optimal position.
