AIRCRAFT ACCIDENT REPORT
OCCURRENCE NUMBER 09/323
AIRBORNE WINDSPORTS EDGE XT-912
ZK-DGZ
IN-FLIGHT BREAKUP
GIBBS HILL, ABEL TASMAN NATIONAL PARK
9 FEBRUARY 2009

AIRCRAFT ACCIDENT REPORT

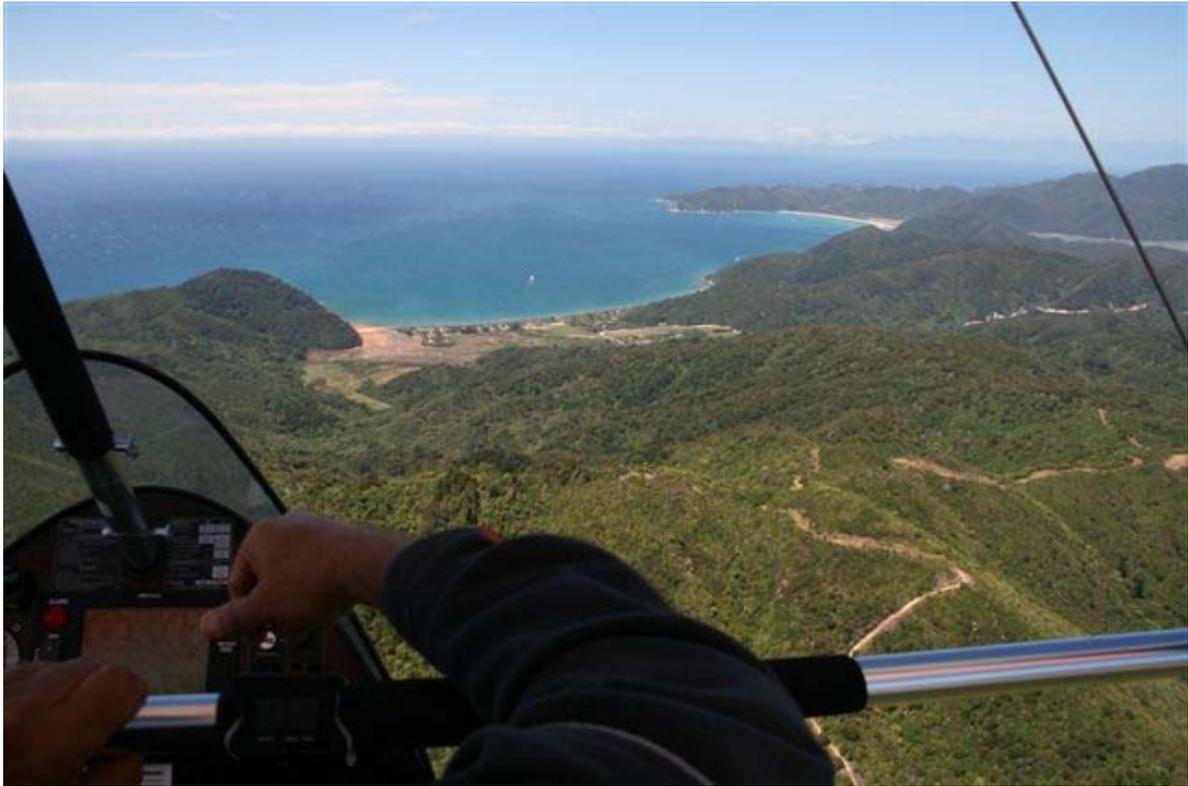
Figure 2: Passenger’s photograph from ZK-DGZ approaching Gibbs Hill.

- 1.1.5 During the flight the passenger took a number of digital photographs which helped to establish the route flown. The flight approached Gibbs Hill at approximately 1356 hours approaching from the north-west at an altitude of 2000 ft amsl, and at an indicated airspeed of 65 mph. This information was obtained from a digital inspection of the photograph and its digital properties (see Figure 2). This photograph also shows a wind lane³ east of Totaranui Bay, which indicates choppy sea conditions off the coast and calm seas within the bay itself.

- The choppy seas along the northern and eastern coastlines (see figures 2 and 3).
 - The aircraft's apparent ground speed and drift¹⁰ near the coastline.

- Wind lanes on the water east of Totaranui Bay in the lee of Gibbs Hill (see figure 2).
- 2.1.3 If the pilot had interpreted the above conditions he would have flown the company's agreed alternative route around Separation Point, thus avoiding flight into the lee side of any high terrain.

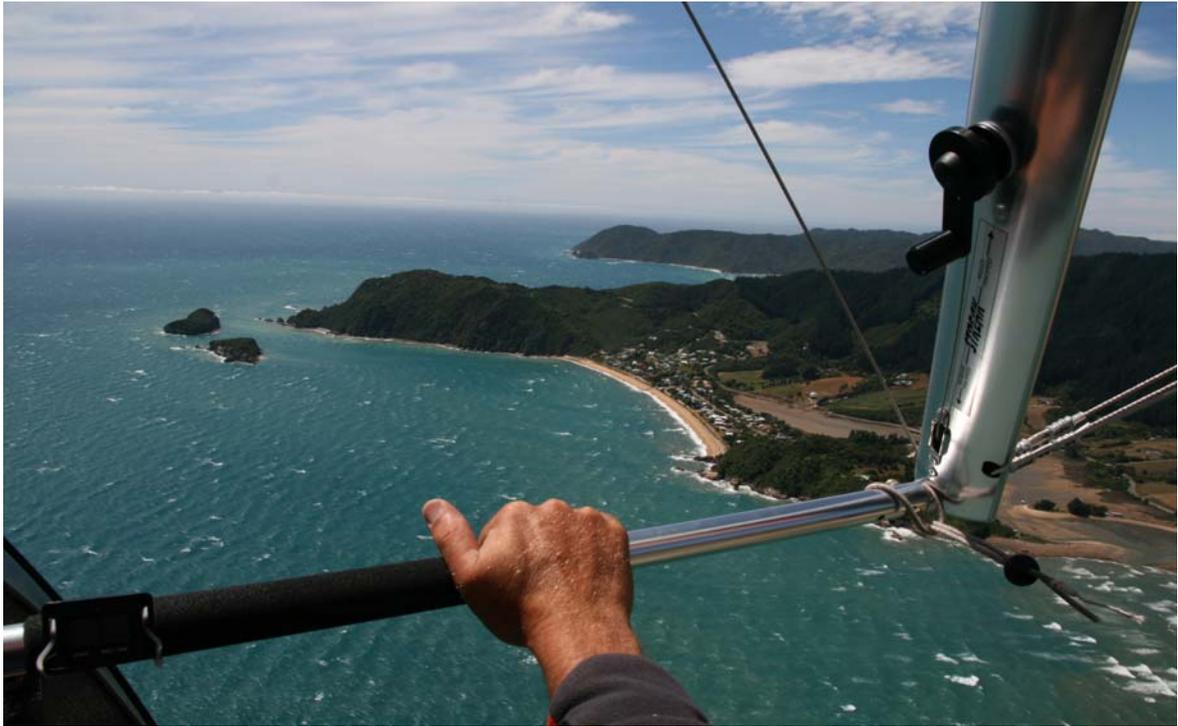
Figure 3: Choppy sea conditions - flying east.

1.7.6 Choppy seas were apparent in a photograph taken as the aircraft flew east along the coast towards Gibbs Hill (see figure 3).

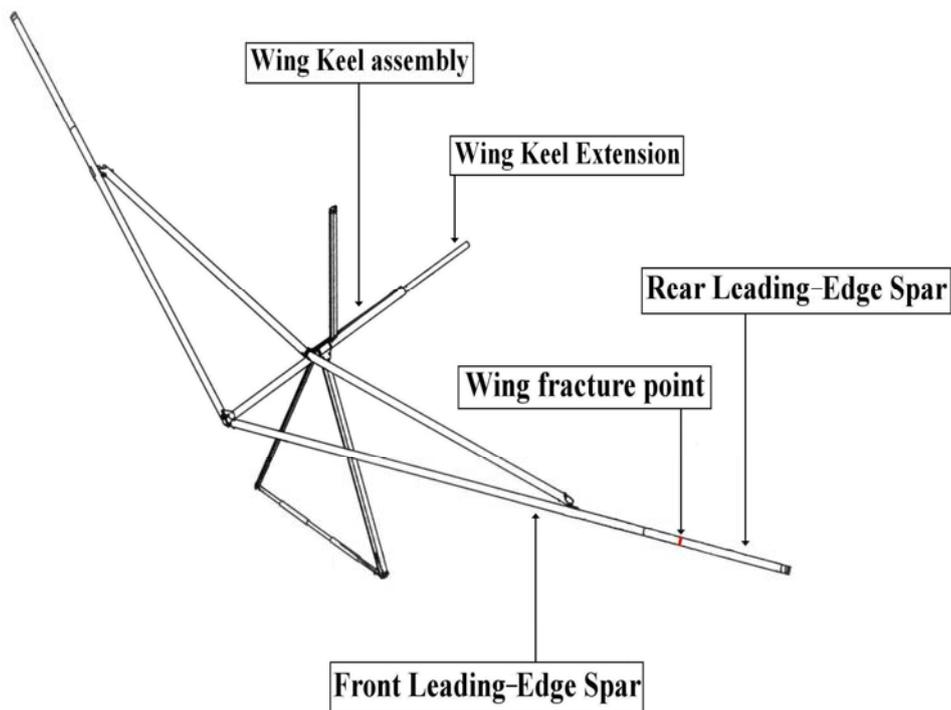
Figure 5: Diagram of wing frame

- 1.12.6 The wing was largely intact, however, the left Rear Leading-Edge Wing Spar had suffered a downwards failure 1.43 metres from the wing-tip (see Figure 5).
- 1.12.7 The wing keel extension had been sheared from the keel tube assembly and was not found. The remaining portion of the keel assembly revealed impact damage consistent with having been severed by the rotating propeller.
- 1.12.8 The front pole and the mast assembly, which connect the wing to the pod, had both failed close to their lowest attachment points.

- 1.16.1 Metallurgical examination of the failed wing components found that they had all failed due to overload (the wing spar in a downward direction, the mast and front pole in a rearward direction). There was no evidence of fatigue or substantial corrosion observed.

- 1.16.2 Metallurgical testing of the aluminium wing spar in New Zealand determined that the tensile strength of the aluminium alloy was up to 29% lower than the reported manufacturer's Mill Certificate and 10% lower than the requirements of AS1866-1997. However it was noticed that this was not the correct standard to use for this type of extrusion process. The correct standard should have been AS1867-1997⁷ and the tensile strength against this standard was found to be 21% lower than what was required.
