AIRCRAFT ACCIDENT REPORT
OCCURRENCE NUMBER 05/3727
NZ AEROSPACE FU24-950/M601D
ZK-DZG
5 KM WEST OF WHANGAREI (PUKENUI FOREST)
22 NOVEMBER 2005

OCCURRENCE No 05/3727

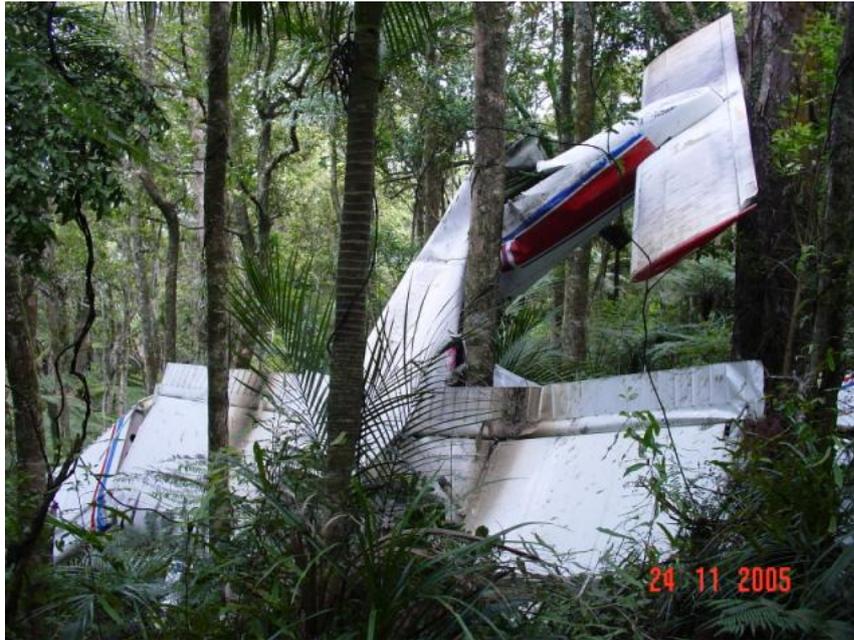
- 1.12.1 The aircraft came to rest in a partially inverted nose down attitude, with the tail section folded around a tree trunk (refer to Photograph 1). The vertical fin had detached and was resting on the ground a few metres away from the main wreckage. A small part of the vertical fin's lower front structure containing the fin's forward attachment fitting was still attached to the aircraft's fuselage. The rudder control surface was still connected to the aft fuselage by its torque tube. The wings had remained connected to the fuselage by their respective wing root attachment fittings. The outboard section of the left wing had detached from the main portion of the wing and there was damage consistent with the left wing leading edge striking a large tree.

Photograph 1 - Aircraft wreckage at accident site.

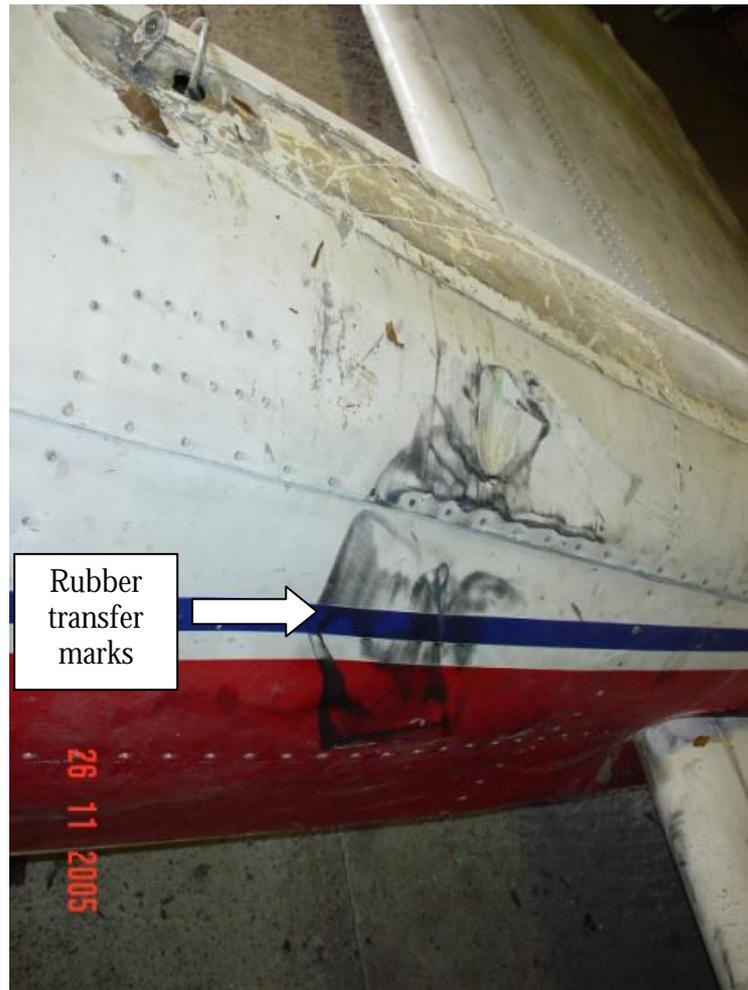
- 1.12.8 The two main landing gear oleos and wheels were separated from their attachments and were located near the wreckage.
- 1.12.9 There were paint and rubber transfer marks and impact damage on the left side of the aircraft's aft fuselage (shown in Photograph 2). These marks matched up with damage found on the vertical fin. Paint transfer marks and damage on the fin suggested that the fin had also folded around the left hand leading edge of the elevator.

Photograph 2 – Rubber transfer marks.

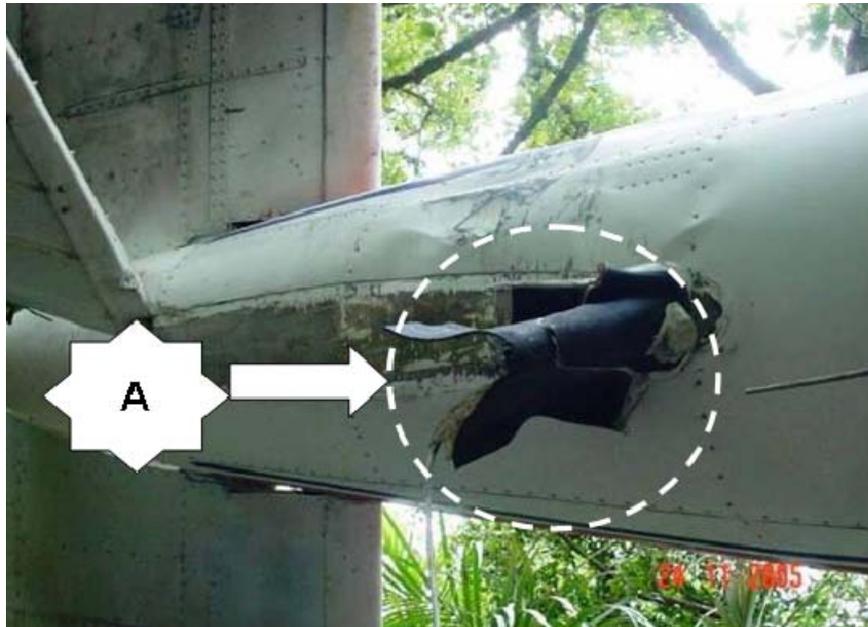
- 1.12.10 A 30 cm high portion of the vertical fin's front lower leading edge around the forward attachment fitting remained connected to the aircraft by its attachment bolt (marked 'A' in Photograph 3). Further examination of this structure revealed that a rectangular section about the size of a matchbox was missing from the fin's leading edge skin (shown in Photograph 4). There were two horizontal marks about one centimetre long inside the protective rubber anti-abrasion strip which covers the fin's leading edge. These marks corresponded with the upper and lower fracture surfaces of the missing rectangular section from the leading edge. The skin either side of the fracture surfaces had also been bent back, indicating that the fin had at some point in the failure sequence moved in a rearward direction. The damage to

the fin's main structural (rear attachment) support beam indicated that the fin had failed as a result of a lateral force being applied to the right side of the fin. The rudder was also bent towards the left side of the aircraft around its torque tube.

Photograph 3 – Vertical fin's lower front leading edge.

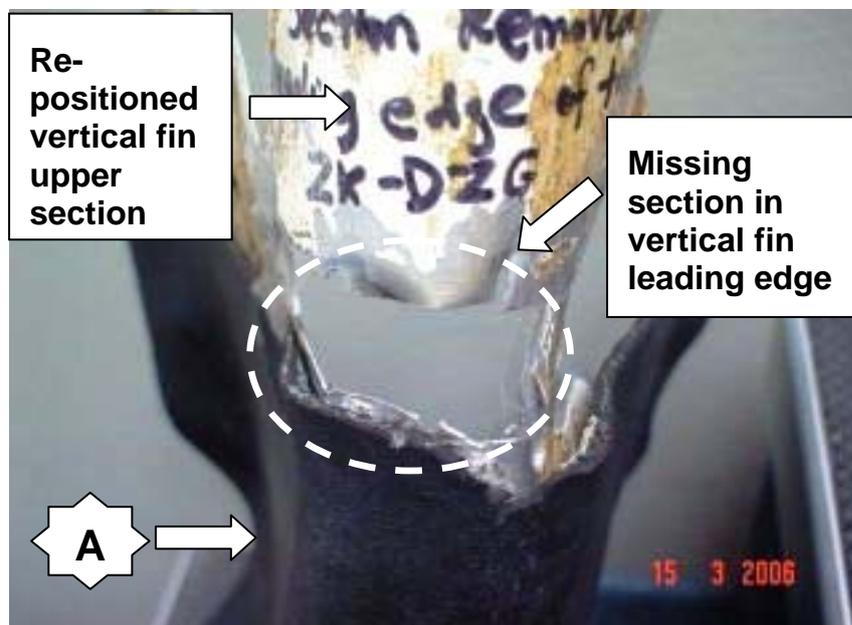
Photograph 4 – Missing section in vertical fin's leading edge.

- 1.16.5 Two marks on the inside of the vertical fin's protective rubber anti-abrasion strip indicated the likely existence of two fractures in the leading edge skin prior to the accident. The surface of each fracture showed signs of wear. This most likely would have been caused by the mating surfaces of the skin rubbing together. The wear marks prevented the age of the fractures from being determined. Microscopic examination of the fracture surfaces indicated that metal fatigue probably caused the fractures. One metallurgical report suggested the fractures could have been up to 11 cms long when the fin suffered a structural failure and may have come from a network of pre-existing cracks in that area.

- 1.16.6 Aircraft maintenance records show that the vertical fin was last visually inspected in the area of the fractures 2070.85 flying hours before the accident. It is very likely the fractures were not present at this time and the absence of any fretting corrosion suggests the fractures were most likely formed relatively recently. A metallurgist commented that the fractures could have been initiated by impact damage; some event or events causing structural overload on the fin; or a manufacturing induced defect. Examination of the protective rubber anti-abrasion strip showed that the tearing and stretching of the rubber had initiated at the same location as the leading edge fractures. Metallurgy tests confirmed that the skin of the vertical fin was made from the correct material and had the required hardness (Alclad 2024 aluminium alloy in the T3 temper condition).

- 3.4 Metallurgical examination confirmed that the vertical fin on the aircraft was weakened by pre-existing fractures in the leading edge section of the fin. These fractures could not be easily detected due to a rubber anti-abrasion strip applied over the fin's leading edge. The fractures were most likely caused by fatigue.

- 4.3 The CAA issued an airworthiness directive DCA/FU24/176 with effect from 1 June 2006, requiring all operators of Fletcher FU24 aircraft to inspect regularly for defects in the vertical fin leading edge skin. The airworthiness directive was later reissued to reduce the inspection interval to 50 hours (time in service) to align with the aircraft manufacturer's maintenance inspection intervals.

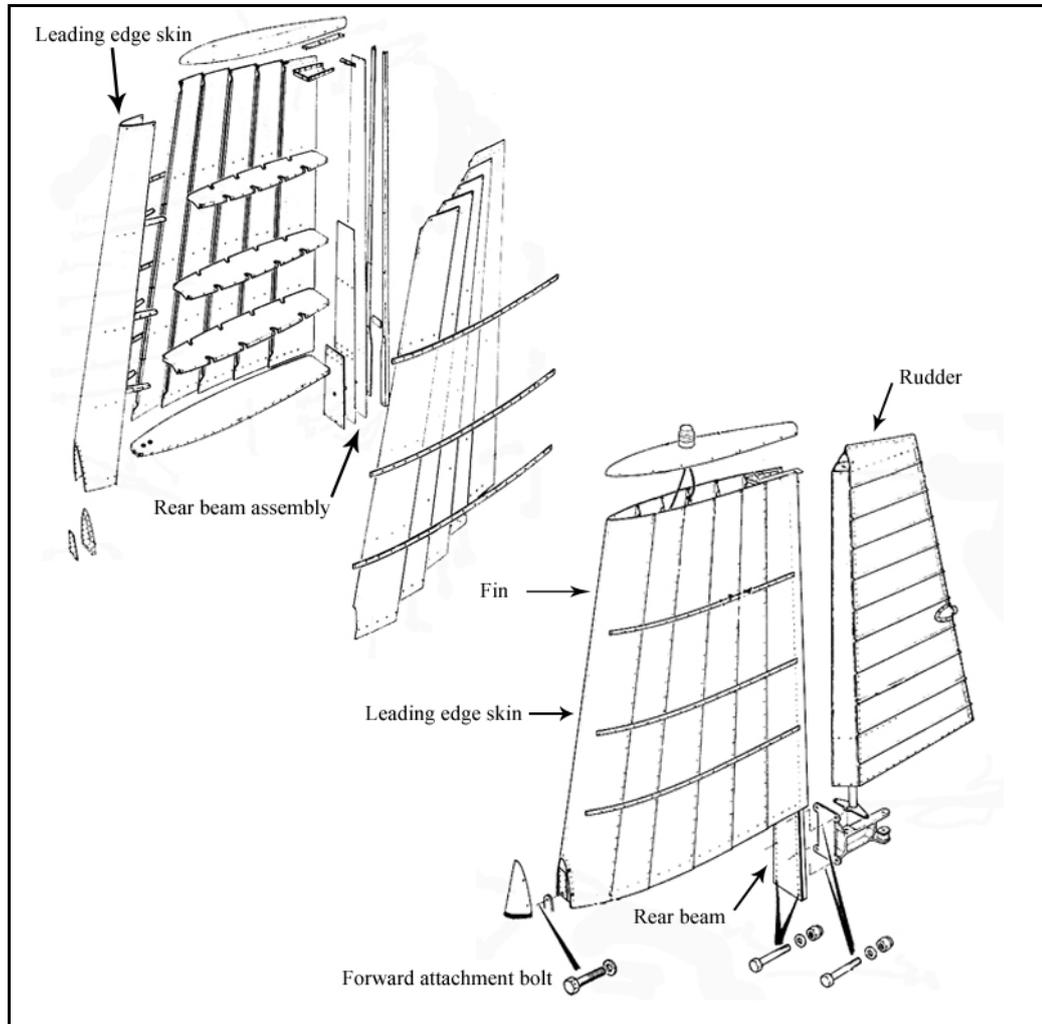
Figure 1 - Fletcher FU24-950 Vertical Fin Construction.

- 1.18.1 The Fletcher vertical fin has remained substantially unchanged since its initial design in the 1950s. The fin is essentially a rear supported cantilever structure. Its construction employs a single channel section post (vertical) beam assembly at the rear of the fin and a single pivoting attachment point at the front (refer to Figure 1). The forward attachment point has minimal design redundancy and allows any side loads on the fin to be transferred to the fin's leading edge skin, particularly in the region of the lower leading edge. Any failure of the fin's forward attachment during flight will allow aerodynamic forces to overload and fracture the fin's rear vertical beam, invariably causing the fin to separate from the fuselage. The vertical fins on other common agricultural aircraft such as the Air Tractor and Cessna A188 Ag-Wagon have a forward and rear spar with at least two forward fixed attachment

points. This provides improved structural strength and inherent design redundancy when compared with the Fletcher fin.
