**AIRCRAFT ACCIDENT REPORT**  
**OCCURRENCE NUMBER 03/3531**  
**CESSNA 172N SKYHAWK**  
**ZK-EOA**  
**2KM EAST OF LAKE LUNA, OTAGO**  
**5 DECEMBER 2003**

## AIRCRAFT ACCIDENT REPORT

### OCCURRENCE No 03/3531

<b>Aircraft type, serial number and registration:</b>	Cessna 172N Skyhawk, 17271497, ZK-EOA
<b>Number and type of engines:</b>	1 Lycoming O-320-H2AD 160hp
<b>Year of manufacture:</b>	1978
<b>Date and time:</b>	5 December 2003, 1630 hours <sup>1</sup> (approx)
<b>Location:</b>	2 km east of Lake Luna, Otago Latitude <sup>2</sup> : S 44° 58.133' Longitude: E 168° 30.266'
<b>Type of flight:</b>	Mountain flying training
<b>Persons on board:</b>	Crew: 2
<b>Injuries:</b>	Crew: 1 fatal, 1 serious
<b>Nature of damage:</b>	Aircraft destroyed
<b>Pilot-in-command's licence</b>	Commercial Pilot Licence (Aeroplane)
<b>Pilot-in-command's age</b>	28 years
<b>Pilot-in-command's total flying experience:</b>	1236 hours 773 on type
<b>Information sources:</b>	Civil Aviation Authority field investigation
<b>Investigator in Charge:</b>	Mr T McCready

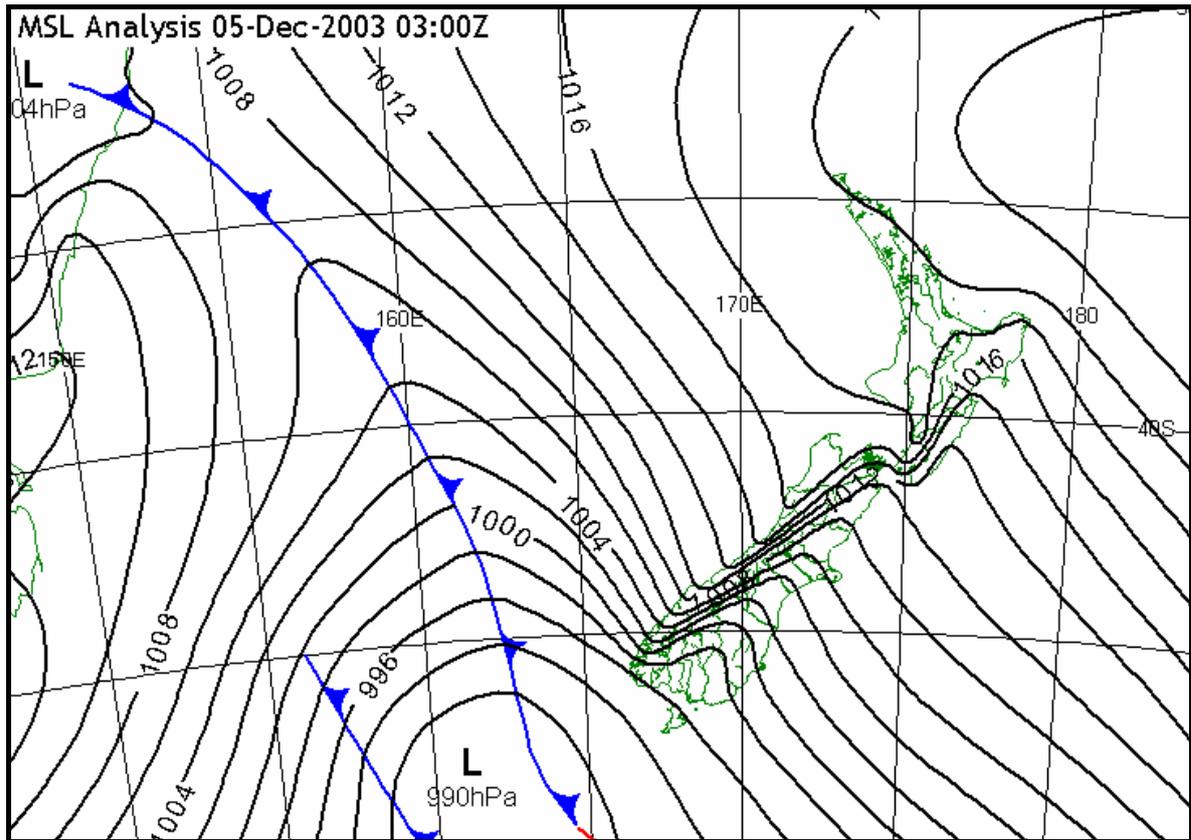
- 1.7.1 A strengthening north westerly flow covered the South Island ahead of a cold front approaching from the west. The cold front was forecast to reach the Queenstown area around midnight on December 5. Ahead of the front in the strong northwesterlies, severe turbulence about and east of the South Island ranges was forecast with numerous SIGMETs. There was also severe icing forecast in lee wave cloud east of the South Island main ranges with numerous SIGMETs issued.
- 1.7.2 SIGMET is information issued by a meteorological office concerning the occurrence, or expected occurrence, of specified en-route weather phenomena that may affect the safety of aircraft operations.
- 1.7.3 Winds above Queenstown at the time of the accident have been estimated by MetService as:

1000ft	340/20KT
3000ft	330/35KT
5000ft	320/50KT
7000ft	310/53KT
10000ft	310/55KT

**Figure 1: MSL analysis chart issued at 1600 NZDT**

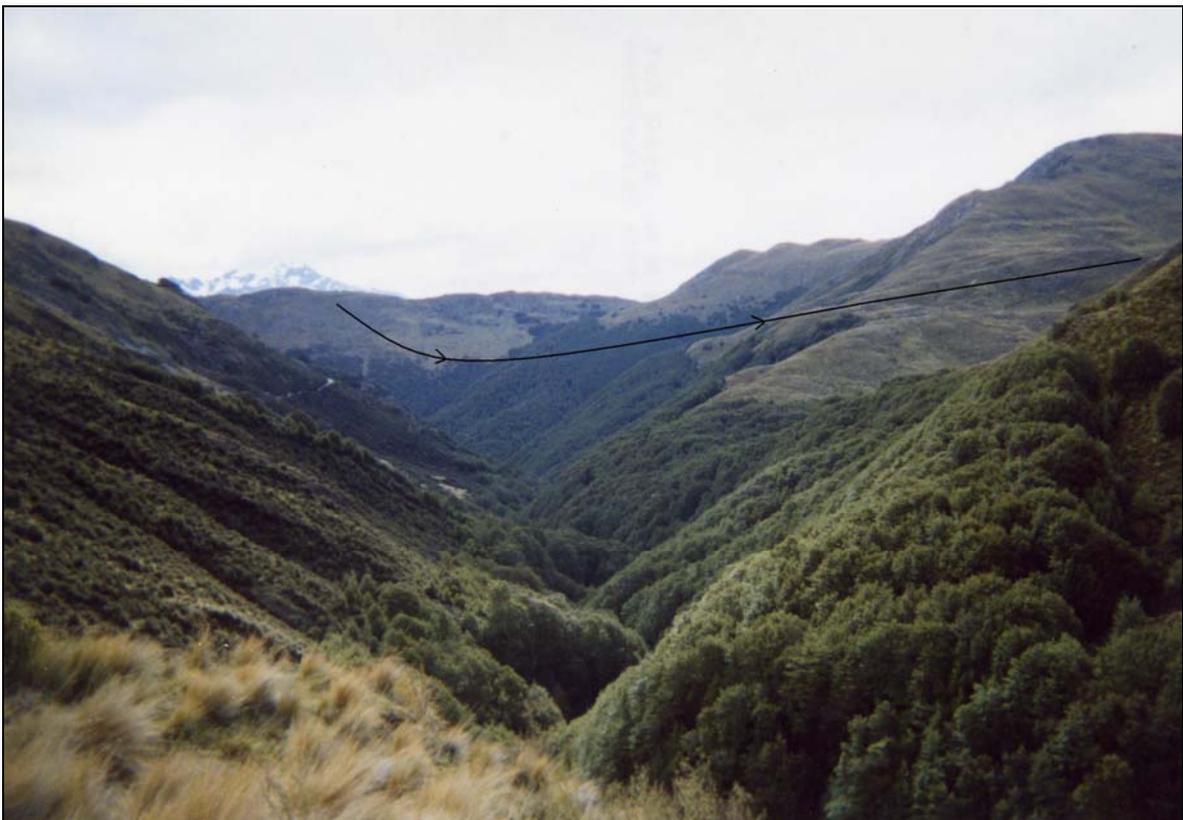
- 1.18.4 The aircraft wreckage was located at 2888 ft AMSL on the lee side of a mountain range. The range is orientated north-east to south west and reaches an elevation of 4,800 feet AMSL in that area.

- 1.18.5 The wind direction was northwesterly and the wind speed was estimated to be between 35 and 50KT.
- 1.18.6 An interview with the surviving pilot revealed that he had limited memory of the accident flight, but he did recall that while conducting circuits at the Glenorchy Airfield he had noted the very high ground speed while travelling downwind and the steep approach which was required on finals due to the high head wind component. He also recalled the deteriorating weather when he had looked up the Dart Valley. His next memory was of reaching the area of the turn inland at the Twenty Five Mile Creek and of the two pilots discussing their options of going inland or continuing to follow the lake back to Queenstown. He does not recall the reason that the inland route was chosen.

**Figure 2: The aircraft flew along this valley in high wind and turbulent conditions towards this point where the photograph is taken from, but should have turned into the valley system at the right of the photograph and continued over Lake Luna.**

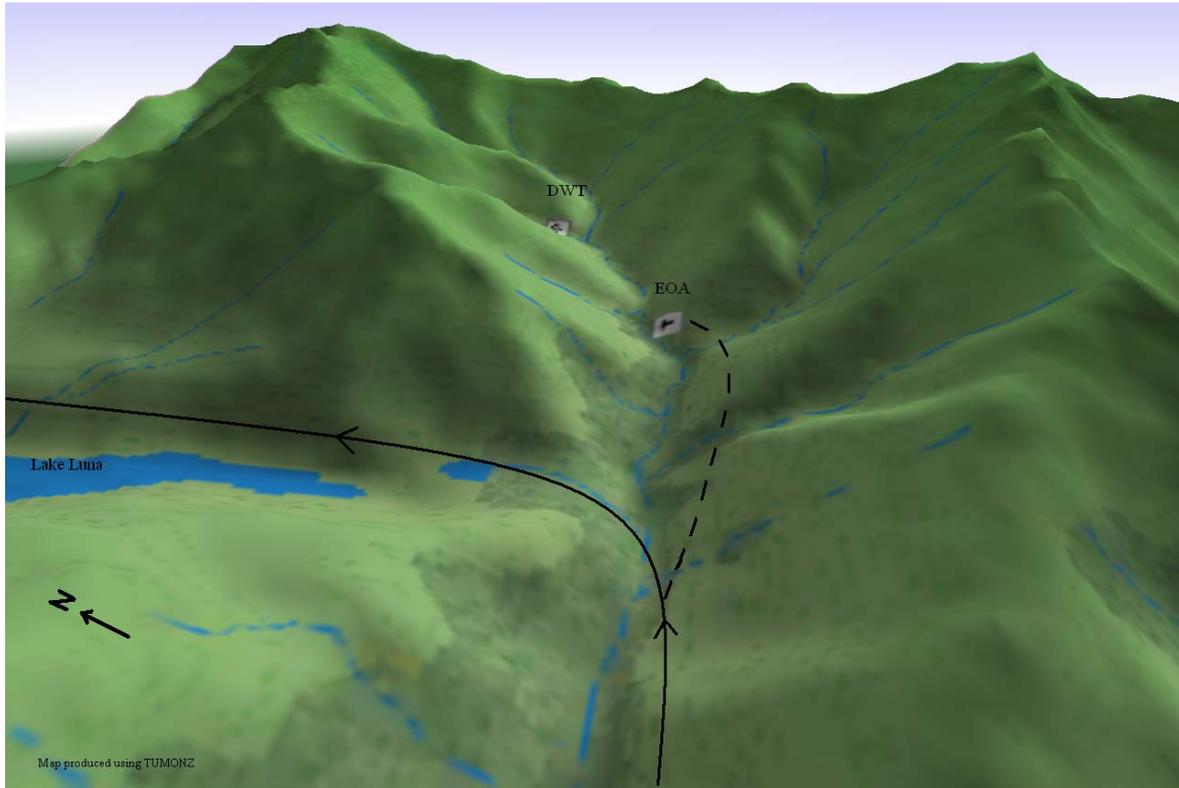
- 1.19.1 Utilising mapping software a 3 dimensional “fly through” was created of the valley. This provided a possible simulation of the flight and showed that after missing the Lake Luna turn off, a more inviting wider area in which to execute a turn out of the valley existed near the accident site, but this wider area also had rising terrain associated with it.

**Figure 3: Solid line indicates intended flight path. Dashed line indicates continued flight path past the Lake Luna turn off. First white square is ZK-EOA accident site. Second white square indicates previous ZK-DWT (1981) accident site.**
