AIRCRAFT ACCIDENT REPORT

OCCURRENCE NUMBER 05/2471

CESSNA 182R

ZK-FGS

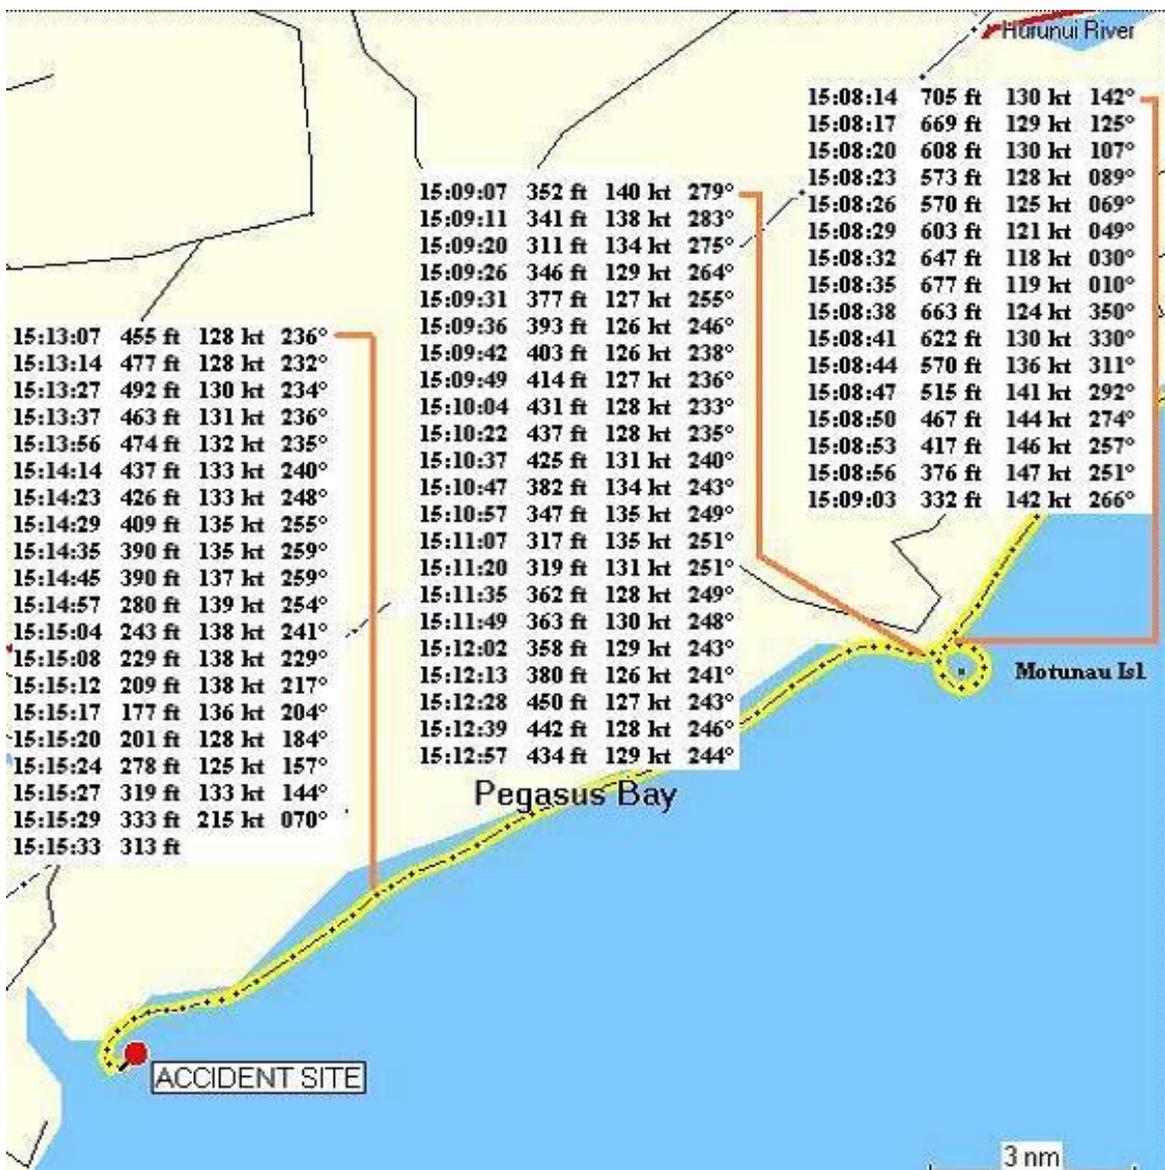
aircraft continued to descend in the turn to 180 ft AMSL. At this point the aircraft began to climb but remained in the left turn. The climbing turn continued to approximately 320 ft AMSL when at 1515:29 hours the GPS recorded an altitude of 333 ft AMSL, ground speed of 215 knots and an abrupt heading change to 070° T. The recorded data ends with a partial plot indicating 315 ft at 15:15:33 hours.

1.1.8 The accident occurred in daylight at approximately 1515 hours NZST in the sea at a location about 1 nm north-east of the Waipara River mouth. Latitude S 43° 09.081, longitude E 172° 48.720.

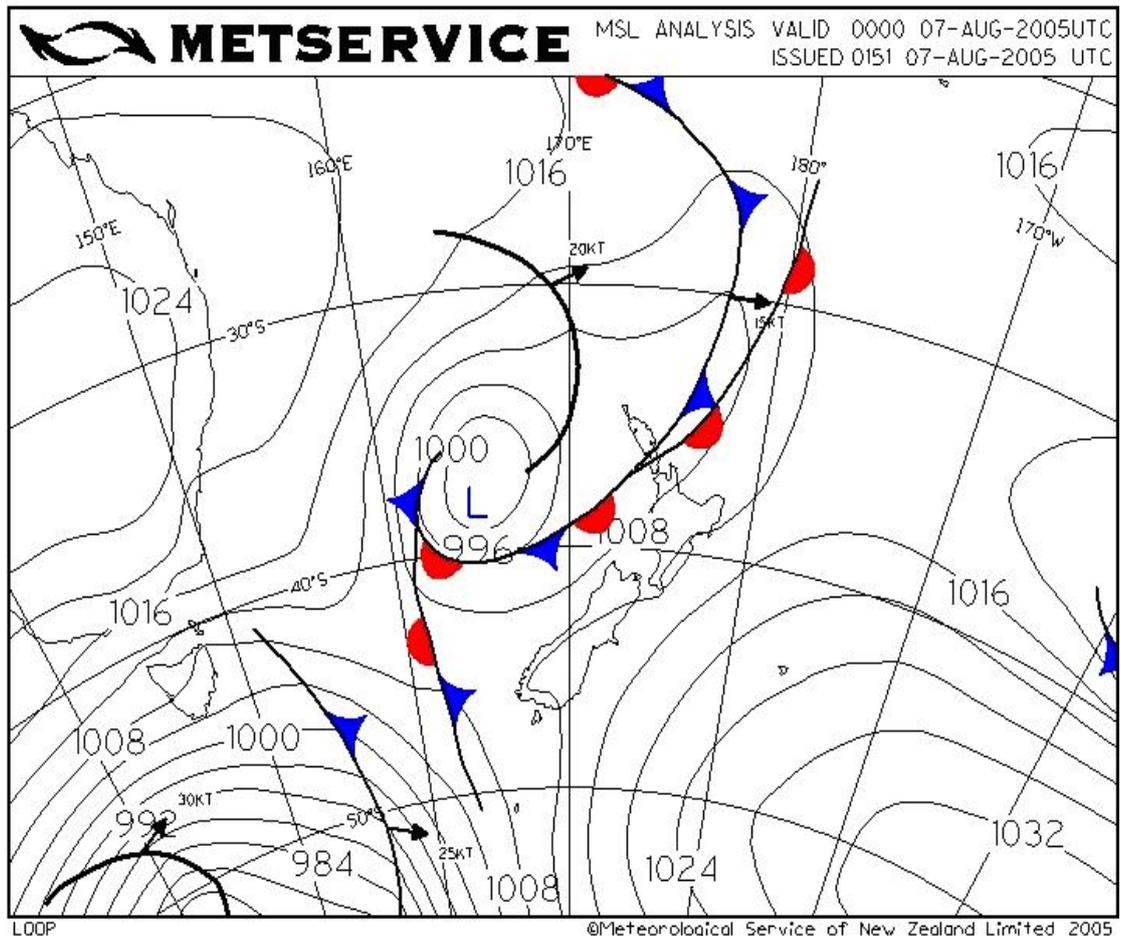
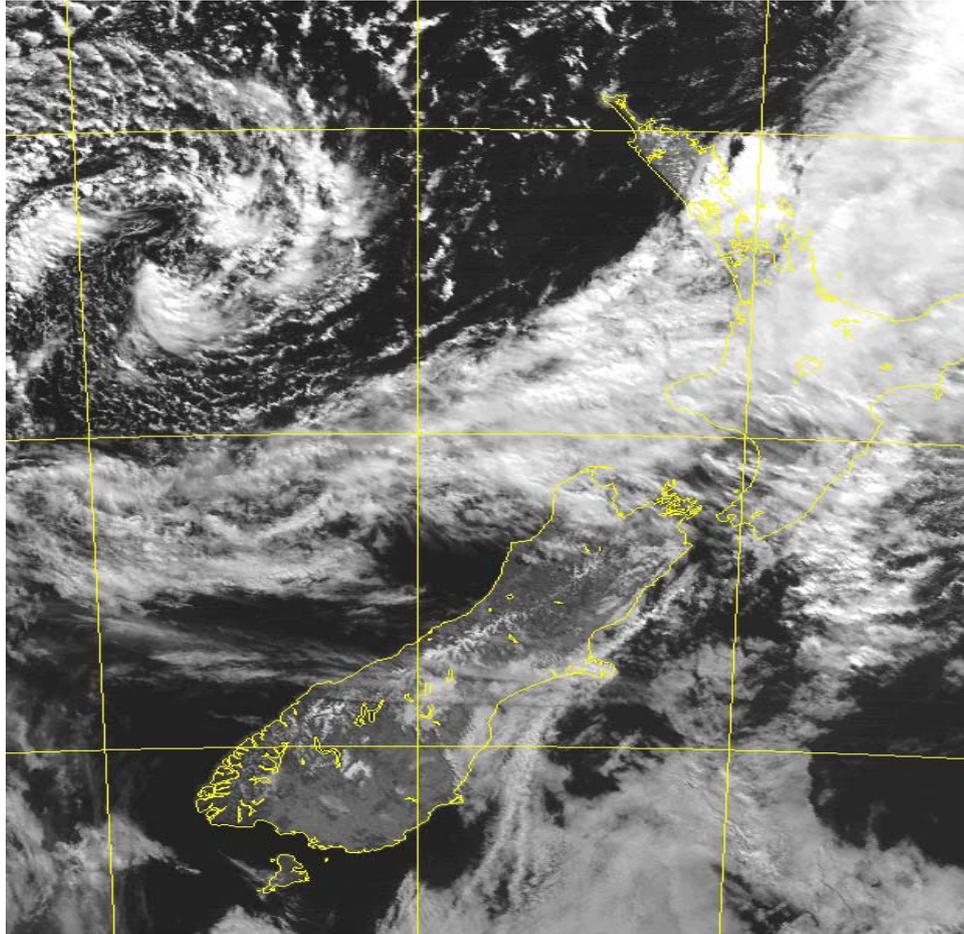
- 1.7.1 At 1200 hours NZST on 7 August 2005, (0000 hours UTC 7 August 2005), a low pressure system existed in the mid Tasman, centred west of Taranaki, moving north east at about 20 knots, with an associated complex frontal system lying to the north of Taranaki through to the north of Auckland. To the south of Auckland, the associated moist on-shore north-easterly flow ahead of the front covered New Zealand. Satellite imagery revealed heavy cloud over the centre of North Island, the southeast coast of North Island and the east coast of the South Island.
