**SAFETY INVESTIGATION REPORT**  
**CAA OCCURRENCE NUMBER 14/1194**  
**PA-38-112, Tomahawk**  
**ZK-FTP**  
**DEPARTURE FROM CONTROLLED FLIGHT**  
**NGARURORO RIVER 5.5 NM WEST OF HASTINGS AERODROME**  
**23 MARCH 2014**

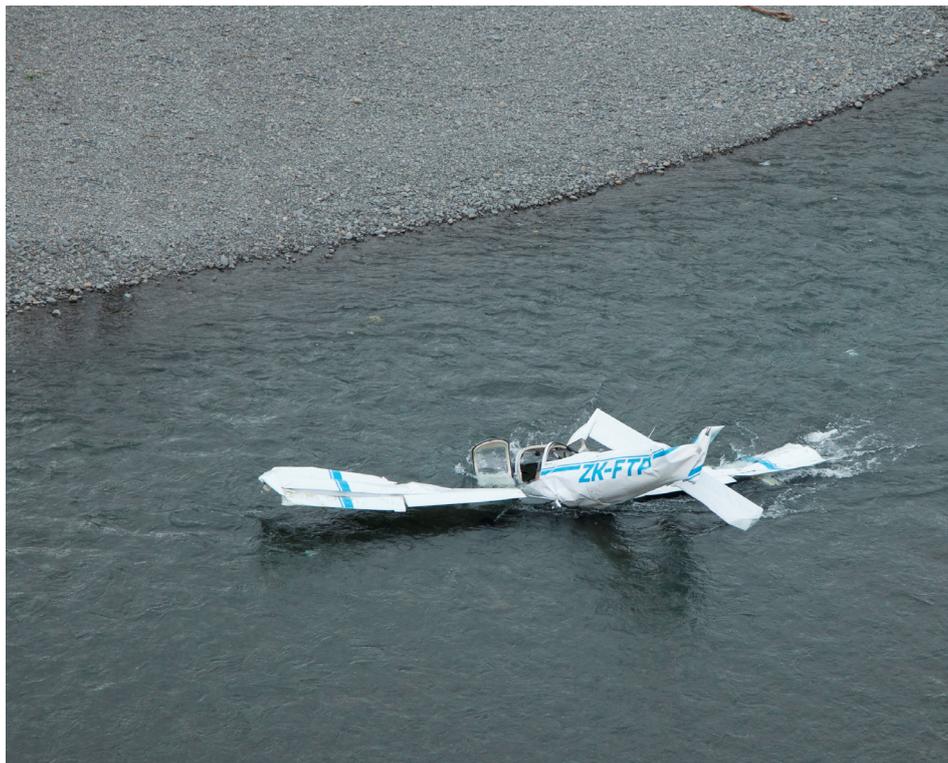
Figure 2:  
Accident Site

1.12.1 The aircraft wreckage was observed from the air by Aero Club pilots partly submerged in the river in an approximate 50° to 60° nose down attitude with the fuselage and empennage rotated to the right. See Figure 2.

1.12.3 The engine and propeller had been fully submerged in the river. Inspection revealed the engine mounts and propeller spinner had twisted to the right. One propeller blade exhibited damage consistent with impact with river stones while under rotation.

- 1.12.7 The rear empennage had partly separated and had folded over the rear of the fuselage forward and to the right.
- 1.12.8 Both occupants were observed slumped forward and to the right. They remained restrained by their lap belt and shoulder harnesses. The right seat was compressed and had failed to the right. Both control columns had been bent towards the right.

- 1.12.9 The aircraft wreckage exhibited several signatures consistent with the aircraft being in, or entering into, a spin.
- 1.12.10 The engine controls and switches were all set in a position appropriate for flight. It was not possible to determine the position of the fuel selector due to damage it had sustained. Readings from the engine instruments showed no anomalies. At the time of impact the engine RPM gauge needle was captured at 700 RPM.
