**AIRCRAFT ACCIDENT REPORT**  
**OCCURRENCE NUMBER 09/4139**  
**SCHEMPP-HIRTH GMBH VENTUS B/16.6**  
**ZK-GVP**  
**WIRE STRIKE AND SUBSEQUENT LOSS OF CONTROL**  
**NIKAU ROAD, BOMBAY HILLS, SOUTH AUCKLAND**  
**28 OCTOBER 2009**

### OCCURRENCE No 09/4139

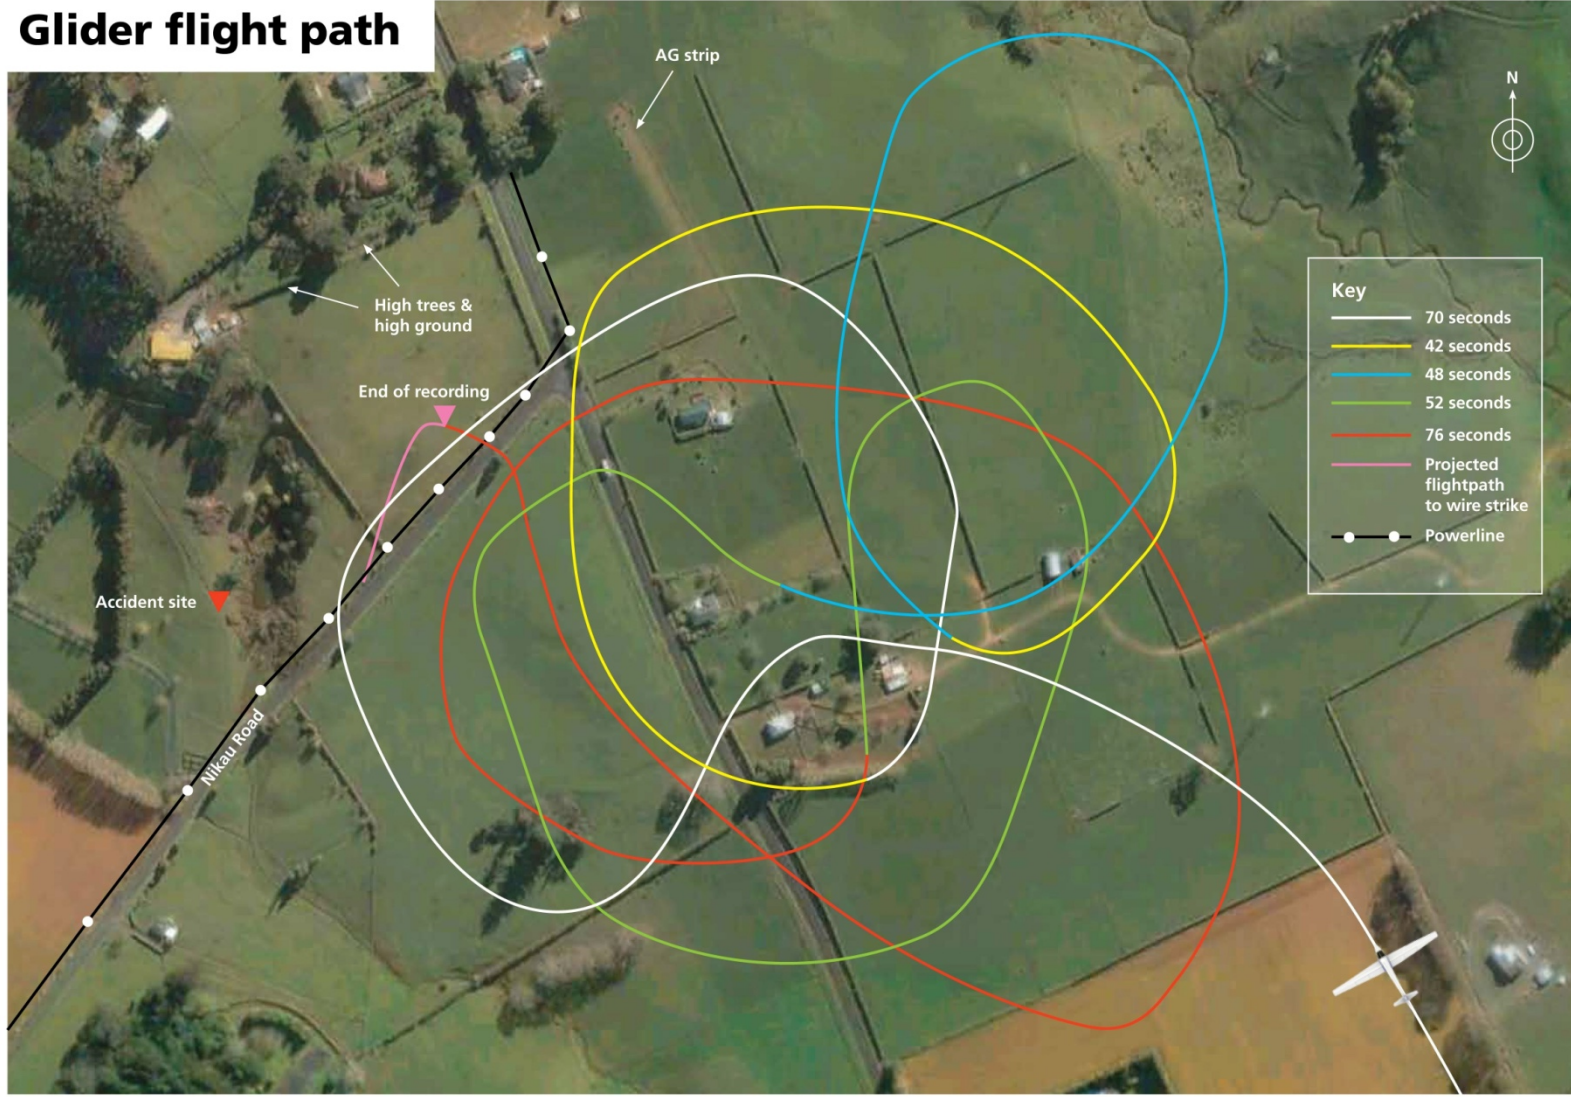
**Figure 1**  
**Last four minutes and forty eight seconds of ZK-GVP flight path data.**

- 1.1.10 The last four minutes and forty-eight seconds of flight data for ZK-GVP is provided in Figure 1, page 14. It illustrates that once the pilot had entered the Nikau Road area he initiated a left turn then completed three right hand orbits before turning back to the left again. He then completed one left orbit prior to commencing another right hand orbit. The last recorded position depicts the glider on the northern side of Nikau Road. The projected final track of the glider is estimated to have extended from the last recorded position to the point of power line contact.

- 2.5 When the pilot reached the Nikau Road area he was at a low altitude and had insufficient height to safely clear the ridge line ahead. In addition, he was blocked from circling over the ridge line by an array of power transmission lines and towers. This provided the pilot with fewer manoeuvring options, increased risk, and possibly a marked increase in the levels of personal stress to the extent he may not have noticed the agricultural airstrip.

- 2.6 The pilots decision to remain in the area and circle was described by GNZ as scratching<sup>6</sup> and not looking to land.
- 2.7 The likelihood of mechanical turbulence and downdrafts in the area was not ruled out and may have had an influence during the last orbit to the extent that the glider's path became obstructed by the Nikau Road 22 kVA power lines.
