**CAA Safety Investigation Report
Collision with terrain involving ZK-GZV
Alexander Schleicher GmbH & Co. ASH 31 Mi
Ben Ohau Range Otago
06 February 2016**

CAA Safety Investigation Report
CAA Final Report 16/437
01 December 2017

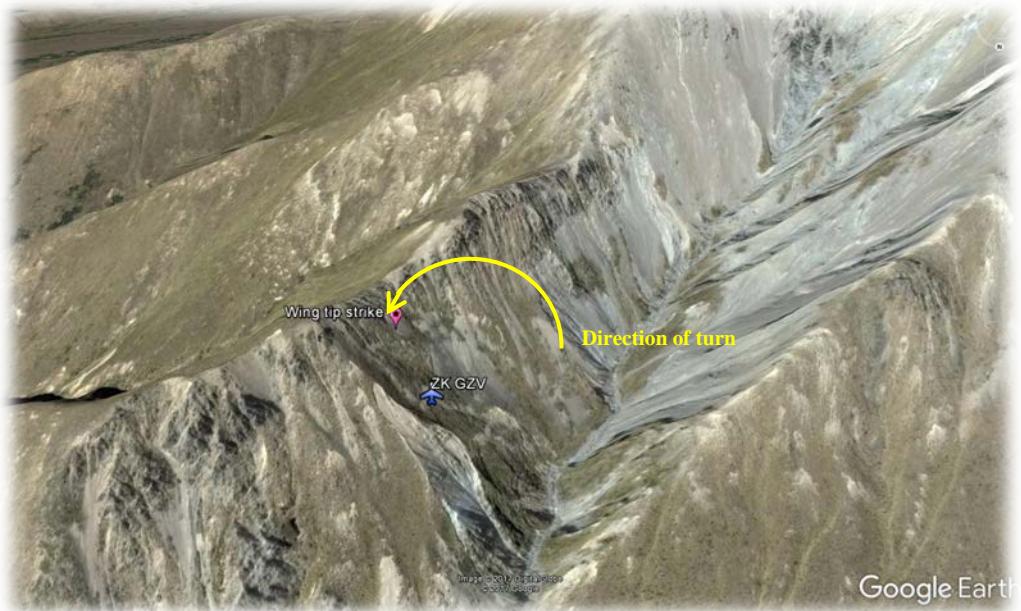
Figure 1: Accident site (Google Earth)

Witness marks observed on the terrain and glider indicate that the left wing tip of the glider had made the initial contact with the terrain. Following the wing tip strike, the glider rolled inverted sliding down the slope for approximately 80 metres before coming to rest.

The glider initially struck the north face of a gully with the left wing tip while in a steep turn to the left. This caused the separation of the outer wing panel with the glider continuing to roll to the left until inverted. The right wing tip then struck the ground resulting in the outer panel separating from the wing. The glider then struck the ground with the top of the forward fuselage which shattered the canopy and destroyed the instrument binnacle. The cockpit area immediately behind the pilot's head was filled with compacted soil. The glider came to rest approximately 80 metres from where the left wing tip initially struck the ground. Refer figures 1 and 2 below:

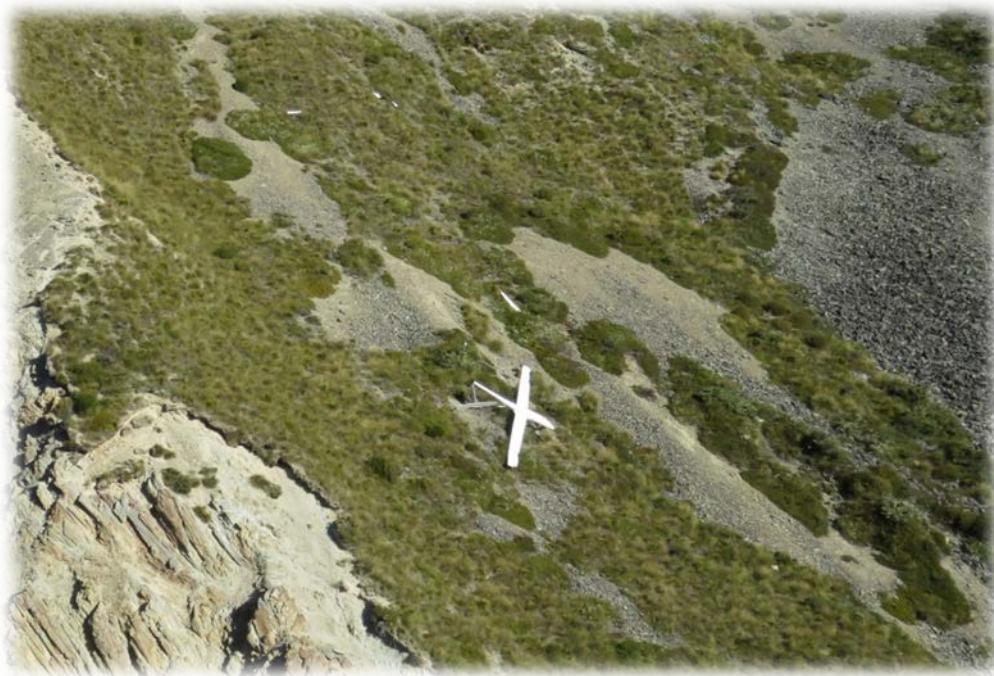
Figure 2: ZK-GZV Wreckage (CAA photo)

The continuity of all flying control systems were established as far as possible, however, the complete integrity of the systems could not be confirmed due to the accident damage.

The propeller and engine controls were found to be in the stowed position indicating that the pilot had not attempted to start the engine during the final stages of the flight to gain altitude.
