AIRCRAFT ACCIDENT REPORT
CAA OCCURRENCE NUMBER 13/6300
HUGHES 369E
ZK-HNA
CONTROLLED FLIGHT INTO TERRAIN
GLADEBURN VALLEY, SOUTHLAND
15 December 2013

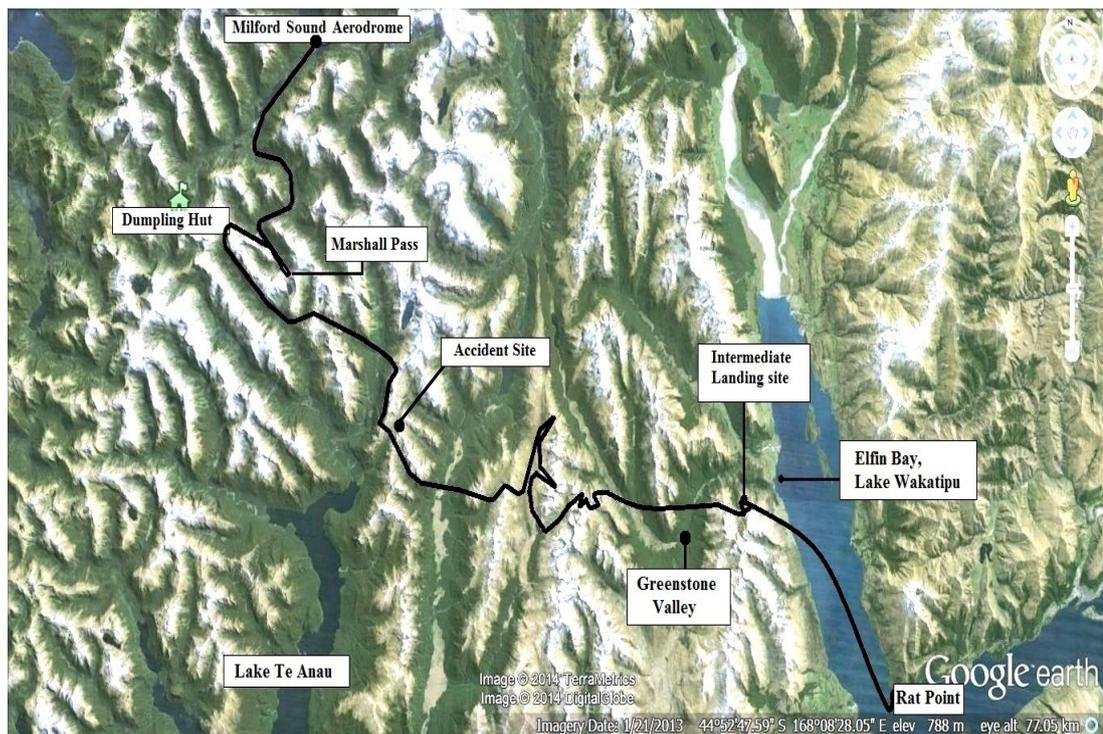
- 1.1.4 Two of the passengers spoken to stated that the pilot made numerous attempts to cross over various mountain passes during the flight to Rat Point, but had to turn back several times due to low cloud. He then searched for and found alternative routes before being able to enter the Greenstone Valley and then on to Rat Point (refer Figure 1).

Figure 1. Outbound GPS track from Milford Sound to Rat Point showing attempted ridge crossings.

2.2 The recovered GPS information showed that numerous attempts had been made to cross mountain passes and ridgelines during both the outbound and inbound flights, rather than fly a more direct route.

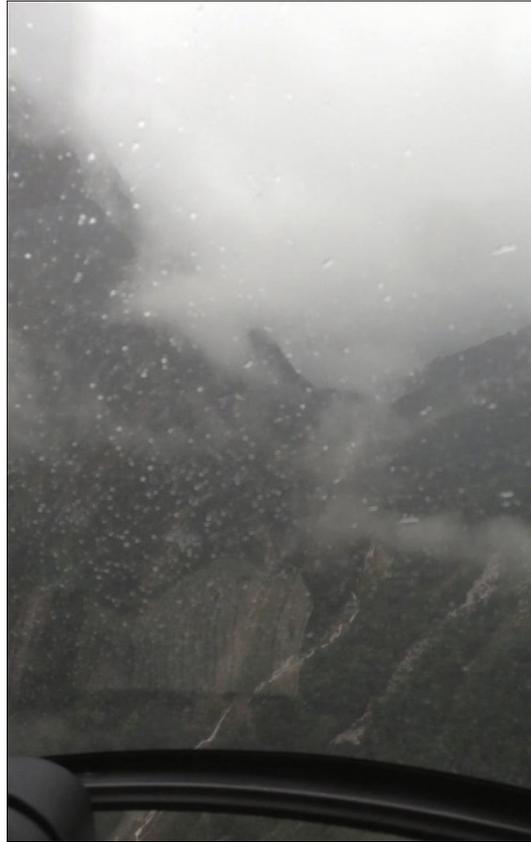
- 1.1.5 A still frame from the video taken by one of the passengers eight minutes after departure illustrates an attempt to negotiate Marshall Pass (Elevation 4,016 feet). The pilot was forced to turn away from this pass and find an alternative route (refer Figures 1 & 2).

Figure 2. Photo of cloud obscuring Marshall Pass (prior to helicopter turning away).

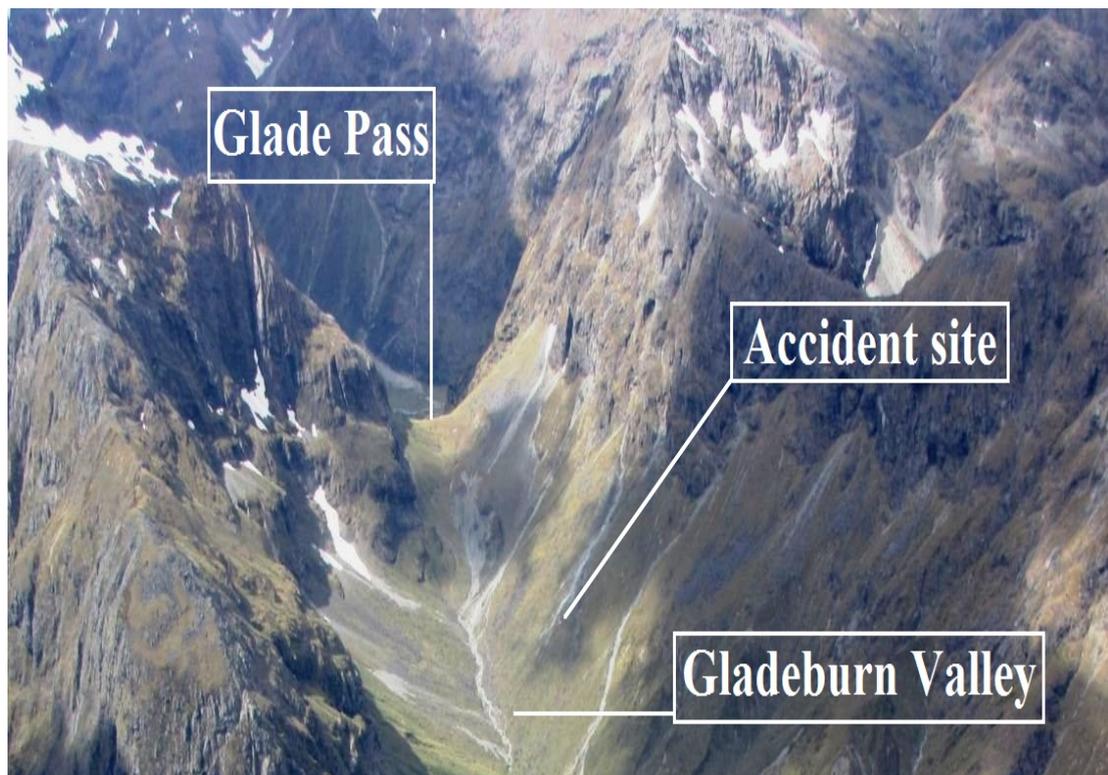
Figure 3. Glade pass and head of Gladeburn Valley. Cloud initially hid the accident site.

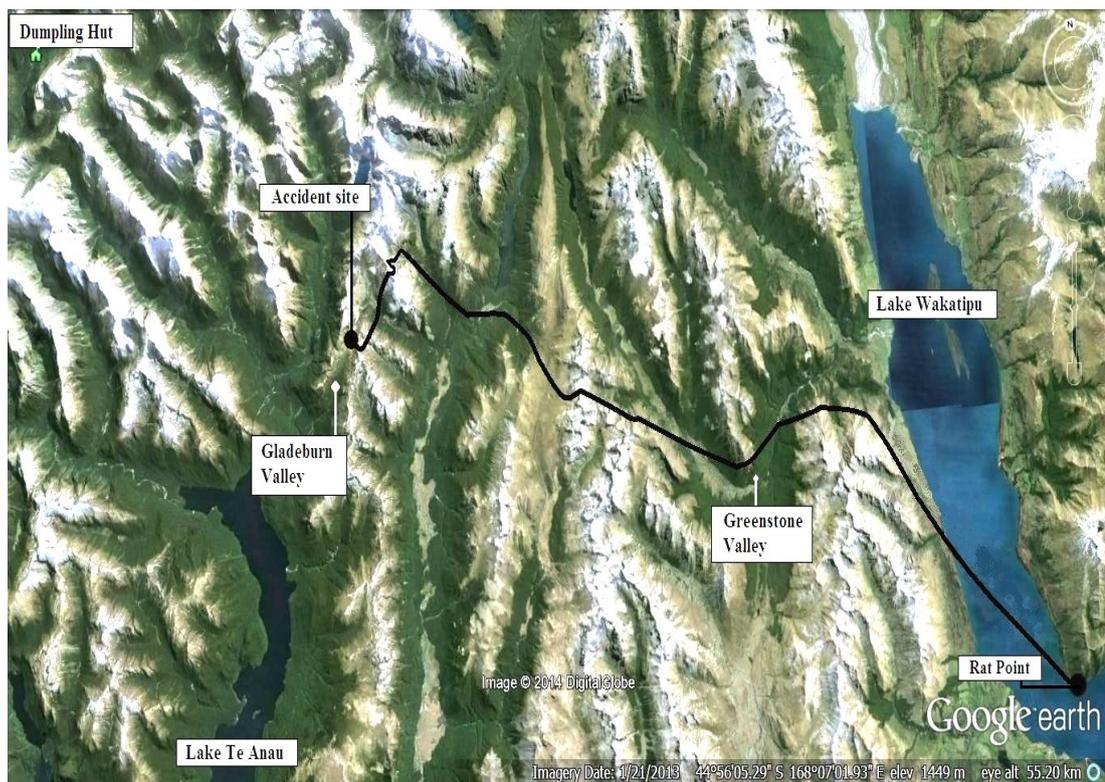
1.1.14 Data recovered from the GPS³ of ZK-HNA provided information of its outbound track from Milford Sound Aerodrome to Rat Point and its inbound track from Rat Point to the accident site. The inbound track showed that the pilot initially flew a more direct north-westerly track towards Dumpling Hut until approximately four minutes before the accident, when the pilot then made a left turn and tracked to the south (refer Figure 4).

Figure 4. Inbound GPS track flown from Rat Point to Accident site.

- 2.4 A review of the ZK-HNA's GPS track to Dumping Hut showed that it initially flew a direct north-westerly track from Greenstone, then turned on to a southerly track approximately four minutes before the accident. This turn and the subsequent track flown prior to the accident were most likely due to low cloud obstructing the more direct route.

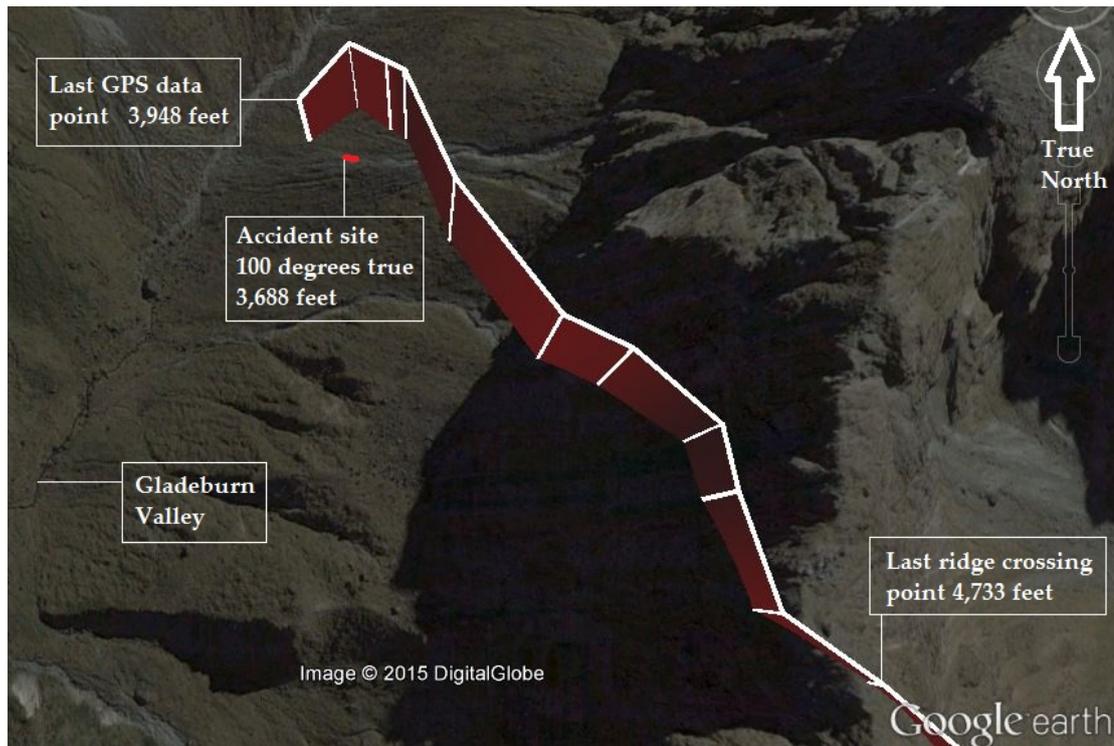
1.1.15 The GPS track showed that after ZK-HNA crossed the last ridge prior to the accident, it initially back-tracked parallel to the mountain slope in a northwest direction while in a shallow descent. It then commenced a left turn away from the mountain slope, in the vicinity of a protruding bluff, and flew towards the centre of the valley (refer Figure 5).

Figure 5. GPS track after crossing last ridgeline showing descending left turn.

- 2.5 After crossing the ridgeline into the Gladeburn Valley ZK-HNA initially back-tracked north-west parallel to the mountain face for approximately 280 meters while in a shallow descent before it turned and flew towards the centre of the valley. This turn was possibly commenced to avoid a protruding bluff.

- 2.6 The track after this point shows that the helicopter continued flying towards the centre of the valley in a shallow descent before continuing a sharper left descending turn with an associated increased rate of descent back towards the mountain slope.

- 2.7 It is considered likely that the helicopter inadvertently entered cloud which resulted in subsequent pilot disorientation and a descending left turn back towards the mountain side until just before impacting the ground.

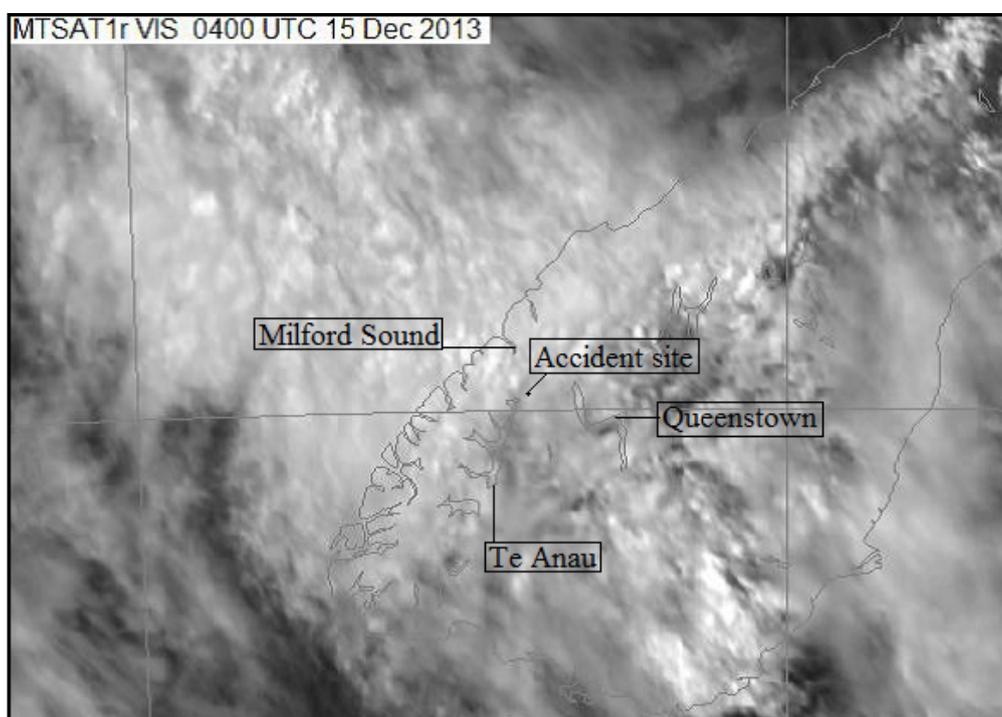
1.6.2 The satellite image shows the broad band of cloud associated with the frontal system lying across the south of the South Island on the afternoon of 15 December 2013 (refer Figure 6).

Figure 6. Broad band of cloud over the lower South Island at 1700 hours 15 Dec 2013.
