**CAA OCCURRENCE 14/1159**

**MD HELICOPTERS INC. 500N**

**ZK-HQP**

**Collision With Terrain Following Engine Failure**

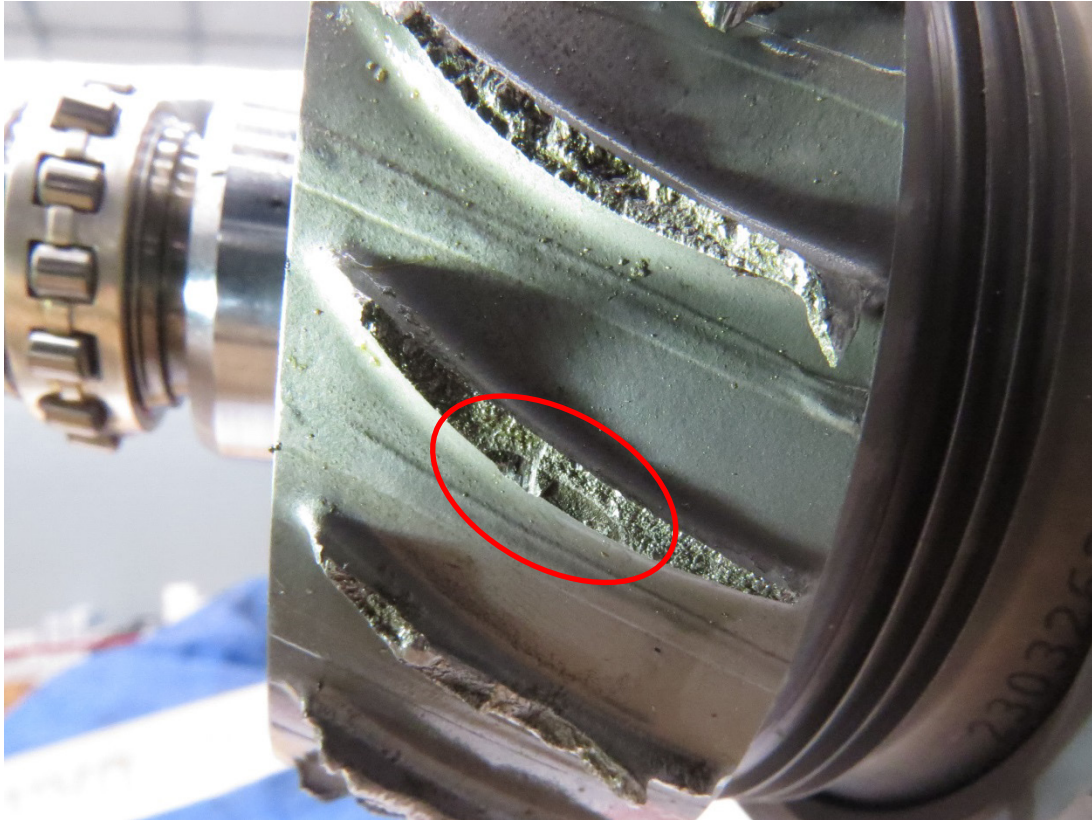
Figure 2:  
ZK-HQP high cycle fatigue crack in first stage blade.

- 1.12.11 Further inspection of the compressor wheel identified evidence of a high cycle fatigue (HCF) crack on the convex (suction) side of a single blade on the first stage compressor wheel (see Figure 2).

- 1.16.1 The Rolls-Royce Engine Investigation Report stated that the fracture surface of the compressor blade on the first stage compressor wheel exhibited a single fatigue crack, with two points of origin. Secondary damage to the fracture surface, associated with the blade release, however, resulted in only one of the origin points being able to be analysed further (see Figure 4). Examination of the intact origin point by scanning electron microscopy identified that the fracture originated subsurface and noted a delta ferrite island at the origin of the fatigue crack.

- 2.3 The first stage compressor blade failed due to a HCF crack propagating in the convex (suction) side of the compressor blade, ultimately leading to the blade fracturing in overload.

- 2.4 The fracture was determined to originate subsurface, which eliminates the possibility of foreign object damage or corrosion pitting as a stress riser and fracture origin.

- 2.9 The reason for the initiation of the HCF crack in the compressor blade could not be conclusively determined but it is considered possible that it was due to one or more of the following factors:

- the compressor assembly has experienced an air blockage/surge event at some time in the life of the first stage compressor wheel, which has initiated a subsurface fatigue crack in the first stage compressor wheel blade; and/or

- A subsurface anomaly, associated with one of the two crack origin points, has led to a fatigue crack in the first stage compressor wheel blade.
- 2.10 It should be noted that the engine's Operations and Maintenance manual stipulates the mandatory immediate removal of the compressor module for inspection and repair following a compressor inlet air blockage event.

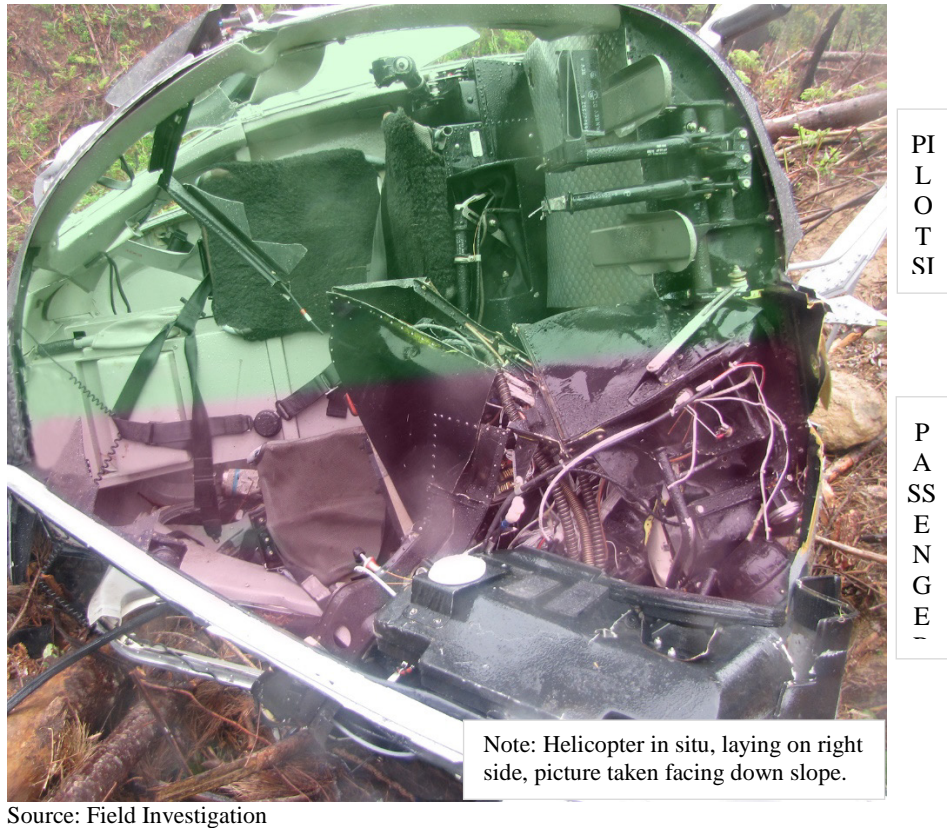
Figure 3:  
Front View of ZK-HQP Showing Pilot and Passenger Occupiable Space.

the right side of the helicopter fuselage and cockpit area sustained extensive damage, see Figure 3.

- 2.17 During the accident sequence the helicopter sustained significant damage, with the right side sustaining the majority of the impact forces. The left side maintained its structural integrity throughout the accident sequence, aided by the truss type structure and integral roll-bar design. The survival of the pilot was in part due to the design of the helicopter, the use of both waist and shoulder harnesses, the integrity of the harnesses, the wearing of a safety helmet and the predominate forces of the accident sequence being to the right side of the helicopter.

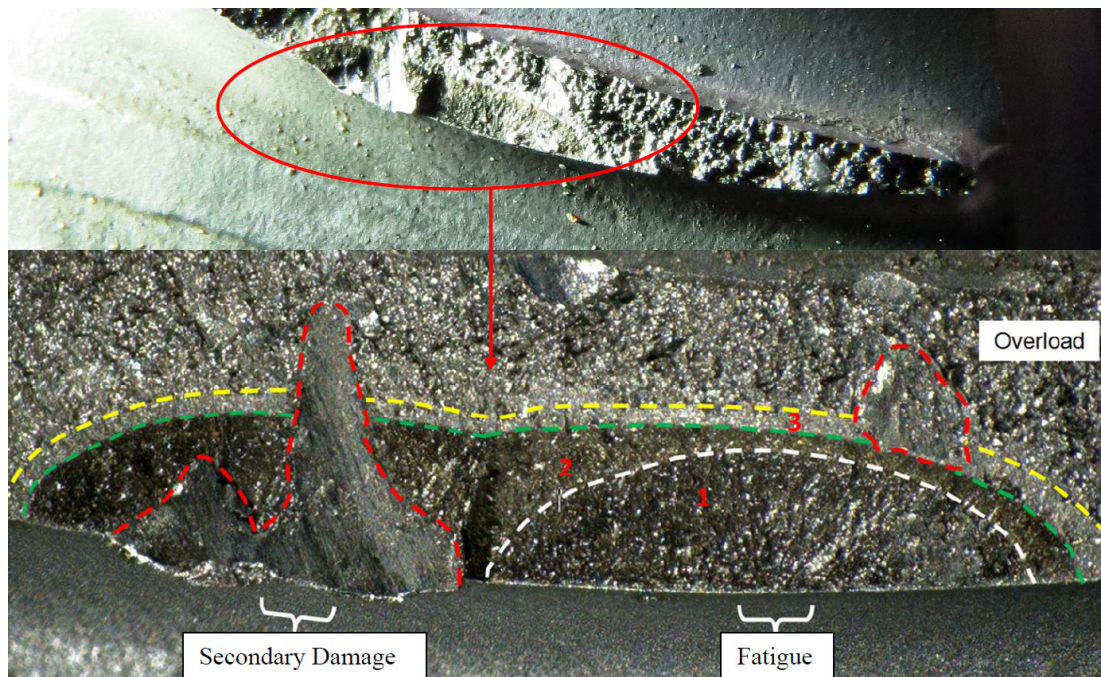
Figure 4:  
Three zones exhibited on fracture surface and secondary damage.

- 1.16.2 Due to varying amounts of coked oil accumulated on the fracture surface three distinct zones were identified (see Figure 4). This signature is considered consistent with the crack propagating over a period of time. The exact amount of time required for the crack to progress until failure in overload could not be conclusively determined.

- 1.16.3 Further examination of the fracture surface identified no traces of fluorescent dye penetrant. The compressor wheels were non-destructively tested using a fluorescent dye penetrant inspection during overhaul. This inspection identified no defects or cracks in the first stage compressor wheel at the time.

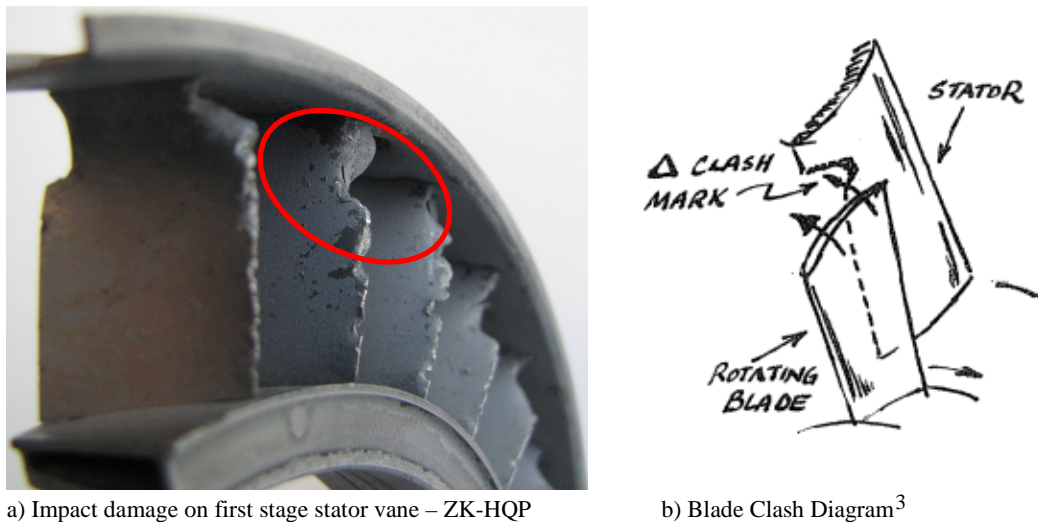
1.16.4 Examination of the first stage stator vanes identified triangular impact fractures on the trailing edge of the stator vanes (see Figure 5(a)). Blade clash is a term given to stator-blade contact due to high blade deflections caused by a surge event. The rotating blades clash with the trailing edges of the prior stator vanes. This often results in a characteristic triangular impact mark on the vane (see Figure 5(b)).

a) Impact damage on first stage stator vane – ZK-HQP

- 2.8 The triangular impact marks on the trailing edges of the first stage stator vanes indicate "clash" has occurred with the second stage compressor wheel blades and further suggests an engine surge occurred. The safety investigation could not conclusively determine if this particular damage occurred pre or post blade release, however it is unlikely to be associated with a recovered surge event.
