SAFETY INVESTIGATION REPORT
CAA OCCURRENCE NUMBER 16/6701
PACIFIC AEROSPACE LTD 750XL
ZK-JPU
COLLISION WITH HIGH VOLTAGE POWER LINES
24 NM WEST OF GISBORNE AERODROME
12 DECEMBER 2016

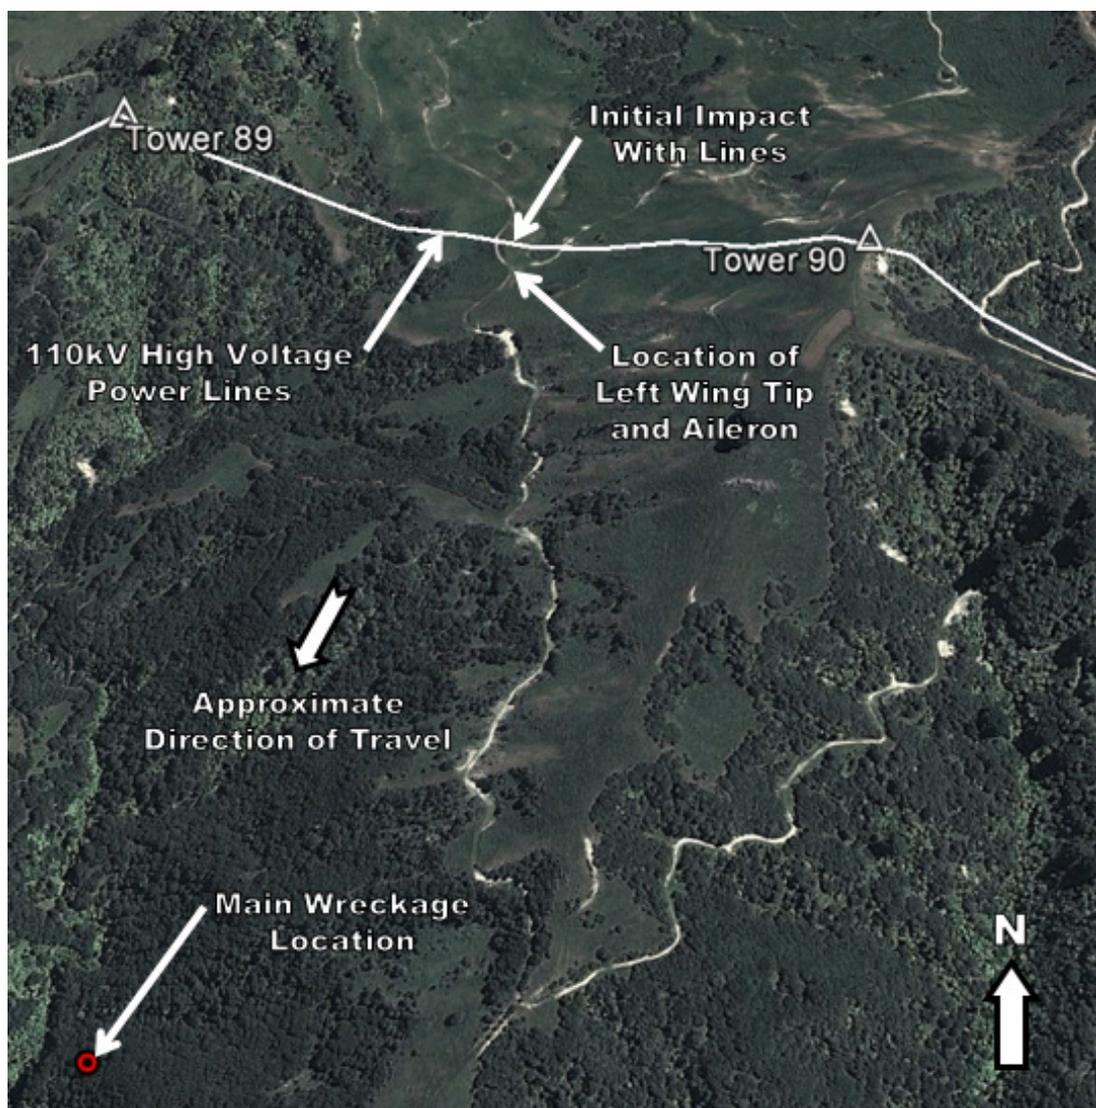
Figure 2:
Wreckage Locations in Relation to 110 kV High Voltage Power Lines

1.12.1 The aircraft initially struck the six conductors spanning the valley, at approximately mid-span between Tower 89 and 90 (Figure 2). The aircraft was in an approximate 50-degree right bank, as shown in Figure 3a. The top two conductors severed the left wing tip and separated the left aileron, which were located in close proximity to the initial impact point (Figure 3b).

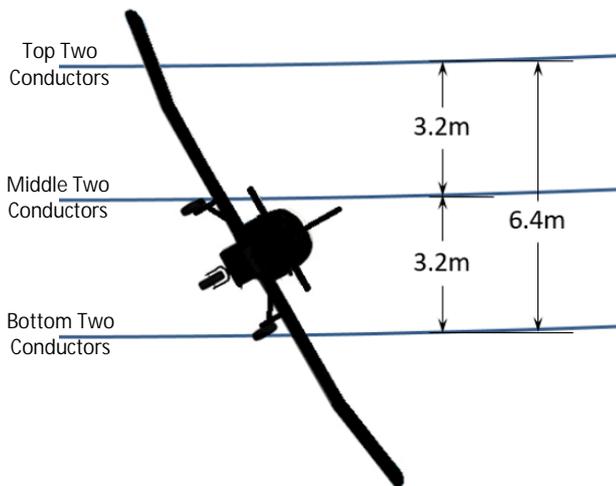
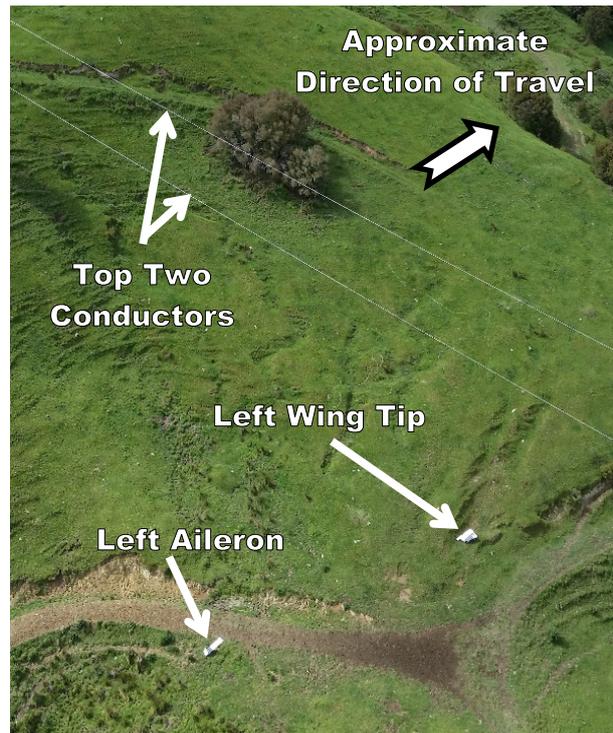
Figure 3:

a) Approximate aircraft orientation (view from aft) b) Left wing tip and aileron locations

Initial impact with 110 kV high voltage power lines.
