AIRCRAFT ACCIDENT REPORT
CAA OCCURRENCE NUMBER 09/2776
REIMS AVIATION CESSNA F152
ZK-NPI
CONTROLLED FLIGHT INTO TERRAIN
40KM WEST OF TE KUITI
21 JULY 2009

AIRCRAFT ACCIDENT REPORT

CAA OCCURRENCE No. 09/2776

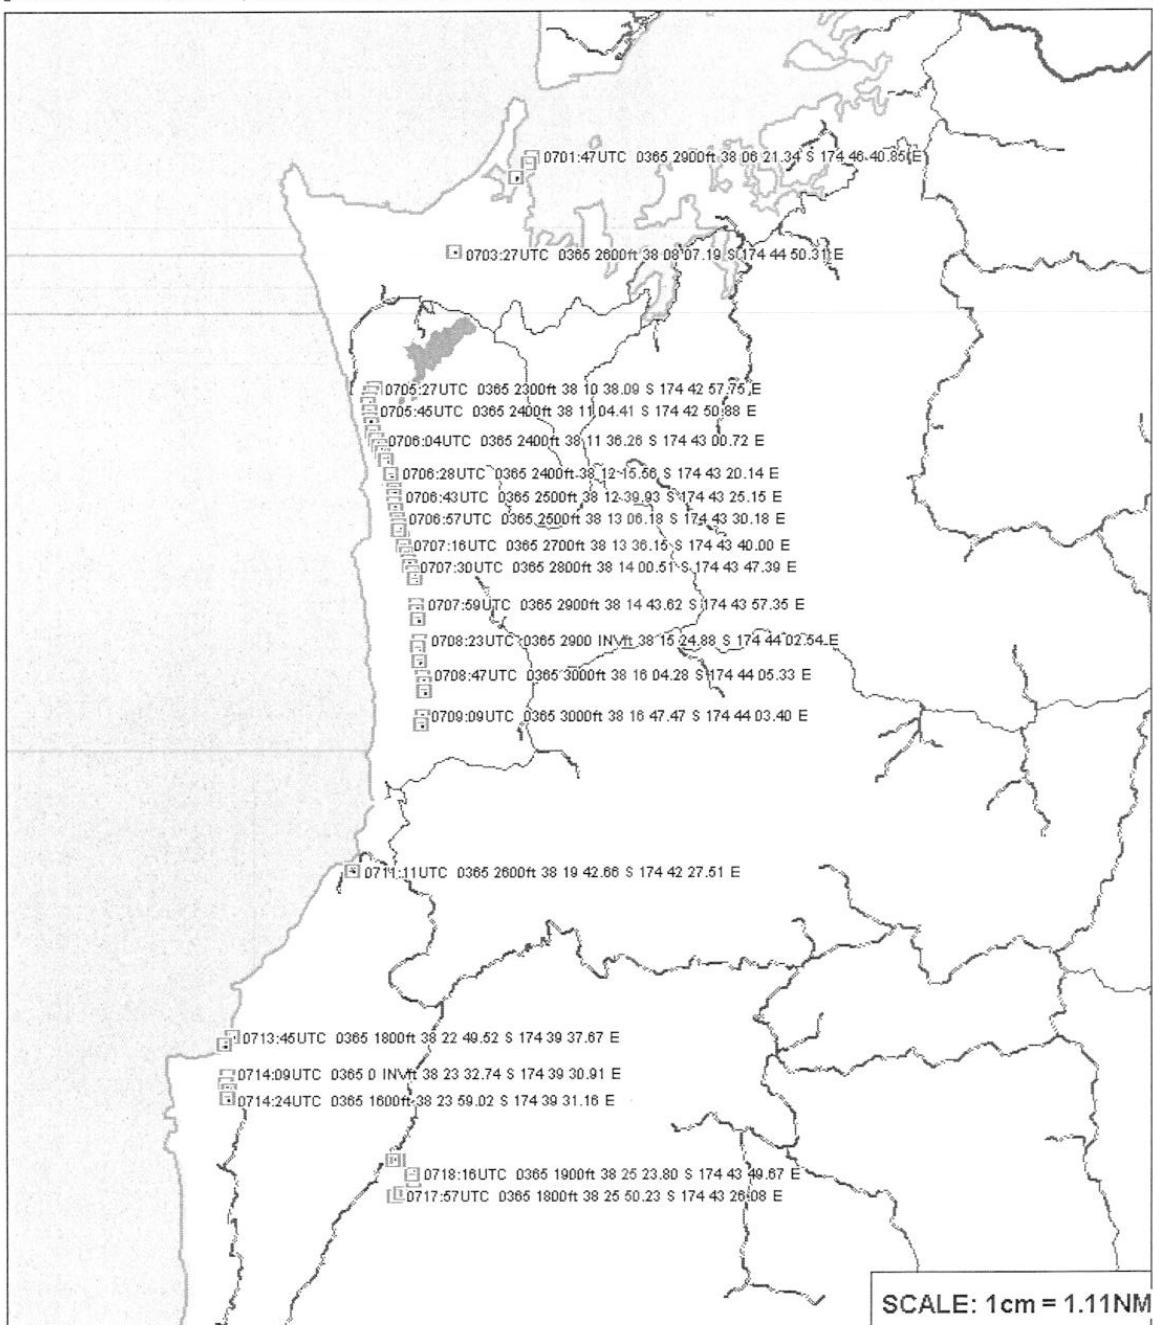
Figure 1: Primary Radar and SSR Returns

- 1.1.11 The first Emergency Locator Transmitter (ELT) signal was received at 1922 hrs by the RCCNZ and a search was initiated that evening. The wreckage was located the following morning by an RNZAF Iroquois helicopter approximately one mile to the north-west of the final SSR return. Refer to figure 1.

- 2.7 The final group of SSR returns commenced at 1917 hrs and positioned the aircraft inland of the coast approximately five miles south-east of Tirua Point at an altitude of 1800 ft in a left hand turn. The final SSR return was at 1918 hrs with the aircraft one and a half miles to the east of Mt Whareorino (2129 ft) near the Mangatua Saddle at an altitude of 1900 ft.

- 2.8 There is a time difference of some four minutes between the final SSR return and the first ELT transmissions being received. The aircraft maintained an altitude of 1900 ft apparently in a level left turn striking the terrain at approximately 1922 hrs while tracking in a south-easterly direction.

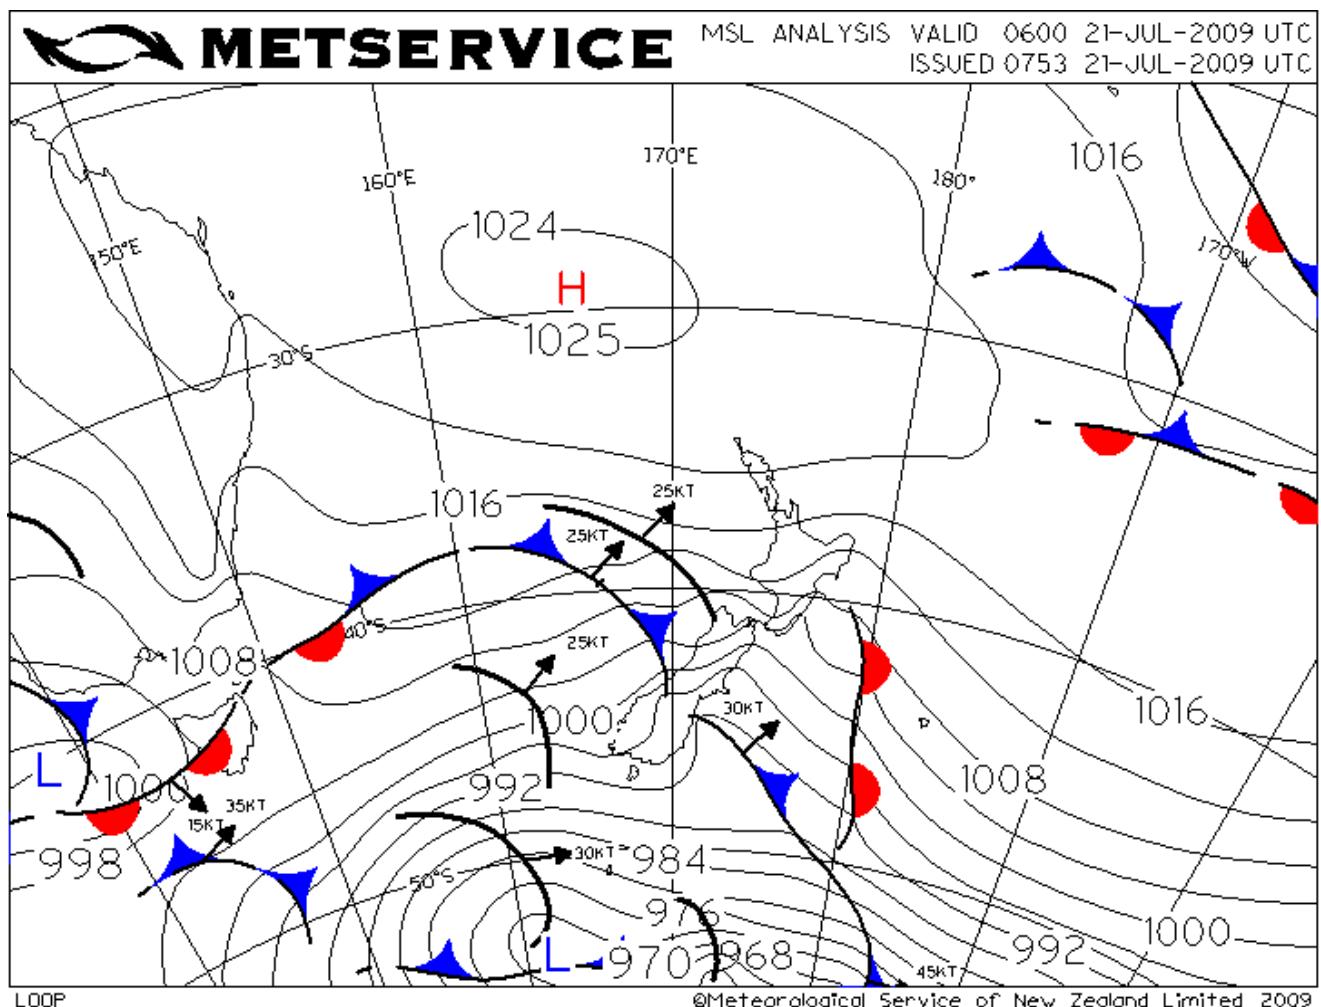
Figure 2: Synoptic Meteorological Chart

- 1.7.1 At 1800 hrs on 21 July 2009 an anticyclone centred in the Tasman Sea was nearly stationary and extended a ridge of high pressure eastward past the north of New Zealand. A broad trough of low pressure was moving eastward over the country and a frontal system was moving north-eastward over the Tasman Sea towards the North Island. Refer to figure 2 below.

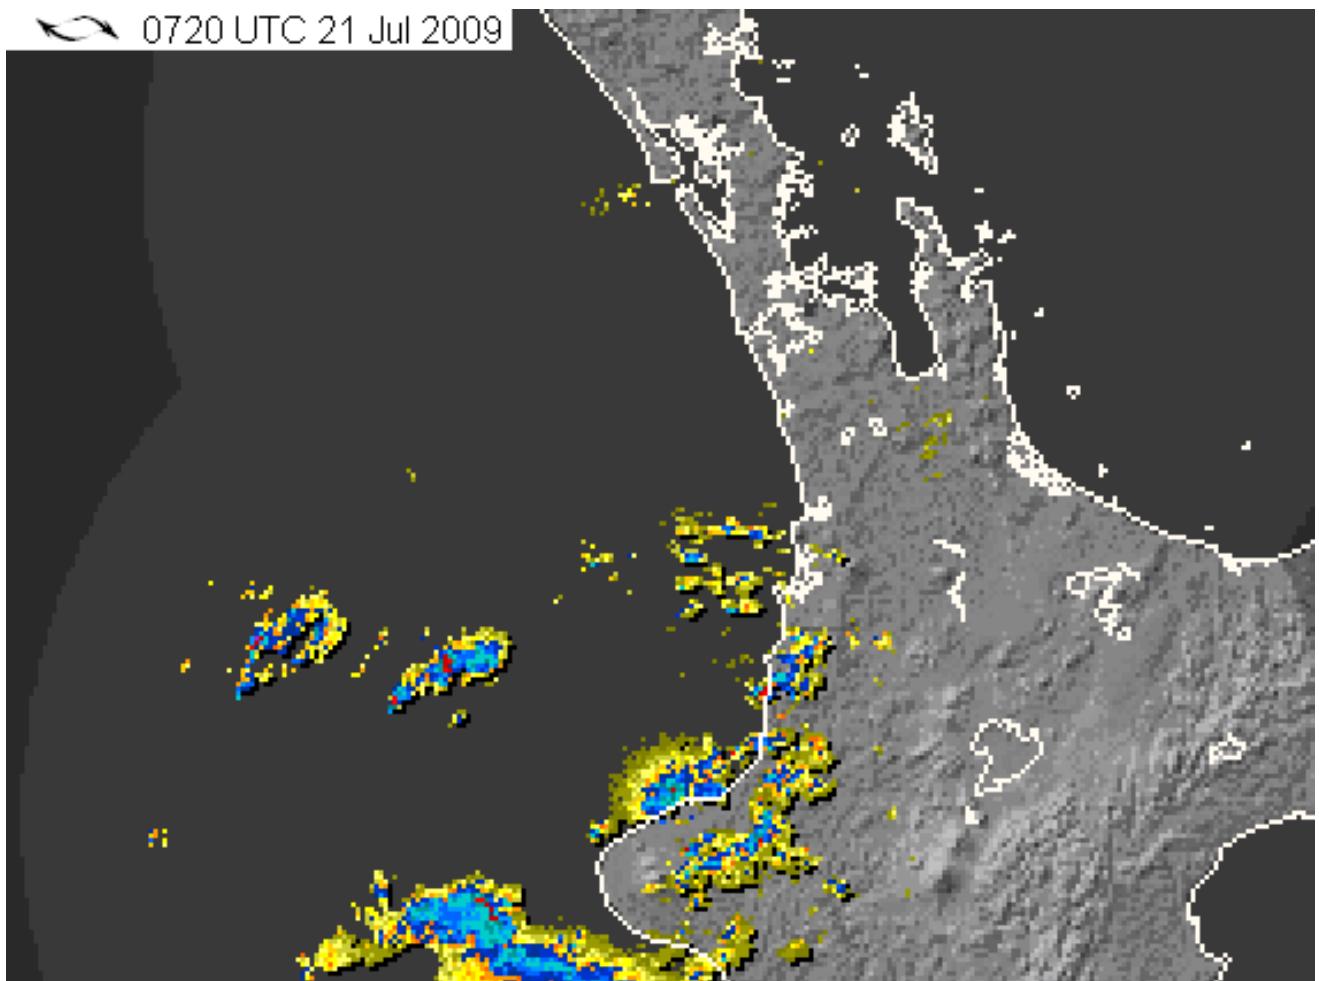
Figure 3: Radar Returns of Shower/Rain Activity

- 1.7.9 METSERVICE also provided composite radar images based from New Plymouth and Auckland which depicted the showers passing through the area at the time of the flight. Refer Figure 3.
