**AIRCRAFT ACCIDENT REPORT**  
**OCCURRENCE NUMBER 08/1753**  
**AMATEUR-BUILT THORP MODEL S-18 W**  
**ZK-WMT**  
**WHENUAPAI MILITARY AERODROME**  
**26 APRIL 2008**

## AIRCRAFT ACCIDENT REPORT

### OCCURRENCE No 08/1753

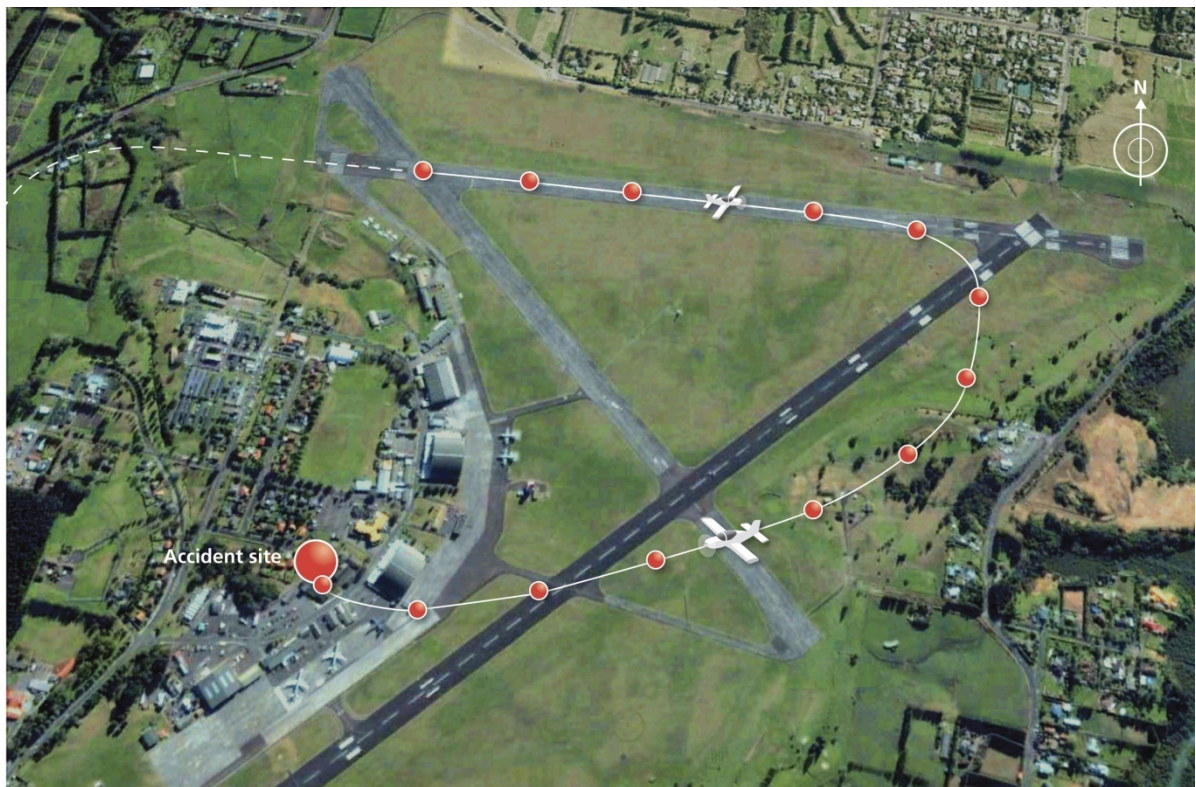
Figure 1

1.1.7 Review of the GPS data revealed that at the time of the last radio transmission the aircraft had continued in an oval type circuit pattern, at a height of 600 feet and constant groundspeed for 16 seconds. The next two position plots were timed four seconds and three seconds apart. See Figure 1.

- ground speed reduced from 108 knots to 81 knots during the four seconds,
- a height increase of 20 feet and a heading change to the right through 30 degrees.

- ground speed 51 knots,
- a height loss of 100 feet, and
- a further change of heading to the right through 50 degrees.

Oval type circuit pattern.
