CAA Safety Investigation Brief

Yakovlev Yak 3M ZK-YYY

Collision with ground equipment

31 March 2018

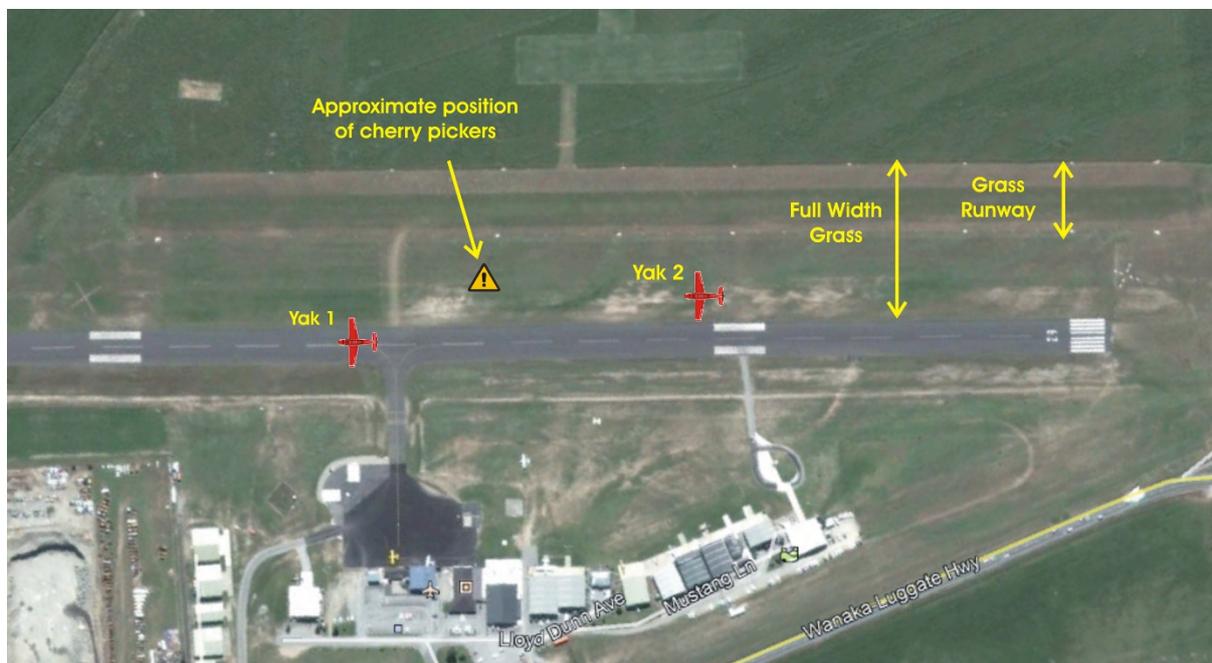
After flying the sequence, Yak 1 (ZK-VVS) landed on sealed runway 29, and Yak 2 (ZK-YYY) landed on the grass area 29 (see figure 1). During the landing roll Yak 2 collided with cherry pickers that had been placed on the grass area north of the sealed runway.

Figure 1. Wanaka aerodrome, showing full width grass, grass runway and disposition of cherry pickers at the time of the accident. (Not to scale.)

Wanaka aerodrome has two runways available for use; a sealed runway, and a grass runway, parallel to and north of the sealed runway (see figure 1).

Before the morning briefing it was noticed by the MDD that two cherry pickers, that were not scheduled to be in place until after the opening sequence of the display, were in place on the grass
