**AIRCRAFT ACCIDENT REPORT**  
**OCCURRENCE NUMBER 11/1471**  
**ROBINSON HELICOPTER R22 BETA PLUS**  
**ZK-IXR**  
**DYNAMIC ROLLOVER**  
**MISTAKE CREEK**  
**6 APRIL 2011**

### CAA OCCURRENCE No.11/1471

<b>Aircraft type, serial number and registration:</b>	Robinson R22 Beta Plus, s/n 2196, ZK-IXR
<b>Number and type of engines:</b>	1 Lycoming O-360-J2A
<b>Year of manufacture:</b>	1992
<b>Date and time:</b>	6 April 2011, 0938 hours <sup>1</sup>
<b>Location:</b>	Mistake Creek, 62km NW of Methven Latitude <sup>2</sup> : S 43° 10'05.79'' Longitude: E 171° 12'15.16'' Altitude: 3750 feet AMSL
<b>Type of flight:</b>	Private
<b>Persons on board:</b>	Crew: 1 Passenger: 1
<b>Injuries:</b>	Crew: 1 Fatal Passenger: 1 Serious
<b>Nature of damage:</b>	Aircraft destroyed
<b>Pilot's licence:</b>	Private Pilot Licence (Helicopter)
<b>Pilot's age:</b>	59 years
<b>Pilot's total flying experience:</b>	1037 hours Total Time 237 hours Fixed Wing 632 hours on type
<b>Information sources:</b>	Civil Aviation Authority field investigation
<b>Investigator in Charge:</b>	Mr S J Walker

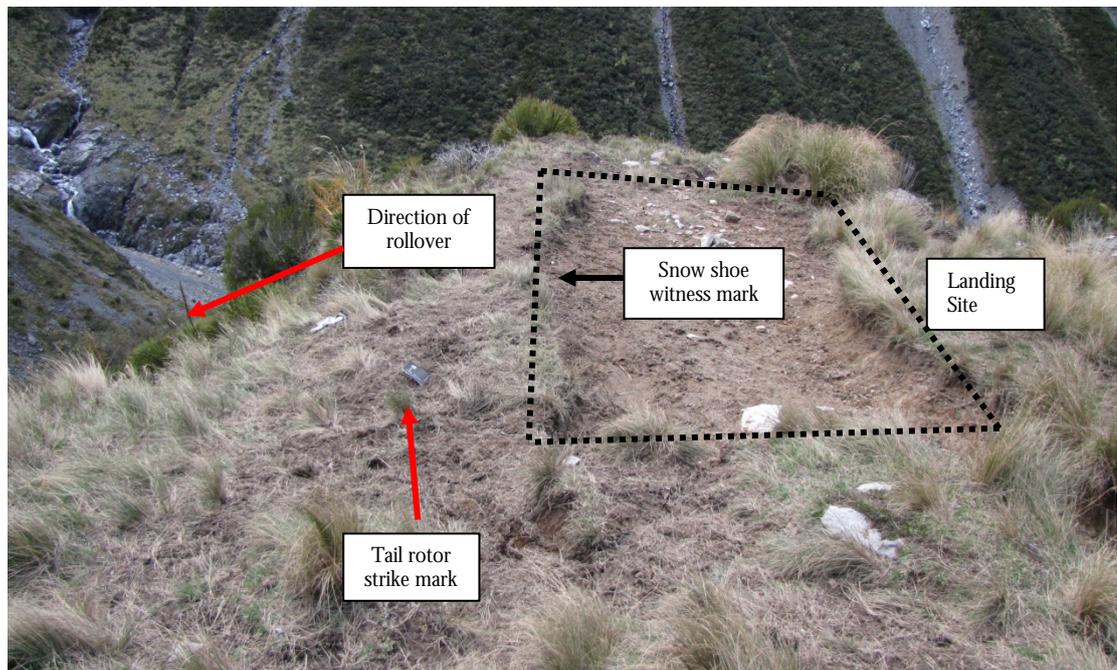
1.12.1 Parts of the helicopter were scattered for 120 metres down a steep sided spur. The main fuselage, including the cockpit area and engine, had come to rest in a stream downhill from a small depression at the top of the spur, (see Figure 1).

1.12.2 The depression, intended to be used as the landing site, measured approximately three metres by seven metres. Small rocks were scattered within the bounds of the landing site with large tussocks at the northern end. The perimeter of the landing site consisted of a small raised dirt bank. The inside of the banked edge was generally vertical, as if cut with a spade. The banked edge varied in height between 100 mm and 400 mm.

Figure 1. Landing site situated at 3800ft AMSL

- 2.3 The landing site was a roughly prepared surface with numerous rocks and irregular shaped small boulders scattered within its boundary. This uneven surface would have required the pilot to carefully select a suitable place to land in order to maintain the stability of the helicopter during landing.

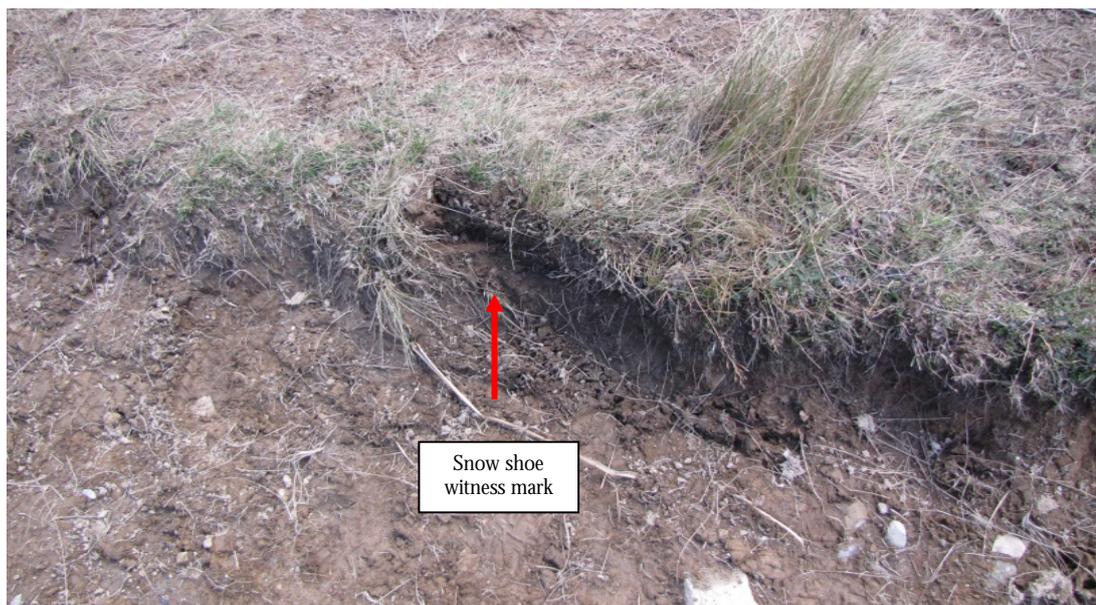
1.12.3 A pronounced witness mark was evident in the western edge of the landing site, adjacent to the edge of the steep side of the spur. This witness mark matched the shape of the snow shoe fitted to the rear of both skid tubes, (see Figures 2 and 3).

Figure 2. Witness mark from left hand snow shoe.

- 2.4 It is evident that, during the landing, the left snow shoe penetrated the vertical banked edge of the landing site. The shape of the penetration revealed that the snow shoe did not penetrate vertically from above the edge of the landing site, but arrived there horizontally, from within the boundary of the landing site.

- 2.6 Having penetrated the edge of the landing site, the snow shoe became a pivot point, a factor in the onset of dynamic rollover.

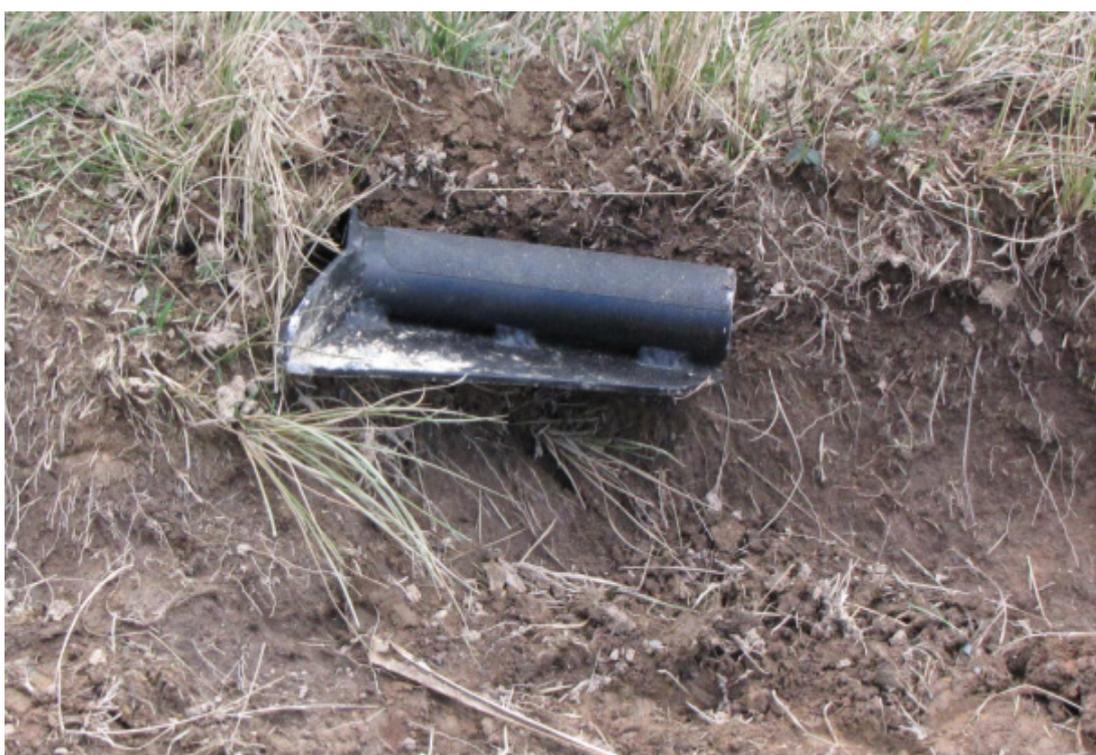
Figure 3. Snow shoe, demonstrating contact with edge of landing site.

- 2.5 The horizontal penetration could be explained as a result of the pilot attempting to reset the position of the helicopter on the landing site. The pilot's seating position being on the right hand side would have prevented him from seeing the proximity of the snow shoe in relation to the banked edge of the landing site.
