# Continuing Airworthiness Notice – 25-005

## Helicopter Winch Cable – Damaged during winching operation

9 June 2025

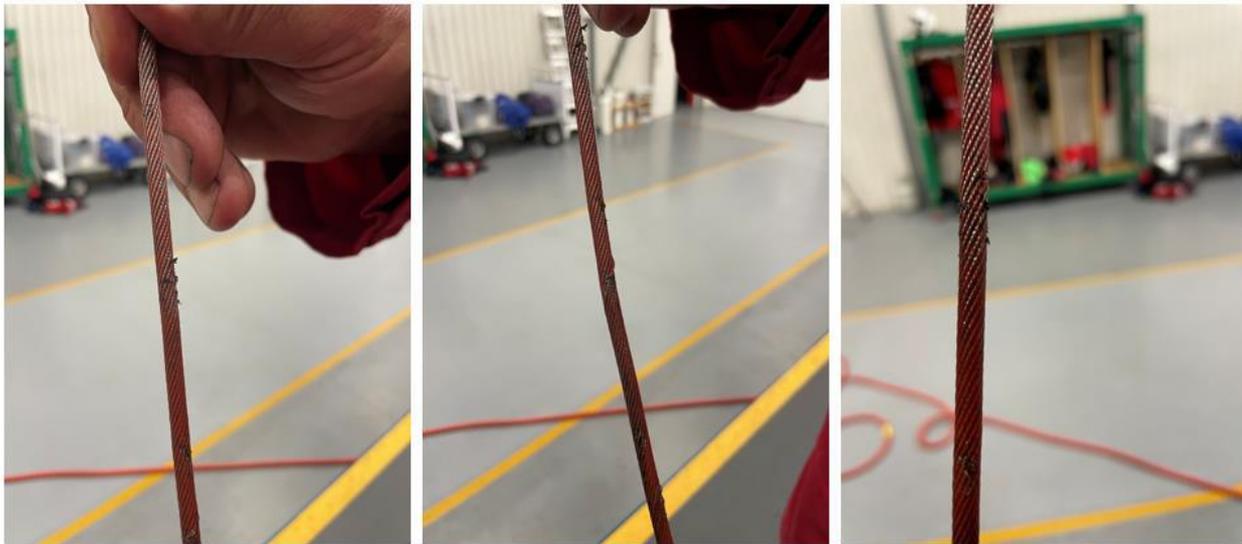
The crew were quickly able to arrest the cable oscillation but not before the cable contacted the helicopter skid causing damage (see figure 1 below).

Figure 1 - Damaged cable.

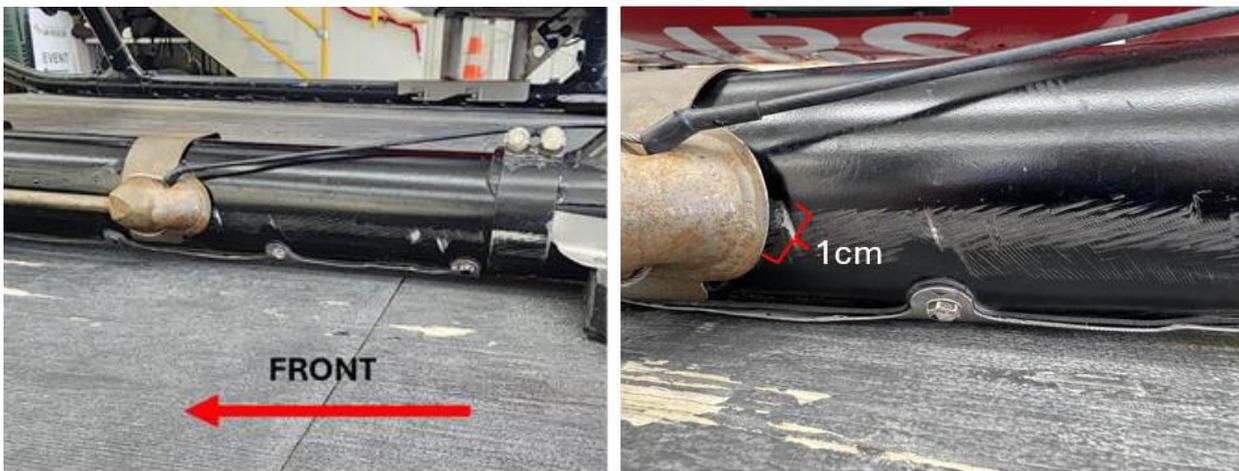
Upon investigation it was determined that the cable had contacted the skid, the snowshoe and the ground handling lug protector. It appears that the cable became momentarily trapped between the skid and an exposed edge of the lug protector, causing broken wire strands in the cable (see figure 2 below).

The operator determined that due to a previous repair to the skid, the ground handling lug protector did not sit flush with the skid. This meant that the cable was able to become trapped in the resulting gap, causing damage to the cable.

Figure 2 - Damaged skid.

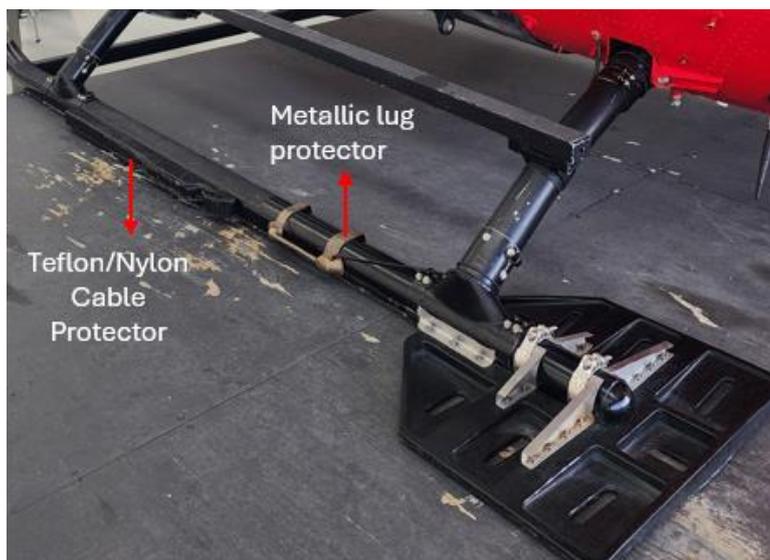
It was also determined that a Teflon cable protector assembly installed by the operator was not long enough to protect the potential cable contact area, nor did it sit flush against the skid meaning that the cable could become trapped between the protector and the skid.

Figure 3 - Protectors installed at time of incident.
