# Continuing Airworthiness Notice 51-003

## MBB-BK117 and Kawasaki BK117 Vertical Fin Spar – Inspection for Cracks

14 September 2022

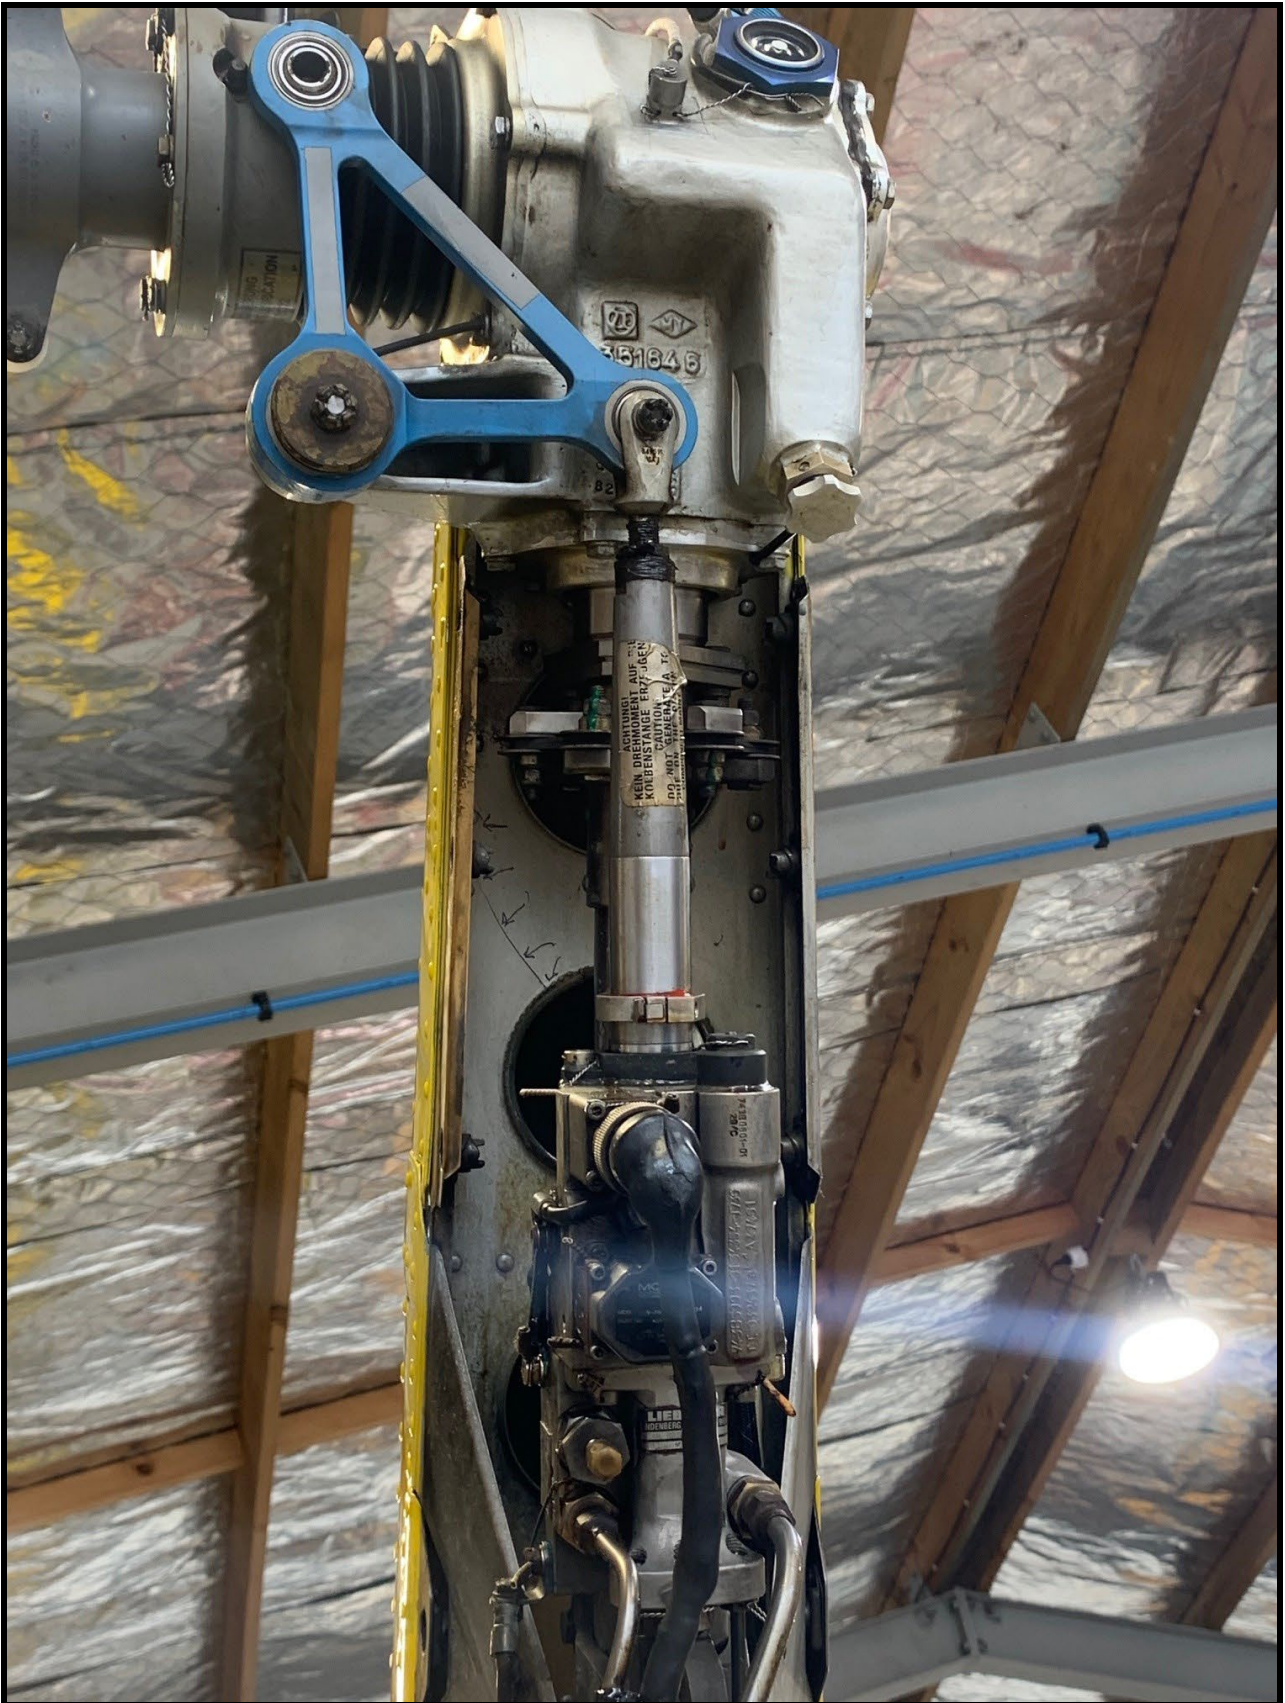
The defect report states: *During the 50hr inspection, the tail boom vertical fin rear cowling was removed for inspection of the vertical fin spar. A crack was found propagating from the second to top lightening hole outwards toward the 11 o'clock position facing forward to a nearby rivet hole. Once the tail rotor actuator was removed and the spar cleaned for a closer inspection it was discovered that the crack also had propagated from the lightening hole downward toward the 5 o'clock position into the radius of the spar edge.*

The CAA understands that the operator was carrying out the required inspections at a shortened repetitive interval of 50 hours TIS (to align with other scheduled maintenance inspections), meaning that the crack had grown from being undetectable, to that shown in the photos below over a period of 50 hours.

Photo 1: Location of crack found in vertical fin spar.

Maintainers are advised to familiarise themselves with the inspection requirements of the vertical fin spar, ensuring that the area to be inspected is clean, and that appropriate lighting and inspection aids are used during the inspection. Engineers should pay particular attention to the area around the fin spar lightening holes which appear to be an initiation point for cracks.

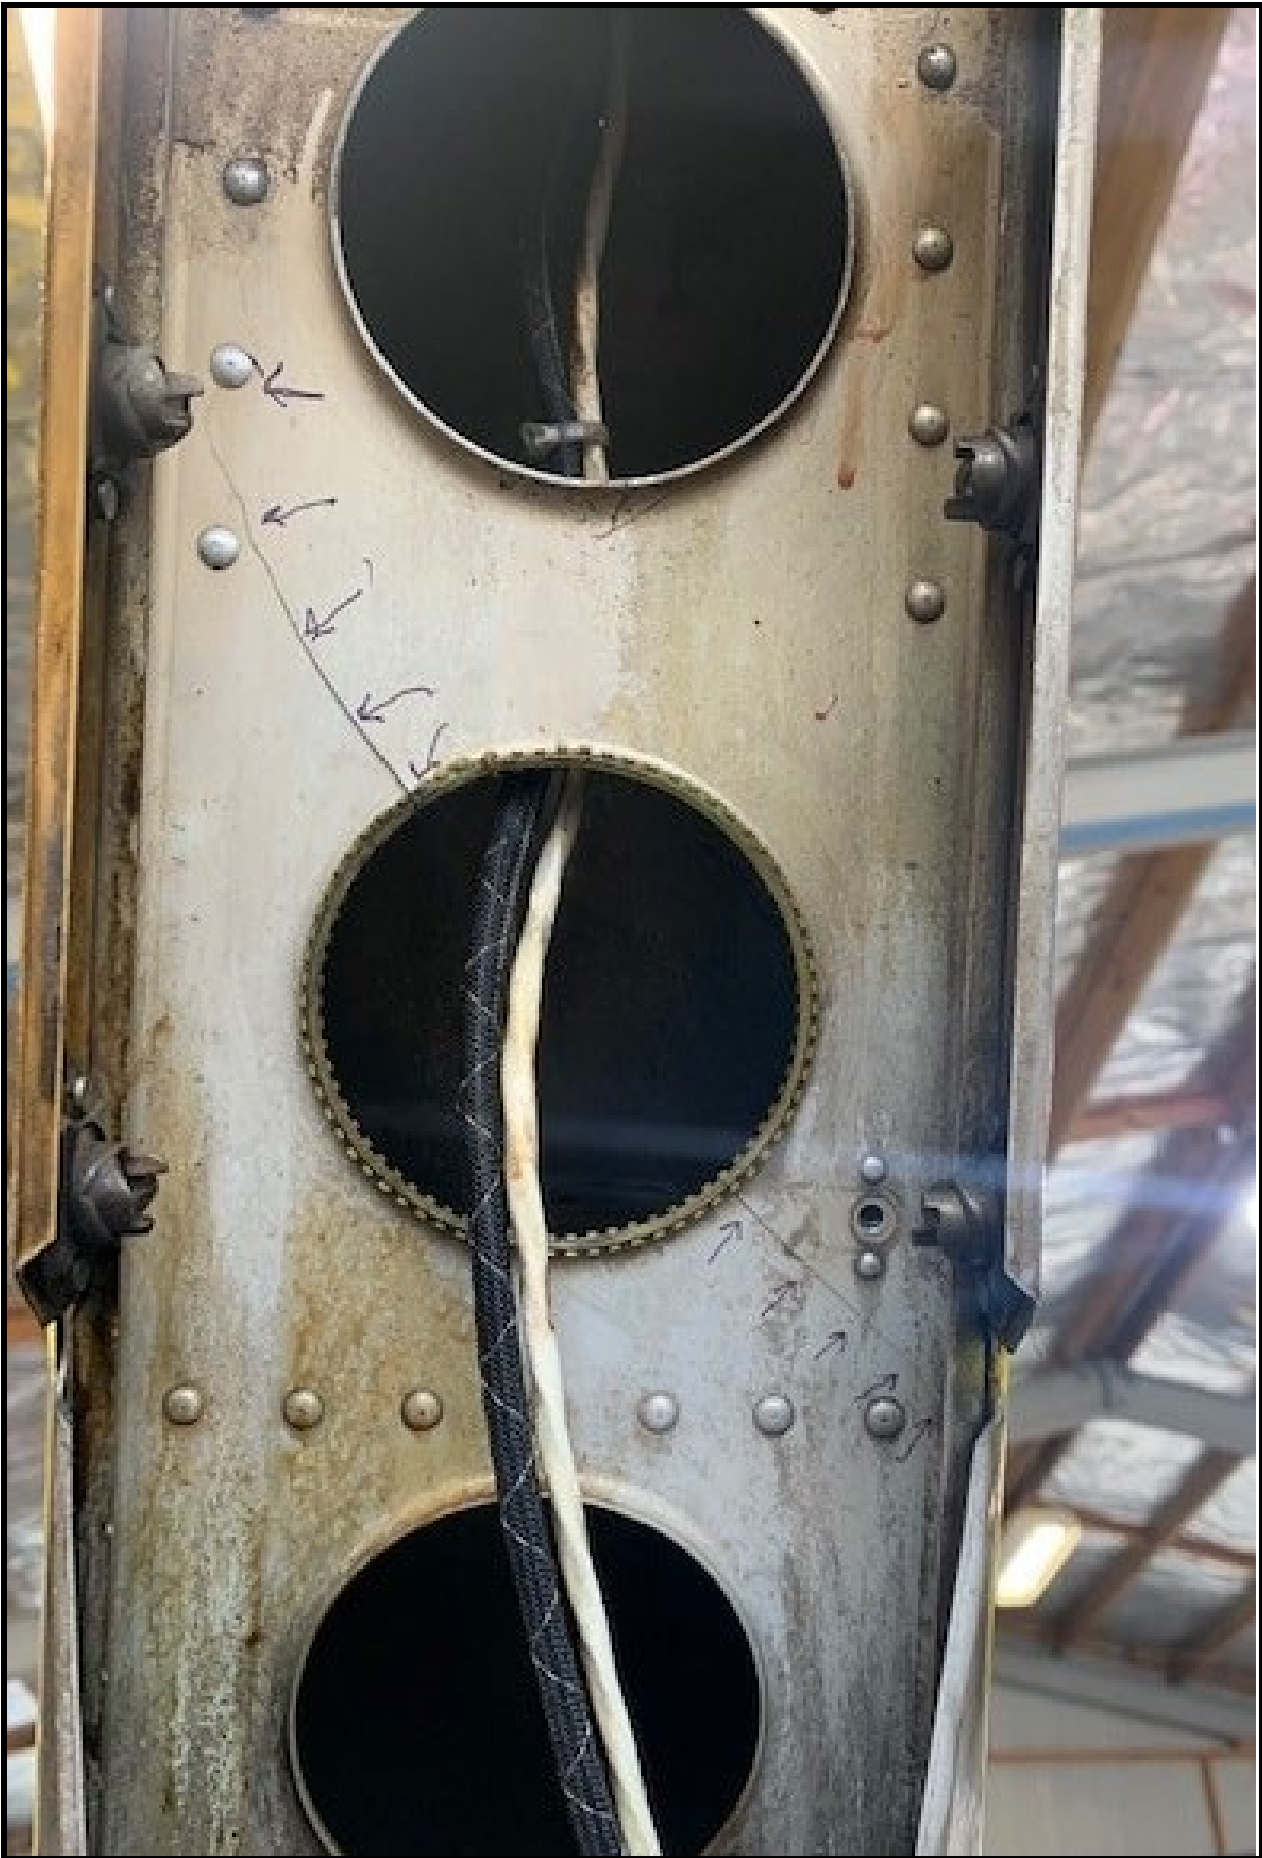
Photo 2: Location of cracks found in vertical fin spar with actuator removed.
