# Continuing Airworthiness Notice – 85-007

## Lycoming O-540 and IO-540 series engines installed on Robinson R44 series helicopters

18 November 2016

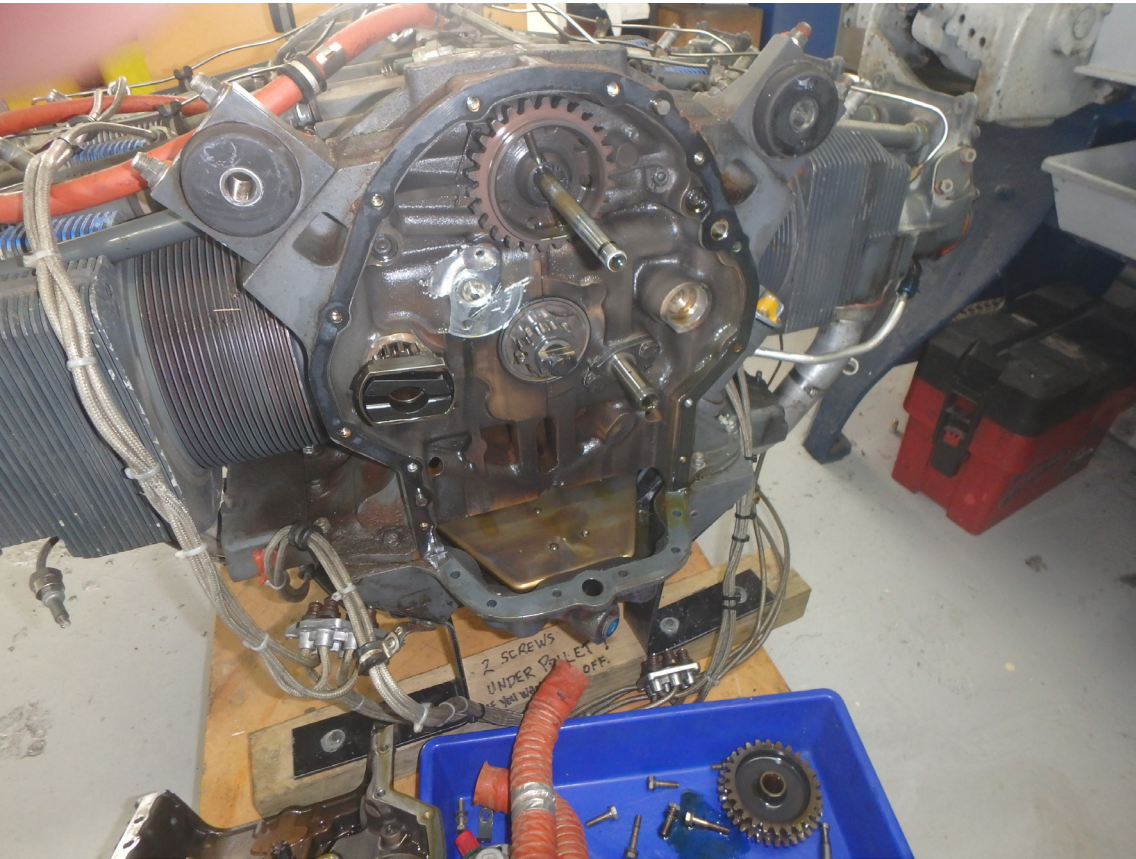
This Continuing Airworthiness Notice (CAN) is prompted by an accident reported to the CAA of a loss of engine power on a Robinson R44 II, which resulted in the pilot carrying out a successful auto-rotation landing. The magnetos were removed and the idler gear was found loose with gear teeth missing. The rear accessory case was subsequently removed and the attachment studs of the LH idler gear post found failed. The failure resulted in a loss of camshaft and LH magneto drive. Refer to the attached photos for more detail.

Failure of LH idler gear resulted in loss of LH magneto and camshaft drive.

If there is any indication of damage to the crankshaft idler gear assemblies, excessive gear backlash, damaged gear teeth, or any gear assembly side play, replace all damaged parts, as required and check the balance the engine cooling fan.

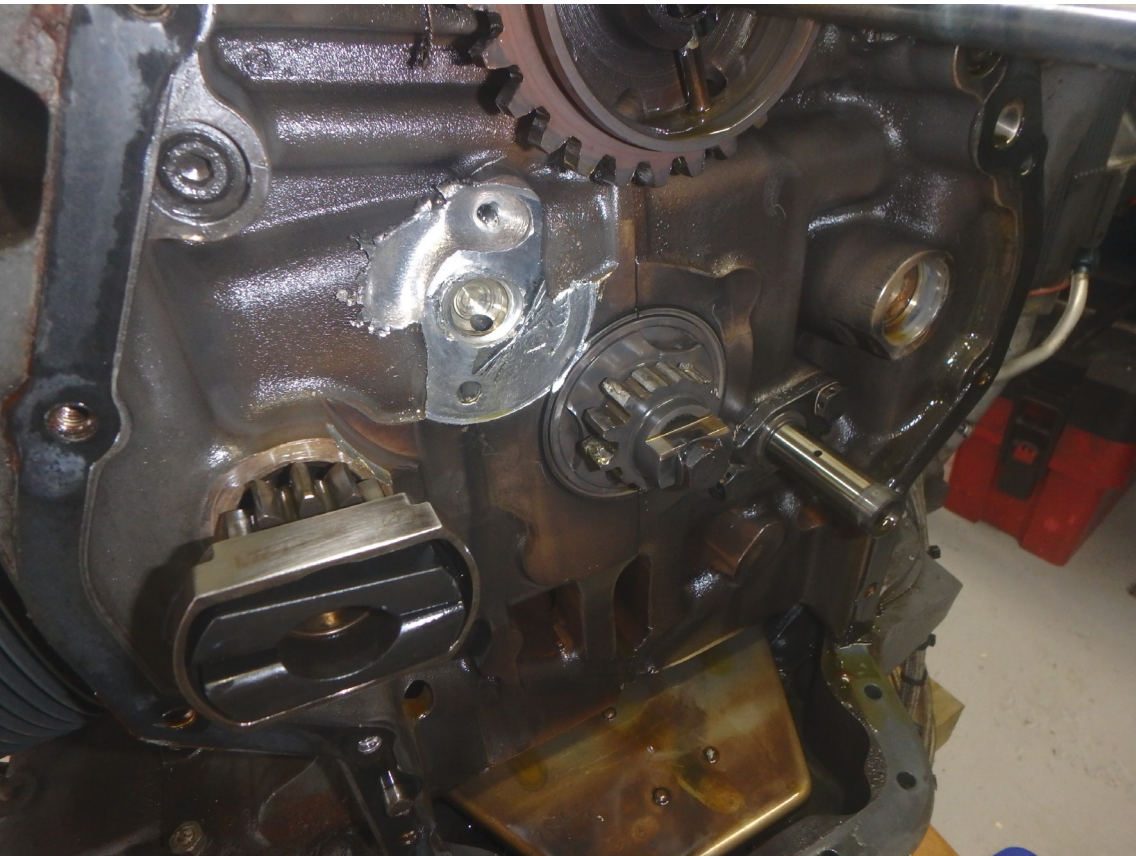
Idler gear post fretting is known to occur on Robinson helicopters due to drive train anomalies. Wear and deterioration of the dynamic counterweight rollers/bushes can result in reduced effectiveness of the pendulum damping system and increase the torsional vibration within the engine. An out of balance engine cooling fan can also increase torsional vibration. Inspection of the pendulum damping system on the affected engine revealed that the crankshaft dynamic counterweight rollers and bushes were worn beyond the manufacturer's limits.

Fretting caused by a loose LH idler gear post, due to excessive torsional vibration.
