## Safety Information Bulletin

**SIB No.: 2019-07R1**

**Issued: 25 February 2025**

**Subject: Sailplane Rigging – Procedures, Inspections and Training**

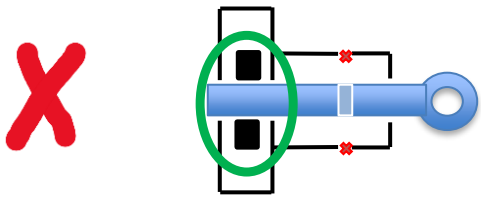
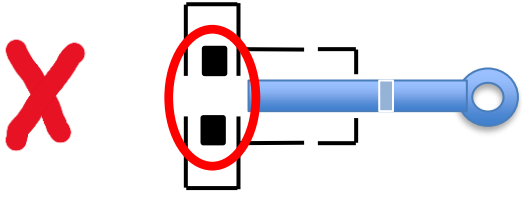
Engaged but <u>not</u> secured.	The bolt moved away from its engaged position, and the control is unconnected.

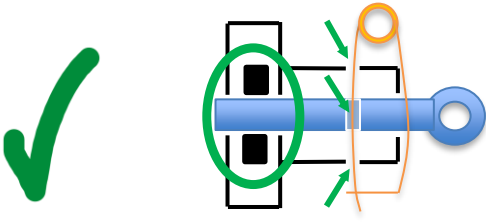
The Fokker-needle needs to be pushed through both holes of the cage and the hole of the bolt.
Engaged and secured.

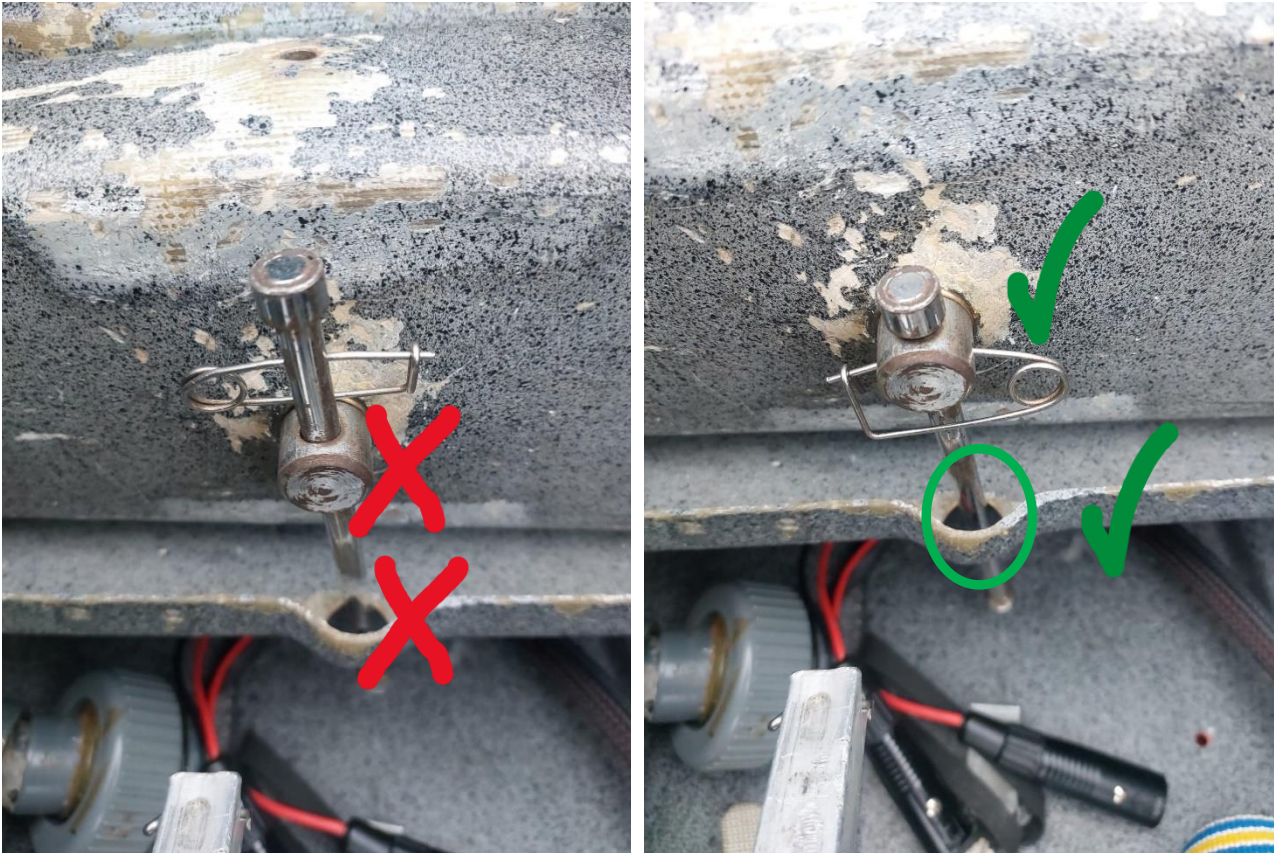
PIK 20

## Example of engage and secure of a main pin (wing connection)

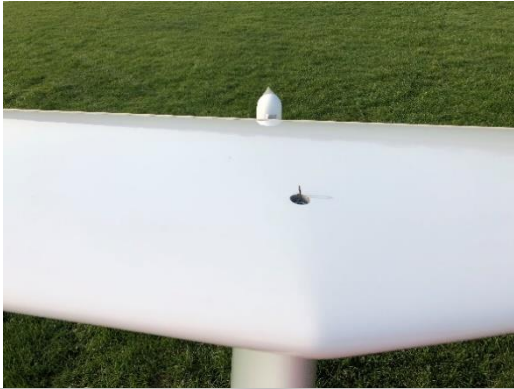
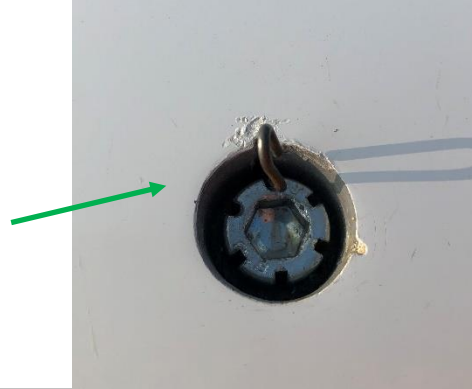
Installation of ASW 19 and later horizontal stabilizer. Screw need to be engaged and secured.

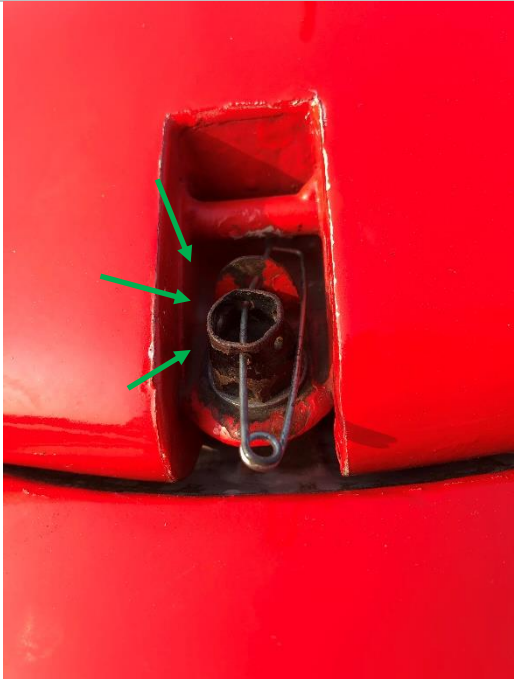
The bolt needs to be engaged and secured against rotation.

Installation of AS K-types horizontal stabilizer. The screw needs to be engaged and secured.

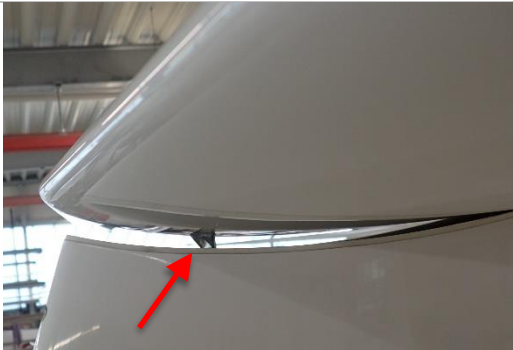
<p>Horizontal stabilizer engaged in its aft fitting but forward fitting not engaged.</p>

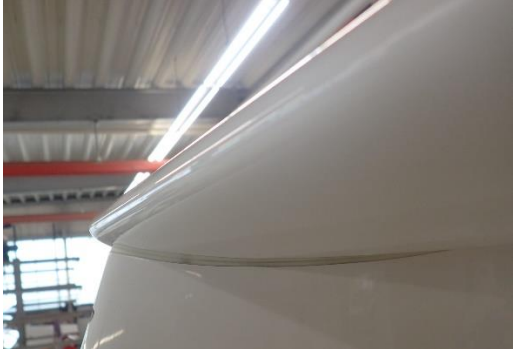
<p>Horizontal stabilizer properly engaged.</p>

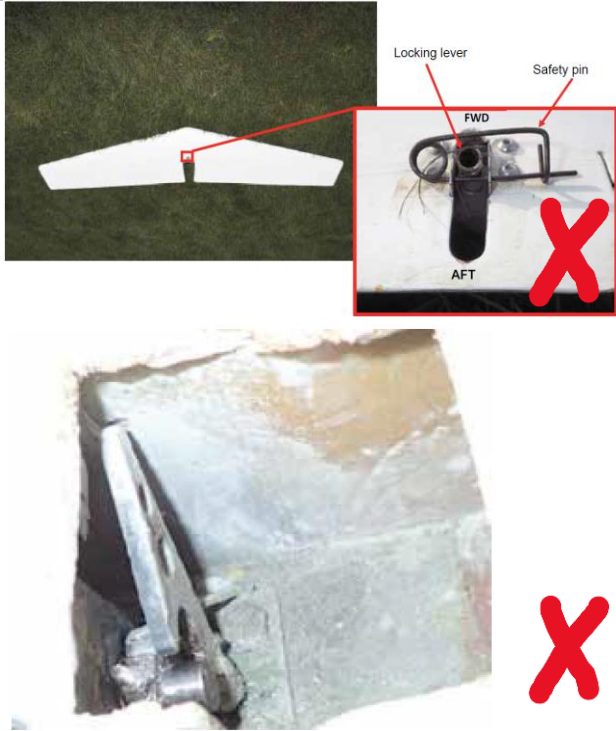
<p>Locking lever</p> <p>Safety pin</p> <p>FWD</p> <p>AFT</p>

<p>Locking lever in the wrong – unlocked – position (<i>on the wrong side</i> of the Safety Pin).</p>

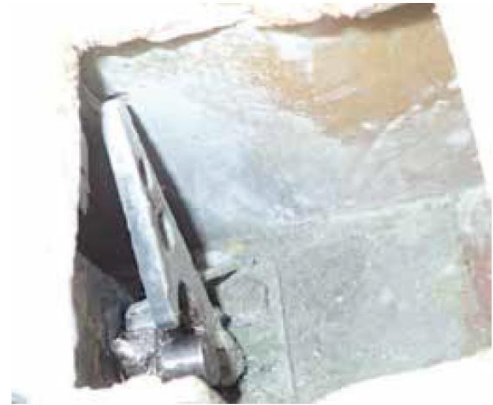
<p>In consequence, the locking hooks (left and right) are not engaged and the horizontal tailplane remains disconnected.</p>

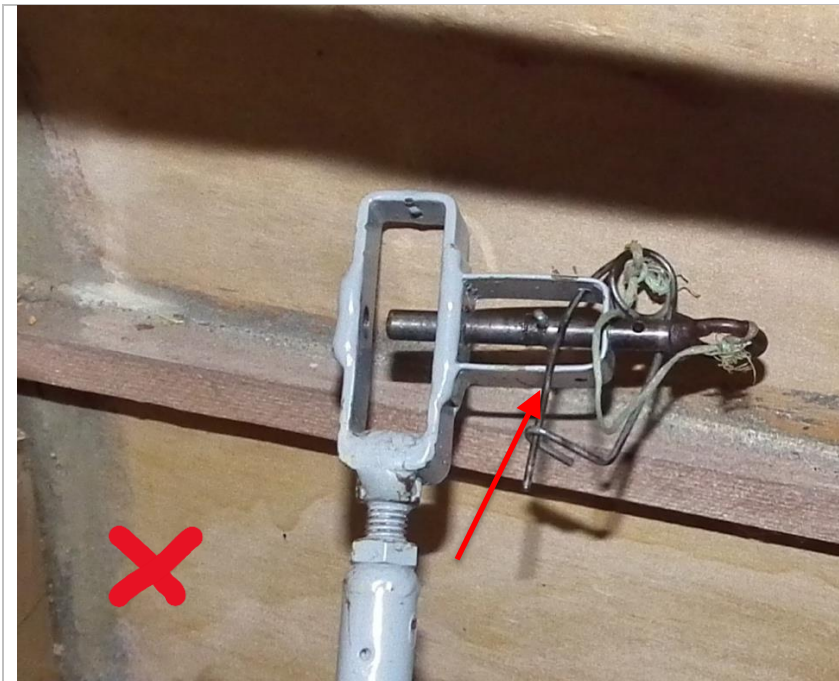
The example below shows an aileron connection, which is typical for old sailplanes with manual control connections. In this case, the connection was engaged during rigging, but not correctly secured. After three flights of short duration, the bolt moved away from its engaged position.

The connection was not secured. The Fokker-needle was put through one hole of the cage only, but not through the bolt and the lower hole of the cage, as well. In consequence, the bolt could move freely, and the control connection could become unconnected.

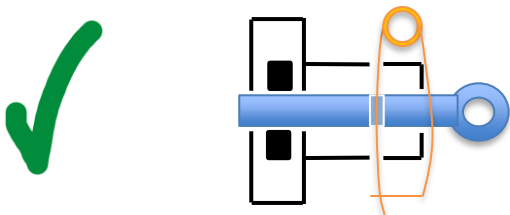
<p>The bolt is secured by pushing the Fokker-needle through <u>all three</u> holes.</p>

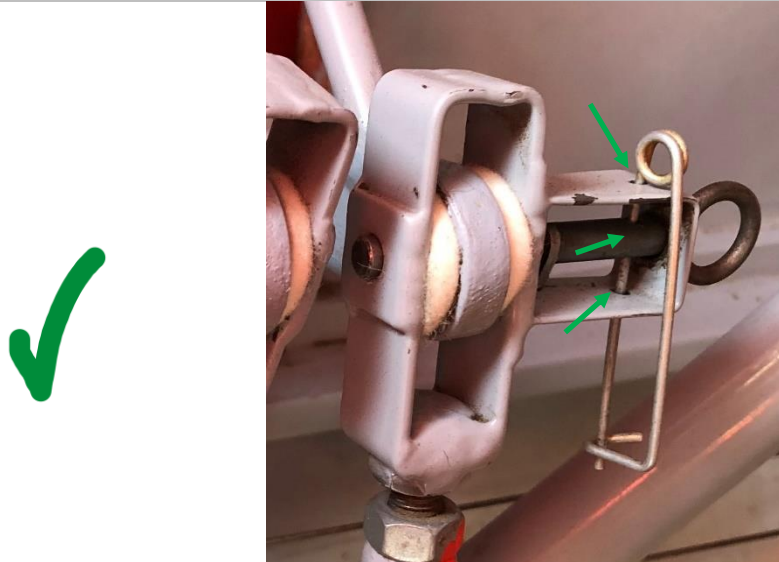
<p>A straight and not bent needle supports its proper application.</p>

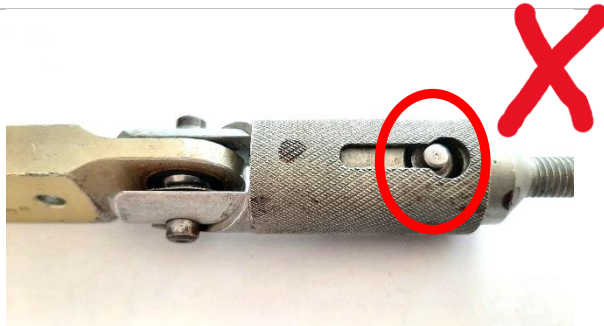
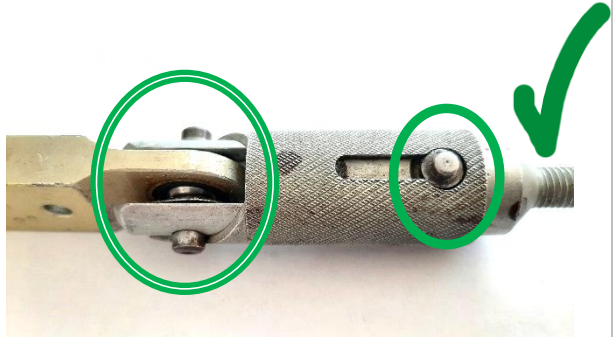
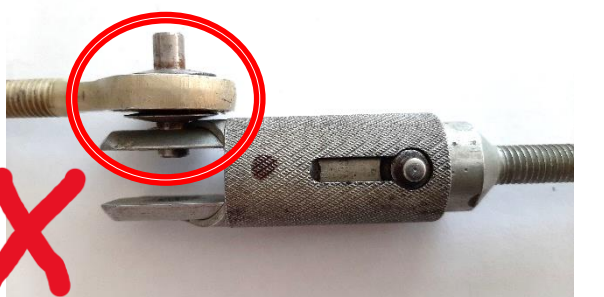
SZD / Allstar PZL Glider models – elevator and ailerons connections

*Connections, which are not properly secured, cannot be detected by positive control checks. The proper securing can be verified only by a manual inspection through turning, pulling, or shaking of the bolt and further visual inspection.*

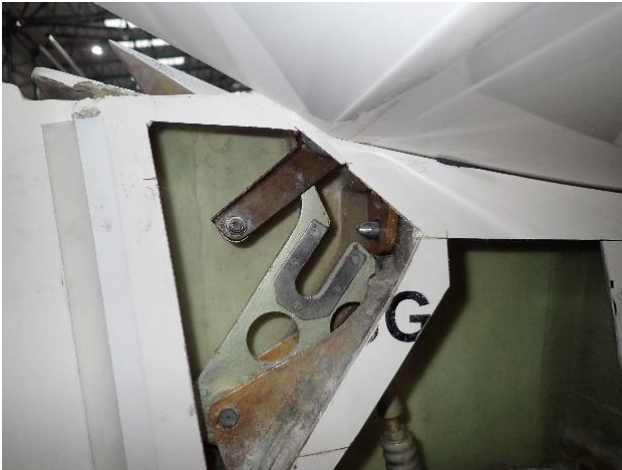
Similar designs can be found for the control connection of the elevator. Pictures below show examples of a mis-rigged vertical stabilizer, which led to a fatal accident. The mis-rigging had its root cause in an unauthorized and apparently unrecorded modification, to make rigging easier.

Disconnected elevator control

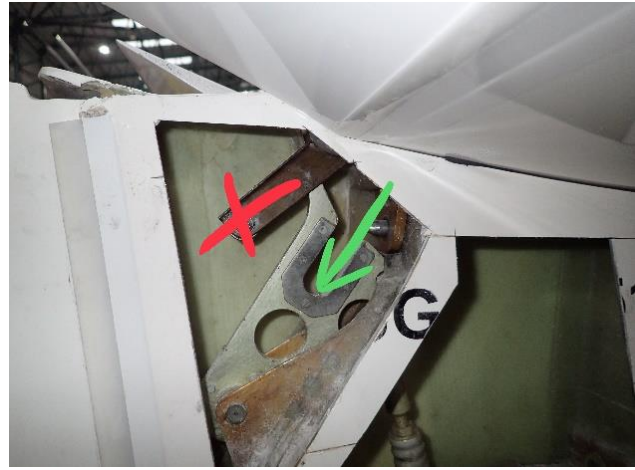
Disconnected elevator control

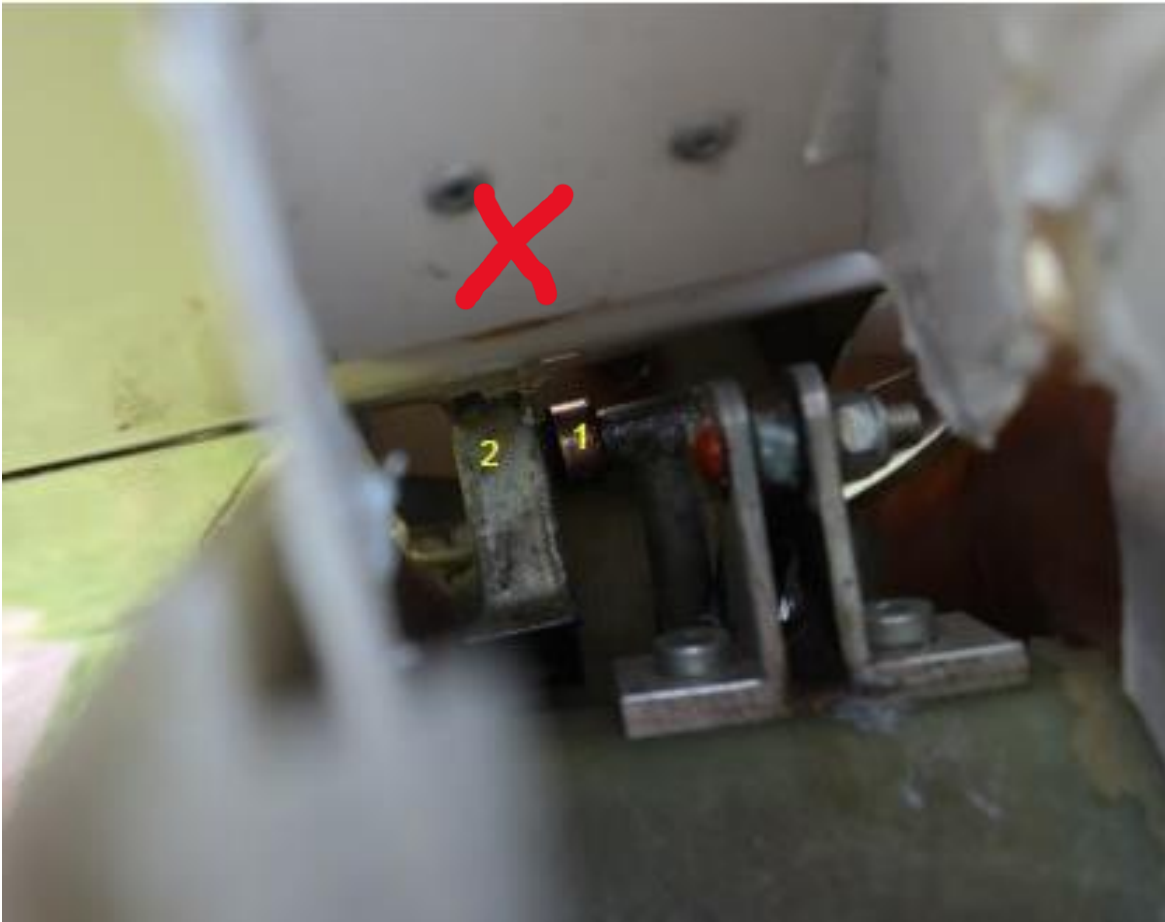
The roller at the fuselage side pushrod (1) is not inserted into the funnel (2) at the elevator

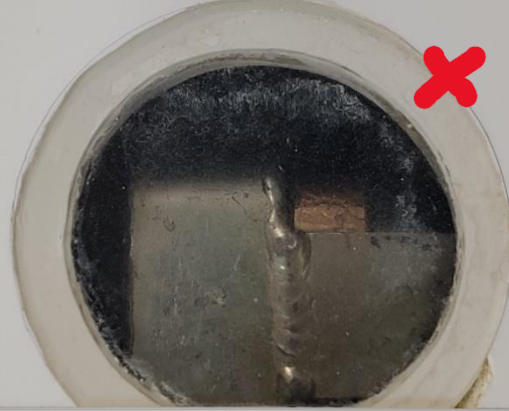
<p>Check for correct elevator connection by looking through the Plexiglas window at the upper surface of the stabilizer: Elevator control connection is not performed correctly, if the roller is visible.</p>

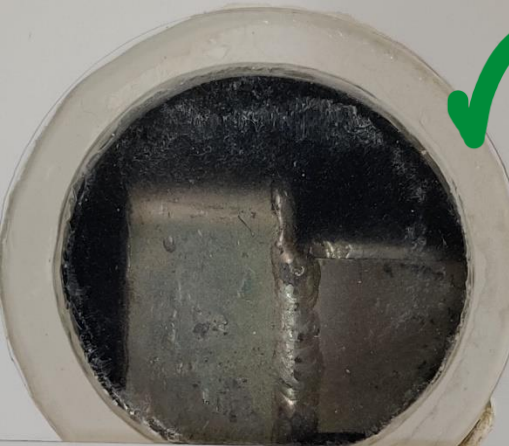
<p>Elevator control connection correct.</p> <p>For details refer to DG Aviation, Service Info No. 111/23</p>

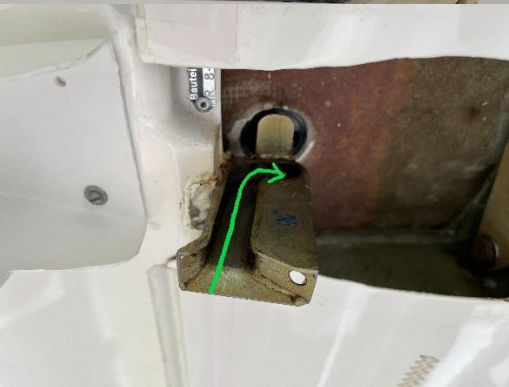
<p>The roller has to move into this funnel.</p>

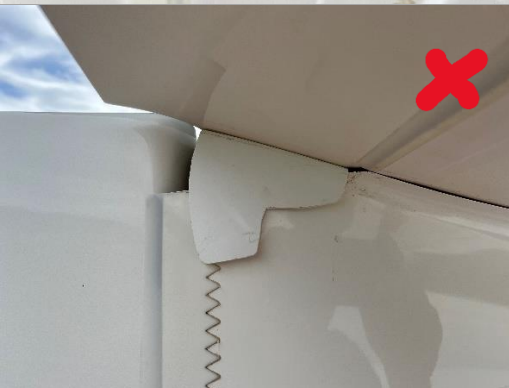
<p>Movement impaired by misplaced bracket. Roller most likely not in correct position.</p>

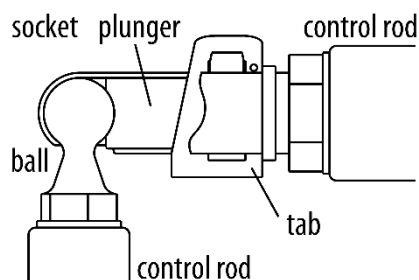
(a) Correct: cut-away shows how tab holds plunger in place

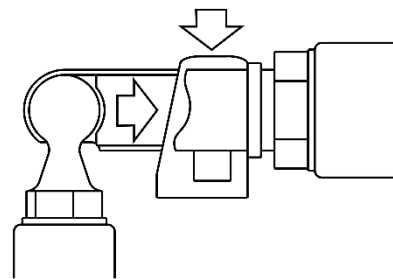
(b) Open: with tab depressed, plunger allows ball to be inserted or removed

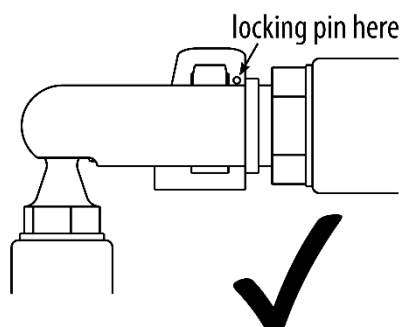
(c) Correct: ball engaged, locking pin may be inserted

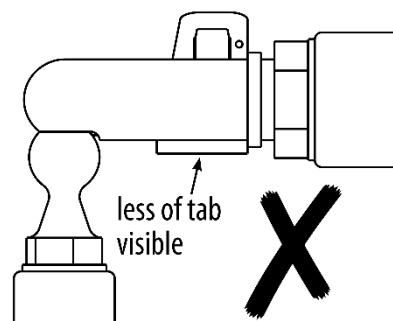
(d) Incorrect: ball not engaged, but locking pin may still be inserted

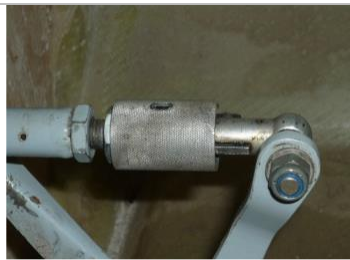
<p>The Wedekind locking sleeve slides outside the l'Hotellier fitting to secure the tab but does not necessarily prevent partial engagement.</p>

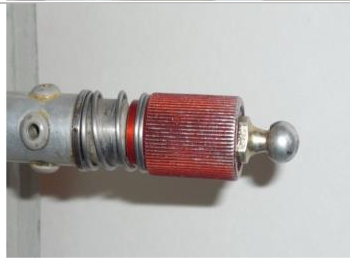
<p>The Uerlings sleeve and similar threaded sleeve used on LS-sailplanes rotate or unscrew over the coupling and cannot be moved into position, if the ball and socket are only partially engaged.</p>

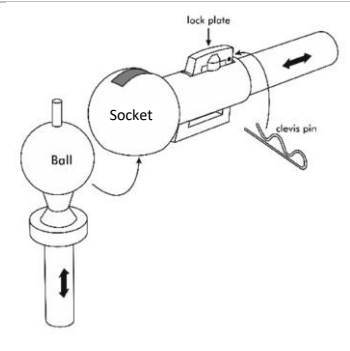
<p>Newer l'Hotellier connectors come with a pin on the top of the ball that becomes visible outside the socket, once the ball and socket are properly engaged. The pin allows also for a tactile inspection. The connection still needs to be secured.</p> <p>However, the pin on the top can cause the controls to move during the pre-takeoff check, falsely confirming a proper connection, even if the ball is not fully inserted and the socket is only resting on the ball with the pin.</p>

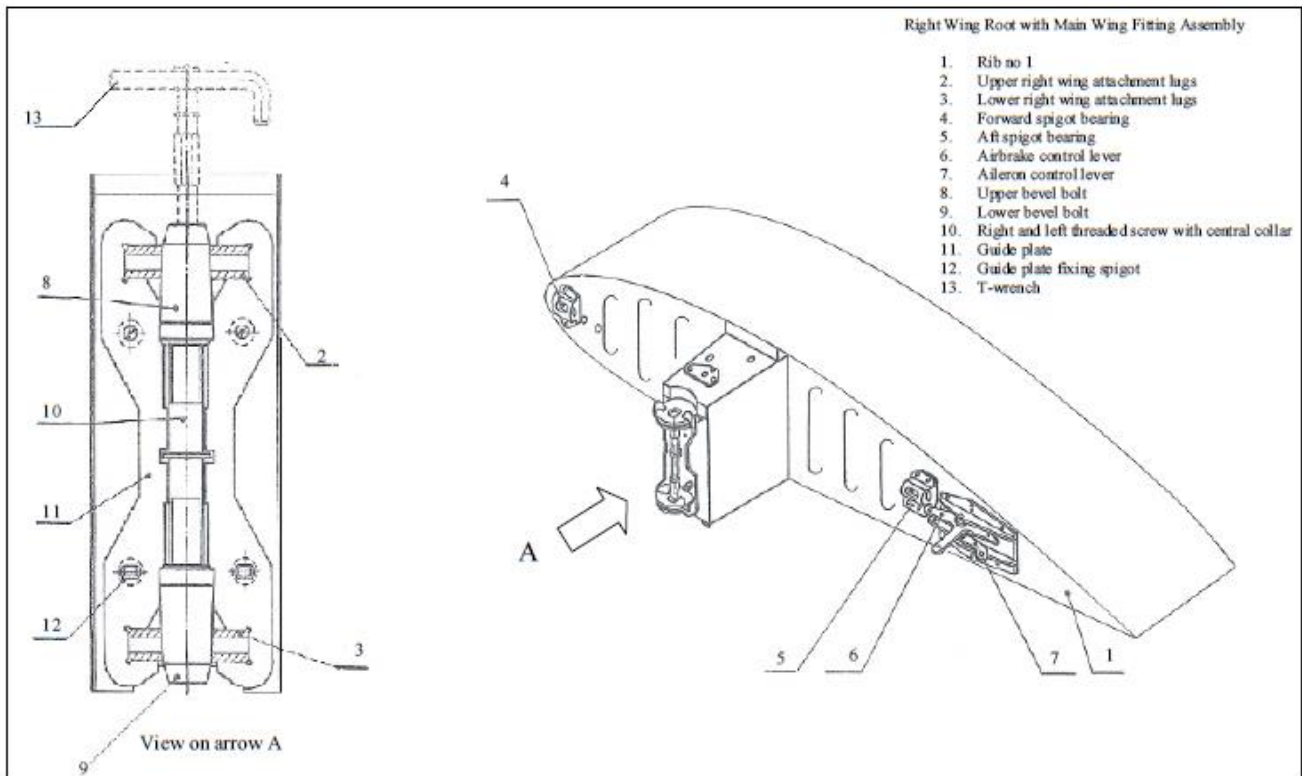
The wing rigging pins for most gliders are smooth cylinders, but those for e.g. the SZD-12/22 Mucha 100/Std., SZD-24/32 Foka 4/C/5, SZD-36 Cobra, SZD-8 Jaskółka, SZD-9bis Bocian 1E, Schempp-Hirth SHK and Schempp-Hirth Austria, consist of expanding pins/cones, which must be fitted exactly in accordance with the instructions of the flight manual. If the pin/cone is not correctly located, the wings can fold up and detach from the fuselage. Unless inspection holes have been cut for the purpose, it can be very difficult in some gliders to see whether the fitting has been assembled correctly.

Example of an expanding main pin wing connection.

*In case of sailplanes with expanding main pin wing connections, practice rigging should be carried out under the supervision of someone who is familiar with the sailplane type.*
