Sector Safety Update: Agricultural aviation

May 2021

This is a further update on activity and safety performance in the agricultural aviation sector, with activity and accident rate information current to December 2020. The report includes details of accidents and incidents for the purpose of raising awareness about risks and sharing safety lessons with the sector. If you have questions or comments [please contact CAA Intelligence Manager Joe Dewar](#).

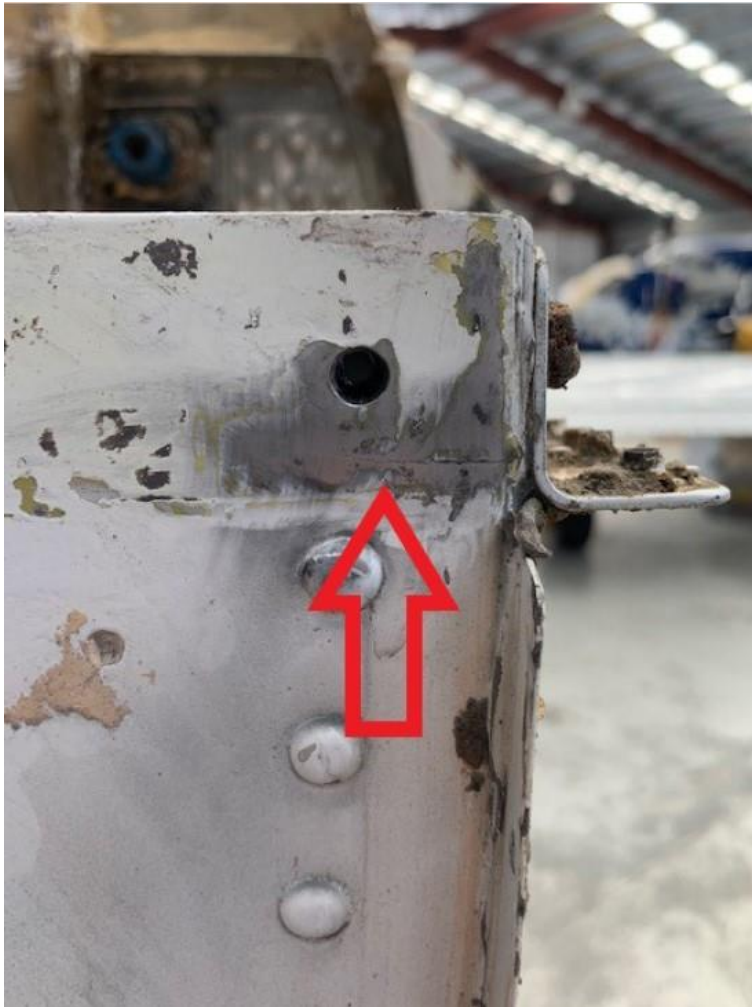
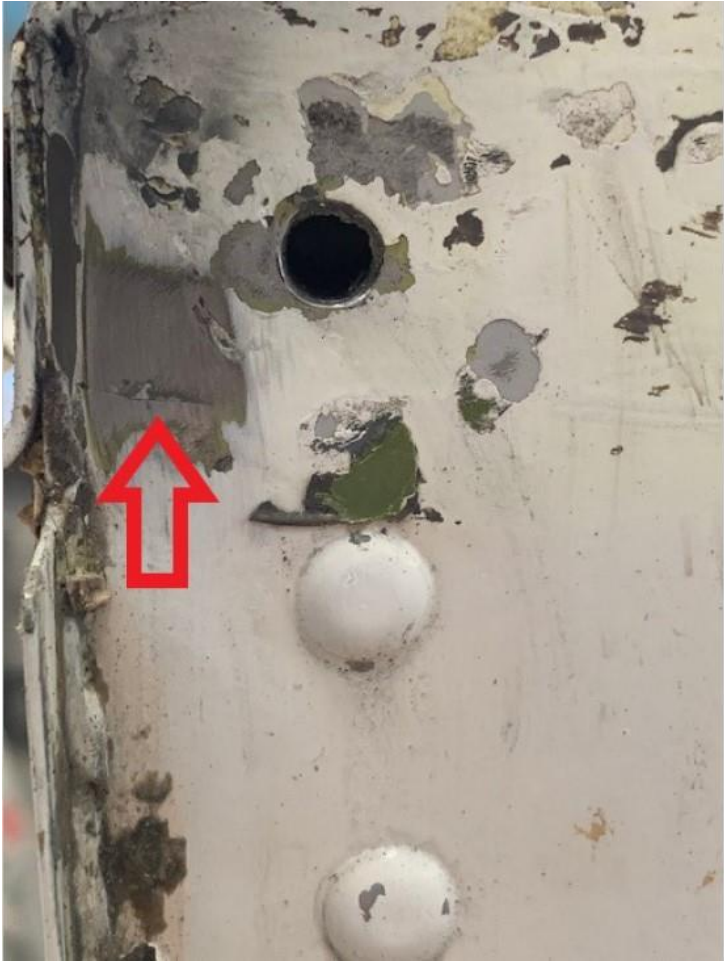
Horizontal stabilizer removed for 2 yearly inspection. Found both rear attach holes cracked on the frame. The frame was installed on an angle, horizontal stabiliser had a tapered packer fitted between the horizontal stabilizer and frame, which has caused undue stress on the rear attaches and thus the frame assy. Frame assembly removed, new frame installed. Images of the cracks below:

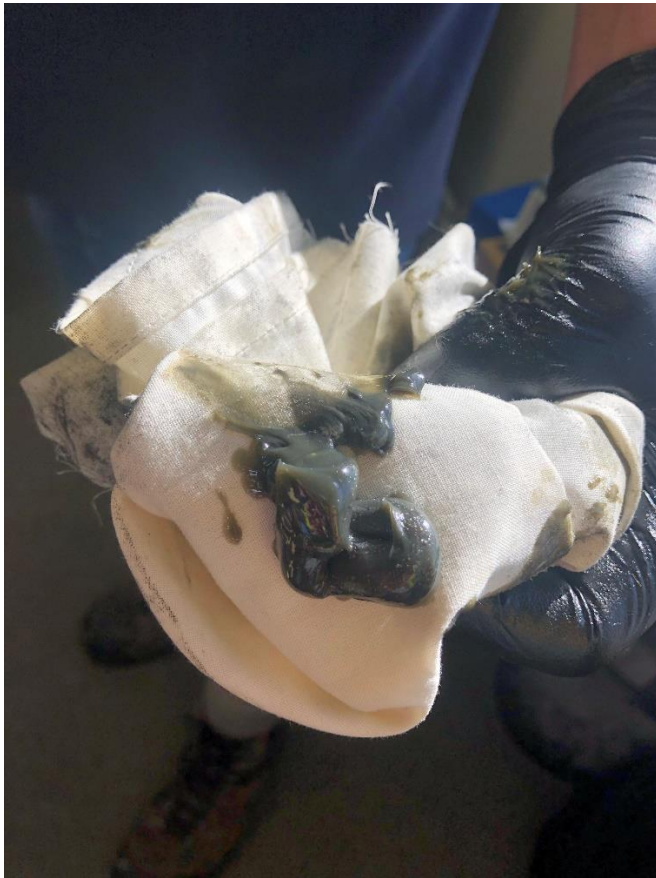
Prop bearing failure

Metal flakes spotted in prop grease during scheduled inspection/lube. Prop link pins removed and blades rotated - very notchy movement indicative of bearing failure. Prop removed and sent for repair, replacement installed. Prop has 233 hrs until due o/h. Image below:

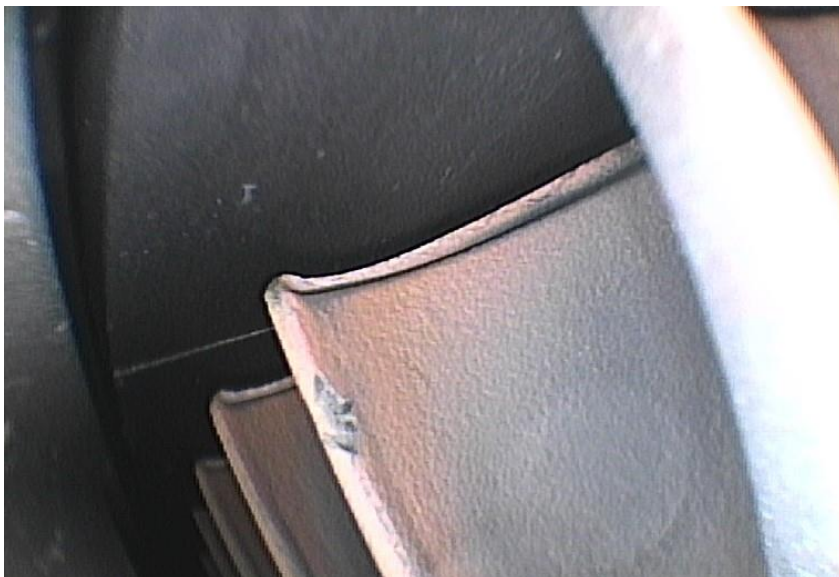
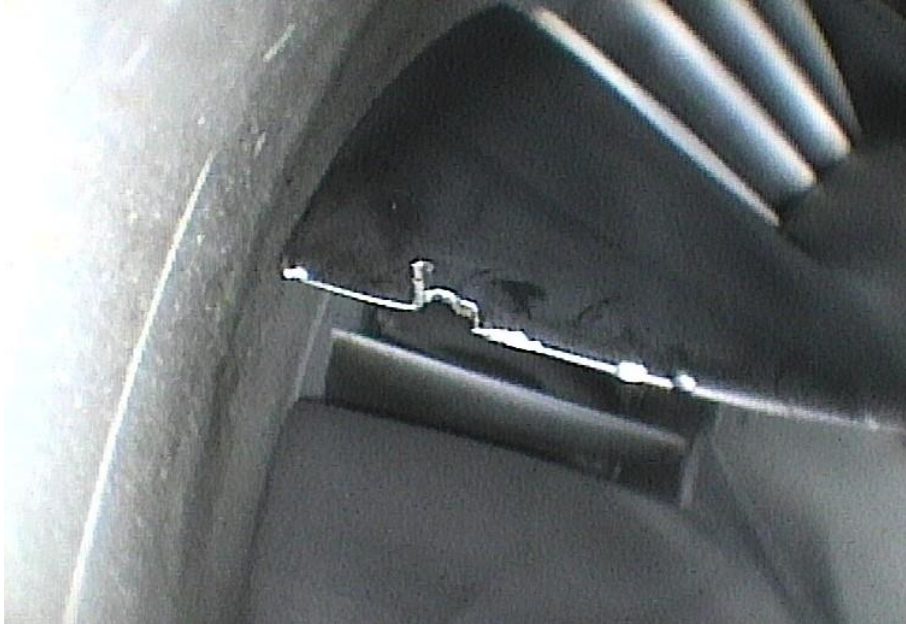
Compressor blade damage

Upon borescope of the engine's Hot Section, chips were found on the leading edge of several Compressor Turbine blades. Carried out a borescope of compressor section and found major FOD damage to 1st stage and 2nd stage compressor. Removed the engine and sent to Pacific Turbine Brisbane for repair. Images below:
