In-flight Breakup

Van's Aircraft Incorporated RV-7 ZK-DVS

Te Kopuru, Northland

CAA final report 17/8080

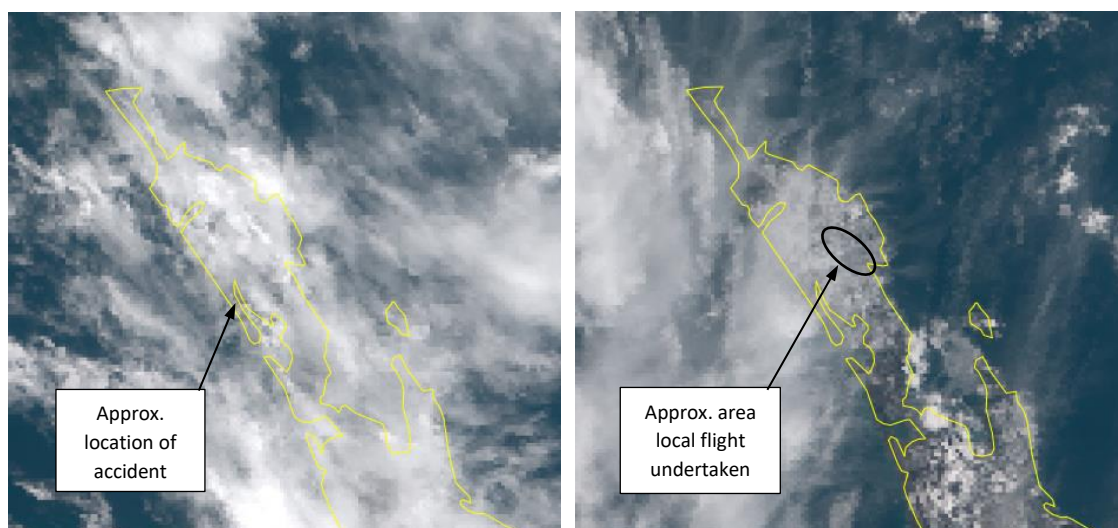
At the time of the accident flight, the cloud base for the region in which the flight was being conducted was forecast to be approximately 4,100ft. The cloud base for the region during the time of the local flight conducted to the north-east of Whangarei on the day before the accident flight, was reported to be around 3500ft – 4500ft, with an additional layer of cloud beginning to form at 6,000ft. Figure 5 shows the satellite imagery of the region at the approximate time and date of the accident flight and the local flight carried out the day before.

The safety investigation has found no evidence to indicate the weather conditions contributed to this accident. It can be observed, however, that the aircraft had been flown at altitudes at which cloud layers had been forecasted and reported to have formed.

1200 Day of the accident

1100 day before
