**CAA OCCURRENCE 22/4516**

**Cessna 182H Skylane**

**ZK-MGB**

**Collision with terrain**

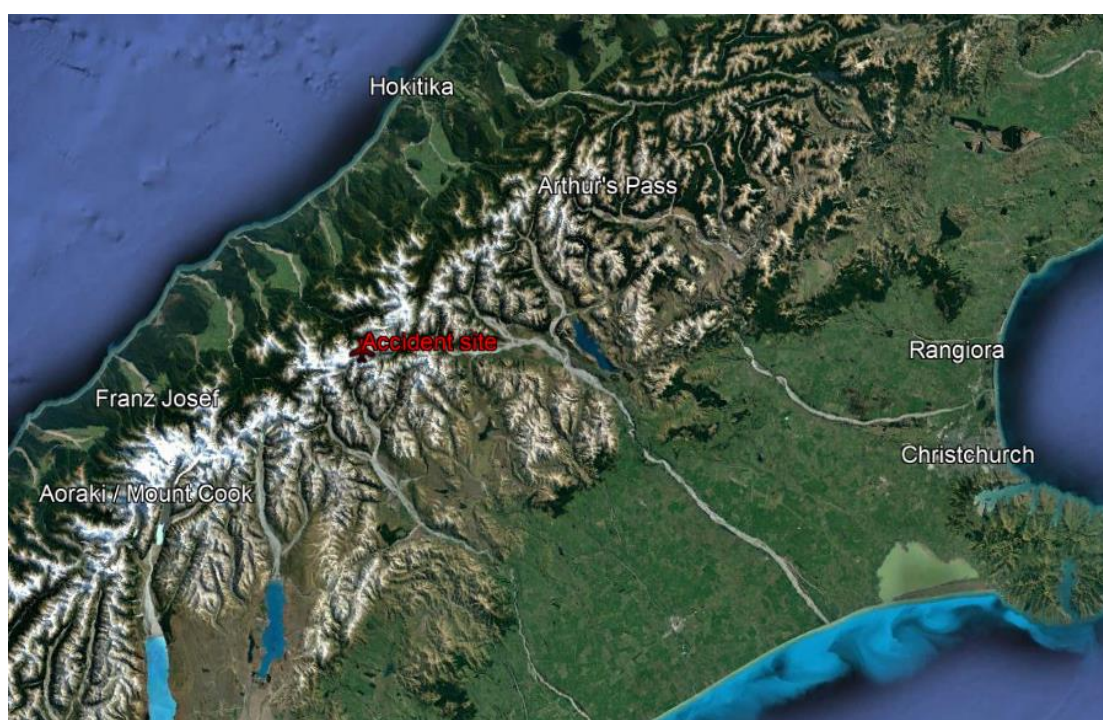
**Figure 1: Map of accident area (for illustrative purposes). Source: Google Earth™.**

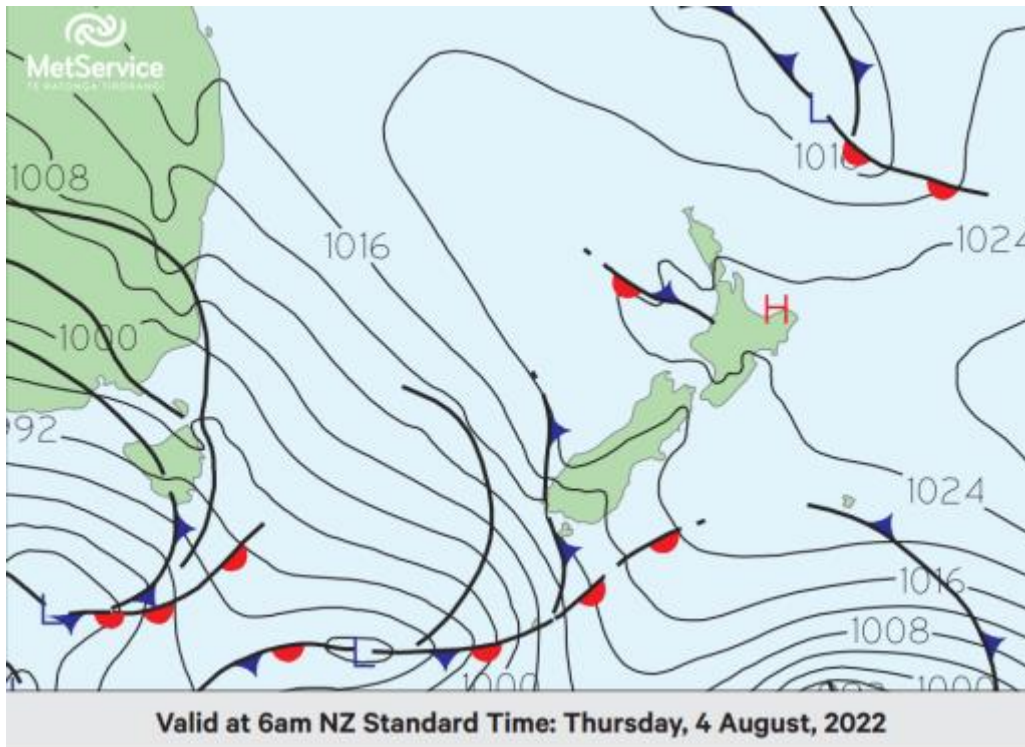
- 1.7.2 A high-pressure system covered the North Island with a weak front over Fiordland. A strengthening north-westerly (NW) flow covered the central South Island, with increasing cloud about and west of the Southern Alps. There was high cloud over the Canterbury plains and east coast.

Figure 2: Mean sea level analysis chart (weather map) valid at 0600 NZST. Source: MetService.

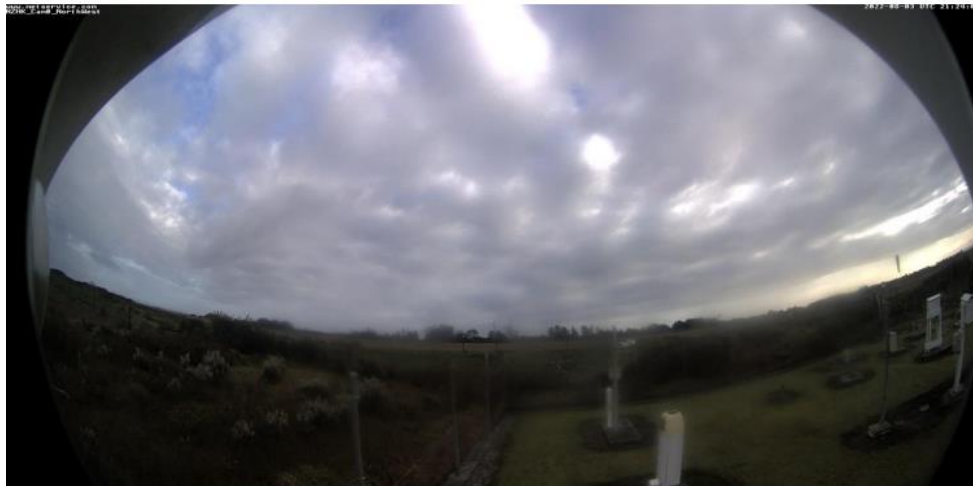
The main cloud layer west of the Southern Alps likely had bases of around 6,000 ft and tops of between 6,500 and 7,000 ft. There were some breaks in the cloud, and the flight path, combined with satellite imagery, suggests the pilot used one of these gaps to climb above the layer. Refer to Figures 3 and 4.

Figure 3: NZHK webcam image, 04 August 2022 looking north-west. Source: MetService.

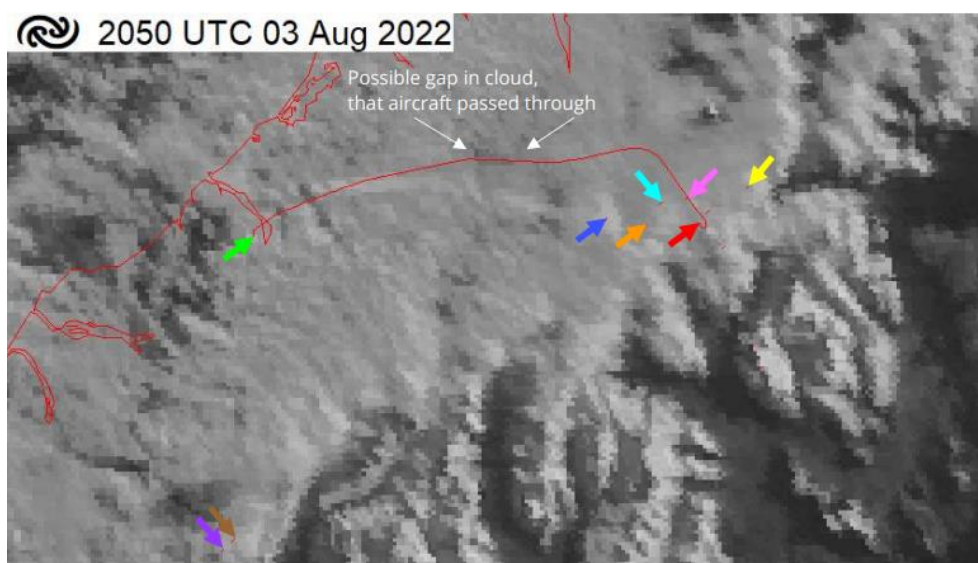
Figure 4: The visible satellite image, 0859 04 August. NZFJ is marked by the green arrow. Flight path and coastline in red. Mountain peaks identified by arrows: Mt Farrar (blue), Mt Nicholson (red), Mt Ramsay (yellow), Newton peak (orange), Mt Lambert (turquoise), Mt Stoddart (pink), The Footstool (brown) and Mt Sefton (purple). Source: MetService.

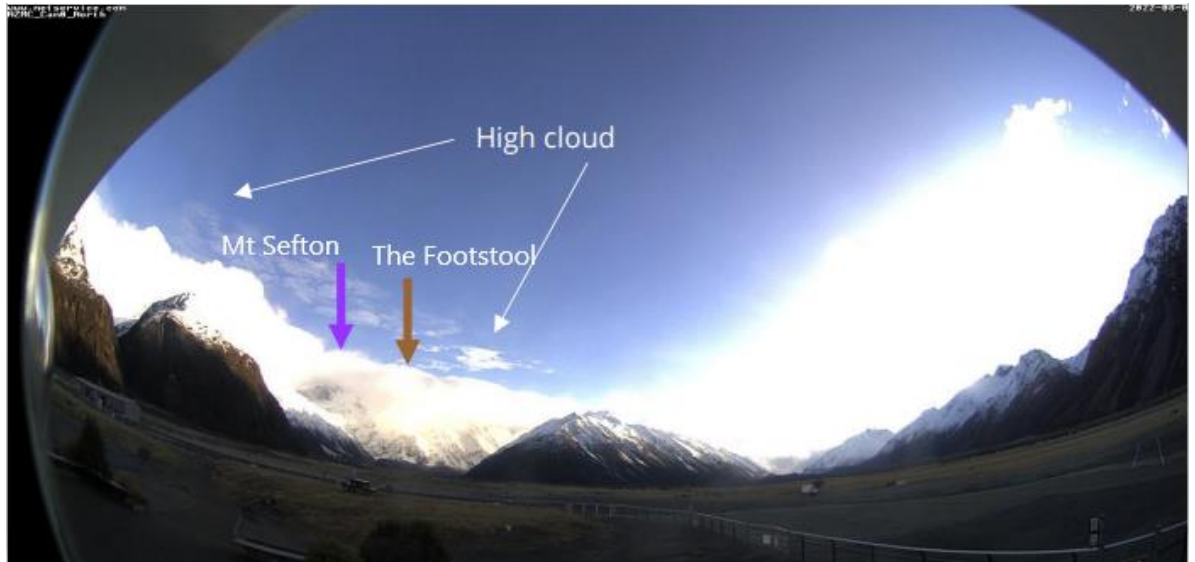
It's likely the cloud was forced up and over the main divide of the Southern Alps, in the strong NW flow. Some higher peaks may have been visible above the cloud layer or through a thin veil of cloud. The cloud tops may have been lower where the main divide is lower, including at the accident site. The cloud then evaporated as it descended into the eastern valleys. Refer to Figure 5.

Figure 5: NZMC webcam image looking north, 0840, 04 August 2022. Source: MetService.

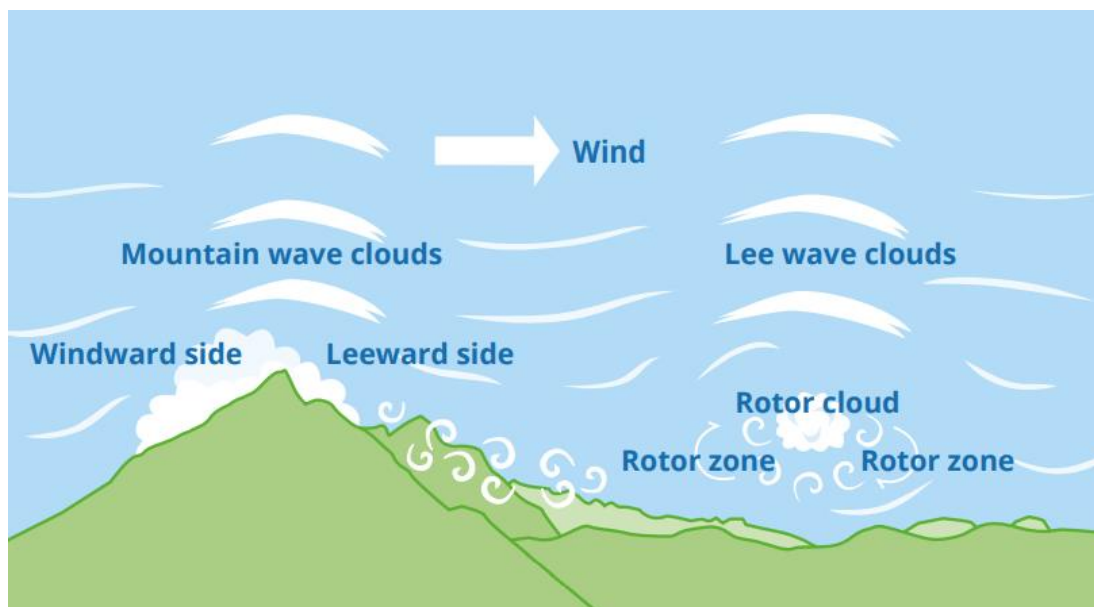
- 1.7.8 The CAA Good Aviation Practice (GAP) - *Mountain flying*<sup>17</sup> booklet, explains how downdraughts and turbulence occurs on the lee side of mountains, and that both will increase in severity and extent with increase in wind strength.
- 1.7.9 Mountain waves are associated with rising, smooth air on the windward side and strong downdraughts and turbulence on the leeward side. Refer to Figure 7.

Figure 7: Mountain wave and rotor formation. Source: GAP-Mountain flying, CAA.

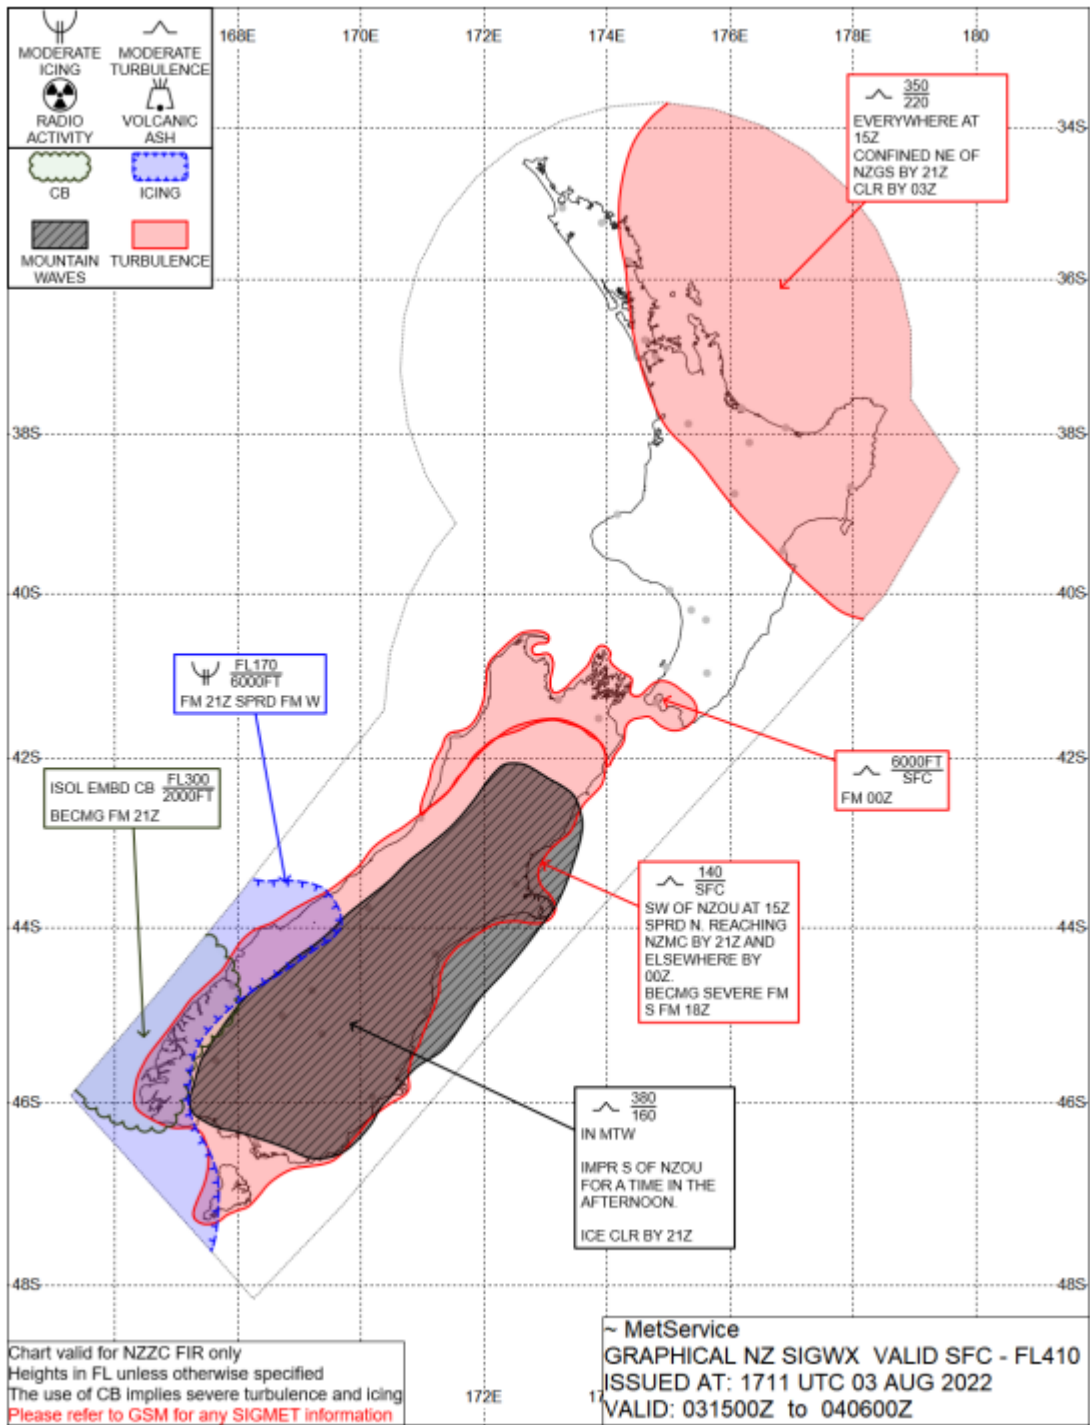
NZ SIGWX issued at 0511 04 August<sup>27</sup> (refer to Figure 12) included the following phenomena:

Figure 12: NZSIGWX issued 0511 04 August 2023 NZST. Source: MetService.

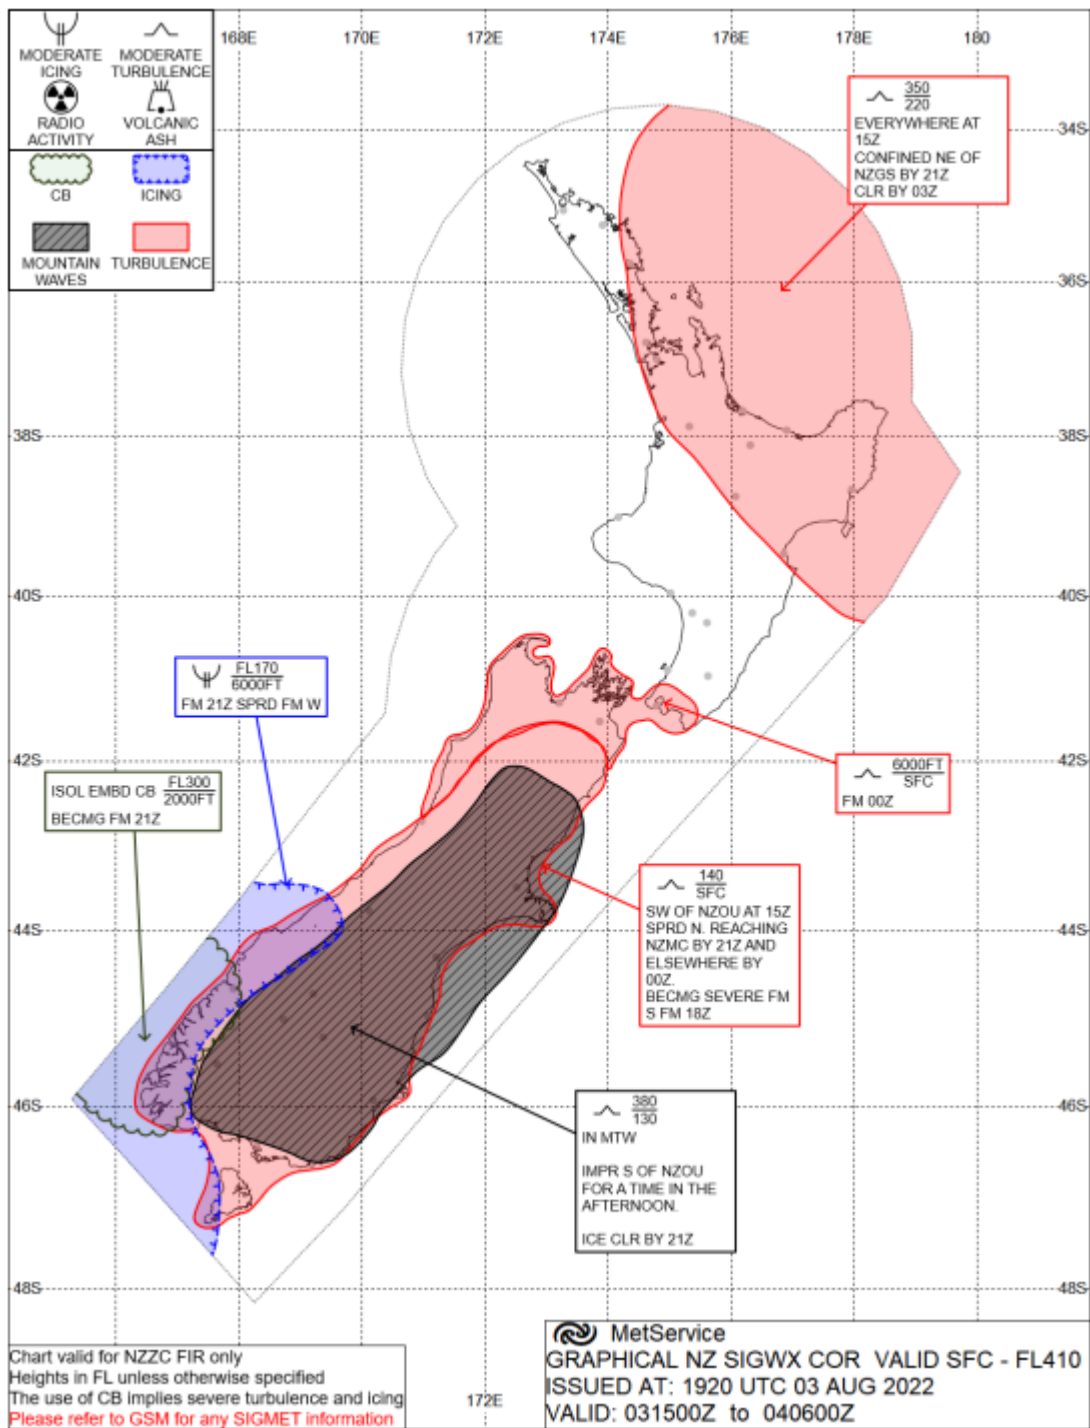
An updated NZ SIGWX was issued at 0720. Of relevance, the base of the mountain waves east of the Southern Alps were forecast to lower to flight level 130 (refer to Figure 13).

Figure 13: NZ SIGWX issued 0720 04 August 2022 NZST. Source: MetService.

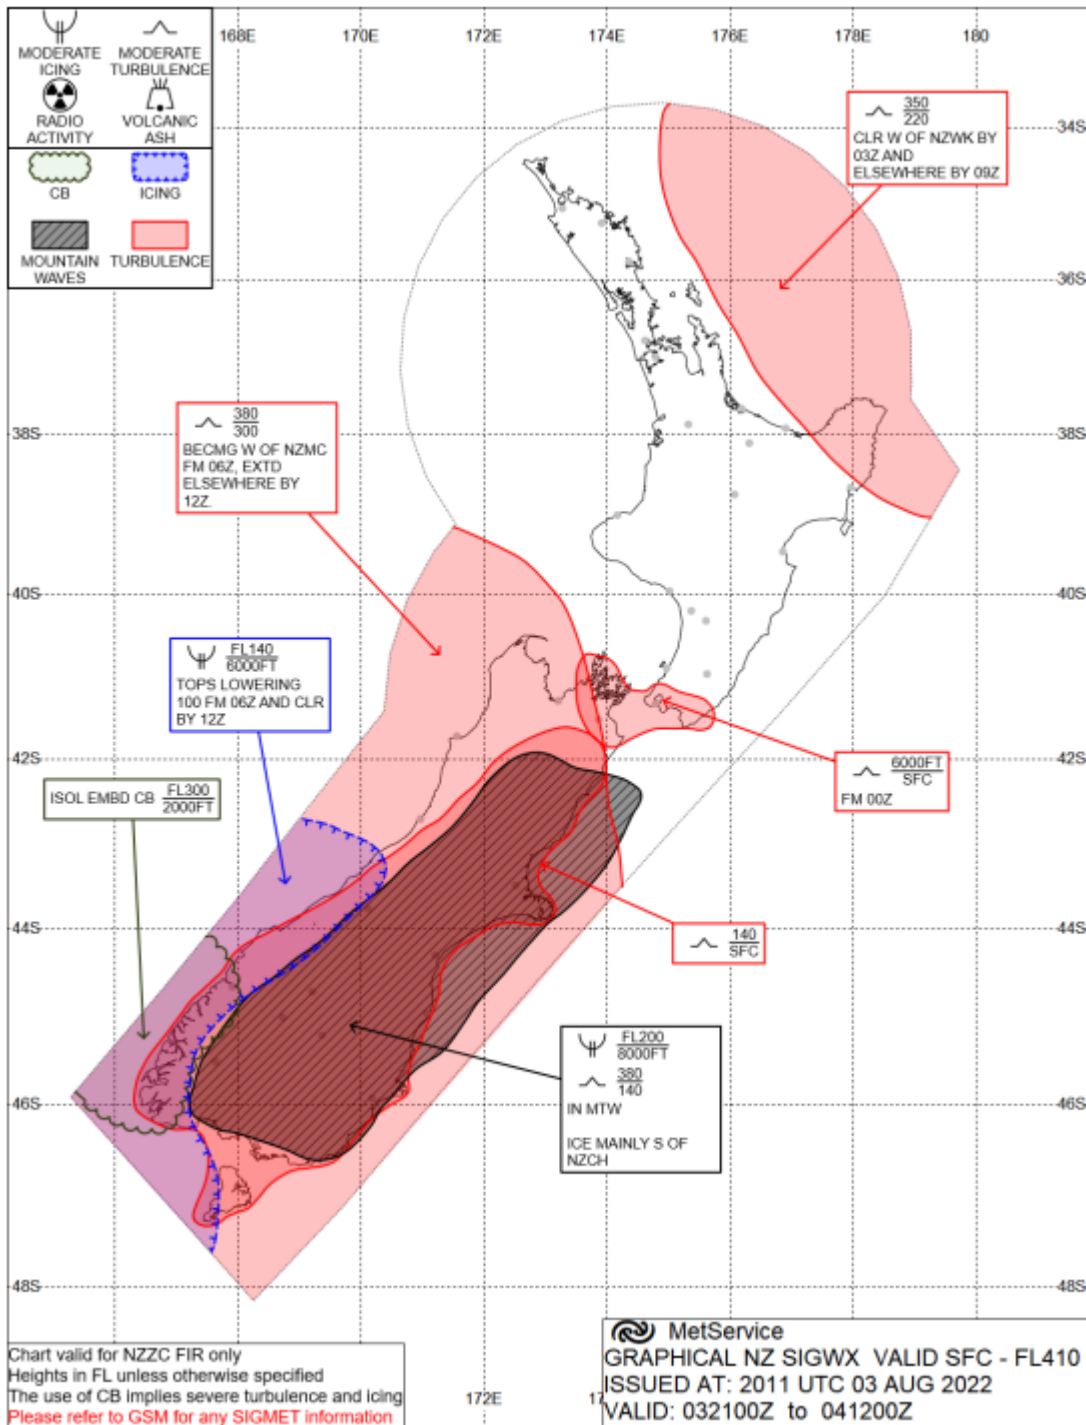
Another updated NZ SIGWX was issued at 0811, valid from 0900 (refer to Figure 14). Changes included:

Figure 14: NZ SIGWX issued 0811 04 August 2022 NZST. Source: MetService.

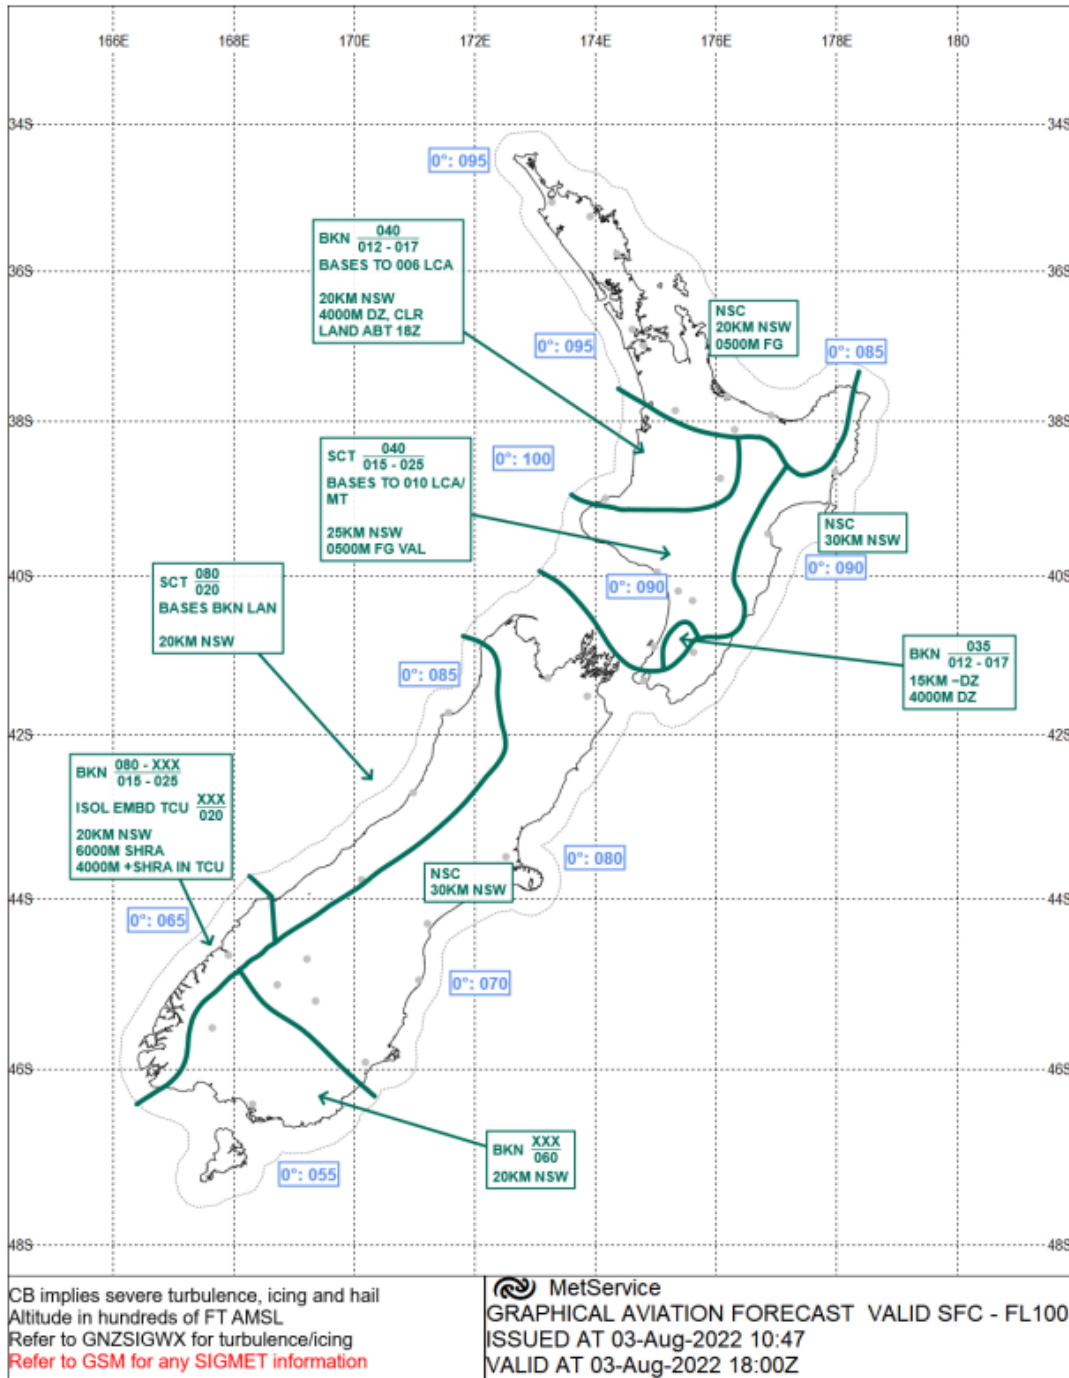
The GRAFOR issued at 2247, 03 August 2022 for the West Coast, forecasted scattered cloud 2000 - 8000 ft, 20 km visibility and nil significant weather. Weather associated with the approaching front was forecast for the Fiordland area. Refer to Figure 15. This was updated 3 minutes later with slightly more cloud and showers forecast from 1200. Refer to Figure 16.

**Figure 15: NZ SIGWX issued 2247 03 August 2022 NZST, valid 0600 04 August 2022. Source: MetService.**

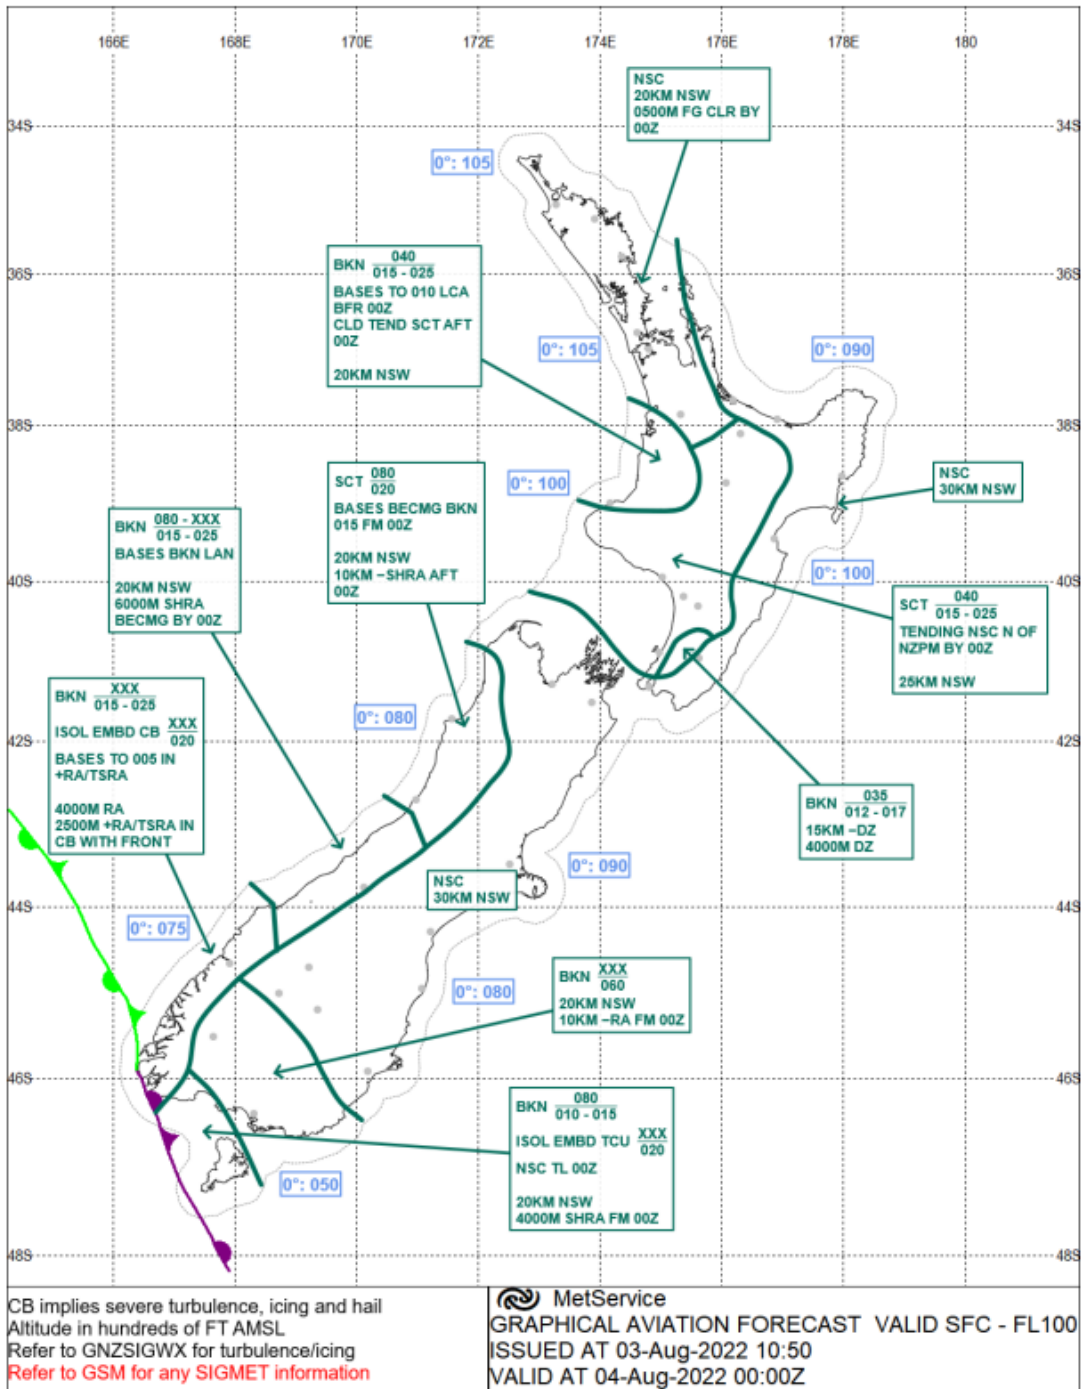
Figure 16: GRAFOR issued 2250 03 August 2022 NZST, valid 1200 04 August 2022. Source: MetService.

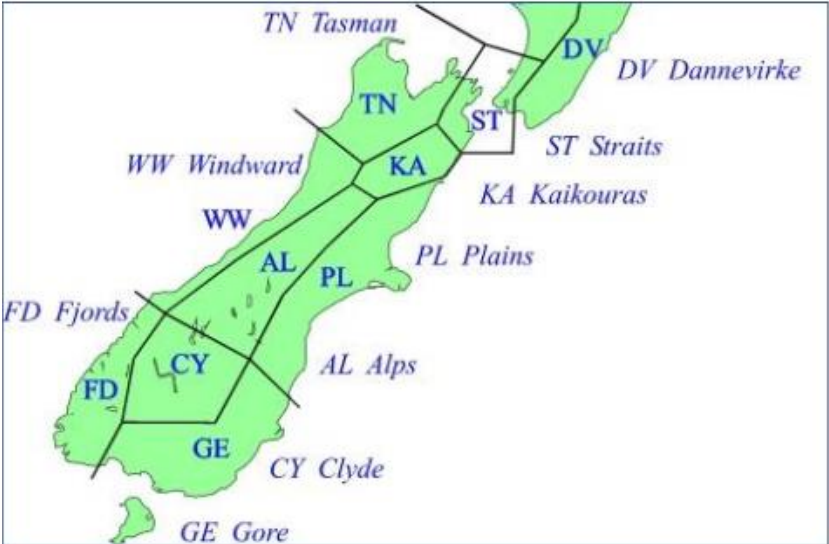
- Windward (WW) – west of the Southern Alps;
- Alps (AL)<sup>30</sup> – about the Southern Alps and foothills; and
- Plains (PL) – Canterbury Plains.

Figure 17: Map depicting the AAW areas over the South Island. Source: MetService.
