**CAA Safety Investigation Report**  
**Controlled flight into terrain involving ZK-CMV**  
**Cessna 185B Skywagon**  
**Motatapu River North Branch near Wanaka**  
**16 March 2015**

## Executive summary

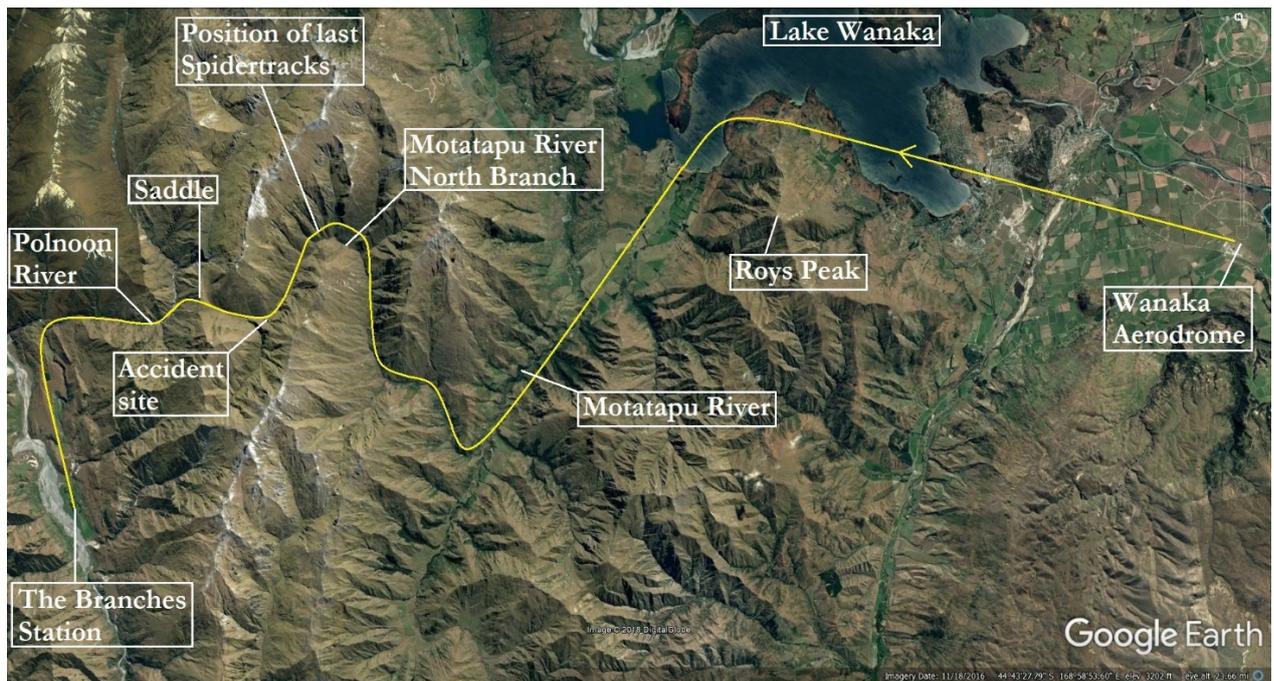
Figure 1: Intended route from Wanaka Aerodrome to The Branches Station

The intended flight to visit friends, was to be conducted under VFR to The Branches Station farm airstrip, located approximately 22 nautical miles west of Wanaka Aerodrome. The route to be flown was familiar to the pilots. Tracking first from Wanaka Aerodrome toward Glendhu Bay, then following the Motatapu River valley system on to their destination. (Refer Figure 1).

The height at the valley head (saddle) of the Motatapu River North Branch, which the pilots needed to cross to reach the Polnoon Burn river valley and the Branches Station, rises to approximately 4100 feet above mean sea level (amsl).

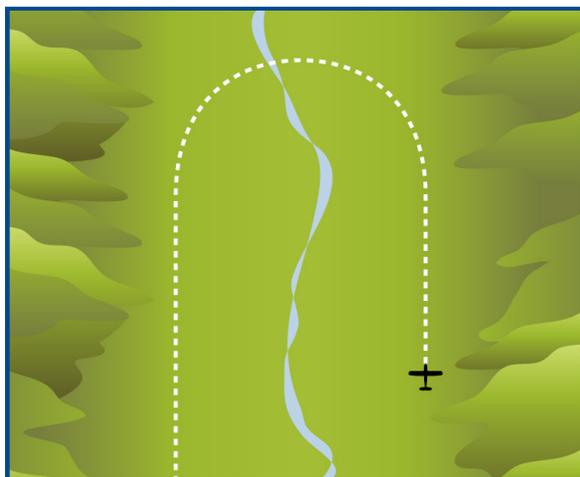
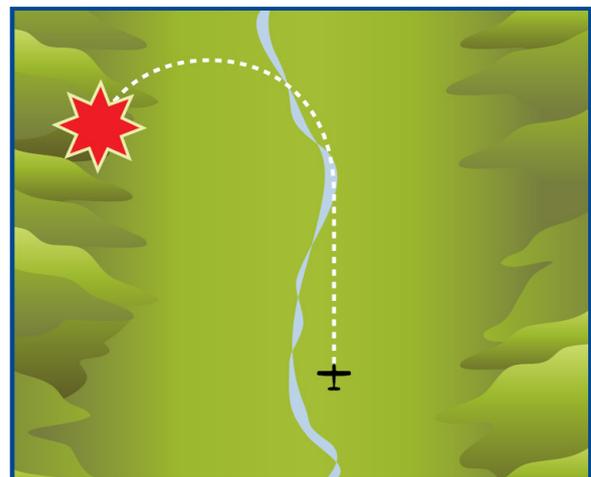
Figure 7: Example of aircraft positioning to enable a safe reversal turn

The fact that the pilots had attempted a left reversal turn would indicate that the aircraft was not positioned on the left side of the valley in the optimal position.

Figure 7 below, published in the CAA *Mountain Flying GAP* booklet, illustrates advice regarding the correct positioning of an aircraft operating in a valley to enable a safe reversal turn to be carried out.

*Positioning to one side of the valley leaves maximum room to turn. Always use the maximum room available in case a 180-degree turn is required.*

*Positioning in the middle of the valley means a steeper turn is necessary and there may be insufficient room to turn back safely.*
