AIRCRAFT ACCIDENT REPORT
OCCURRENCE NUMBER 09/323
AIRBORNE WINDSPORTS EDGE XT-912
ZK-DGZ
IN-FLIGHT BREAKUP
GIBBS HILL, ABEL TASMAN NATIONAL PARK
9 FEBRUARY 2009

AIRCRAFT ACCIDENT REPORT

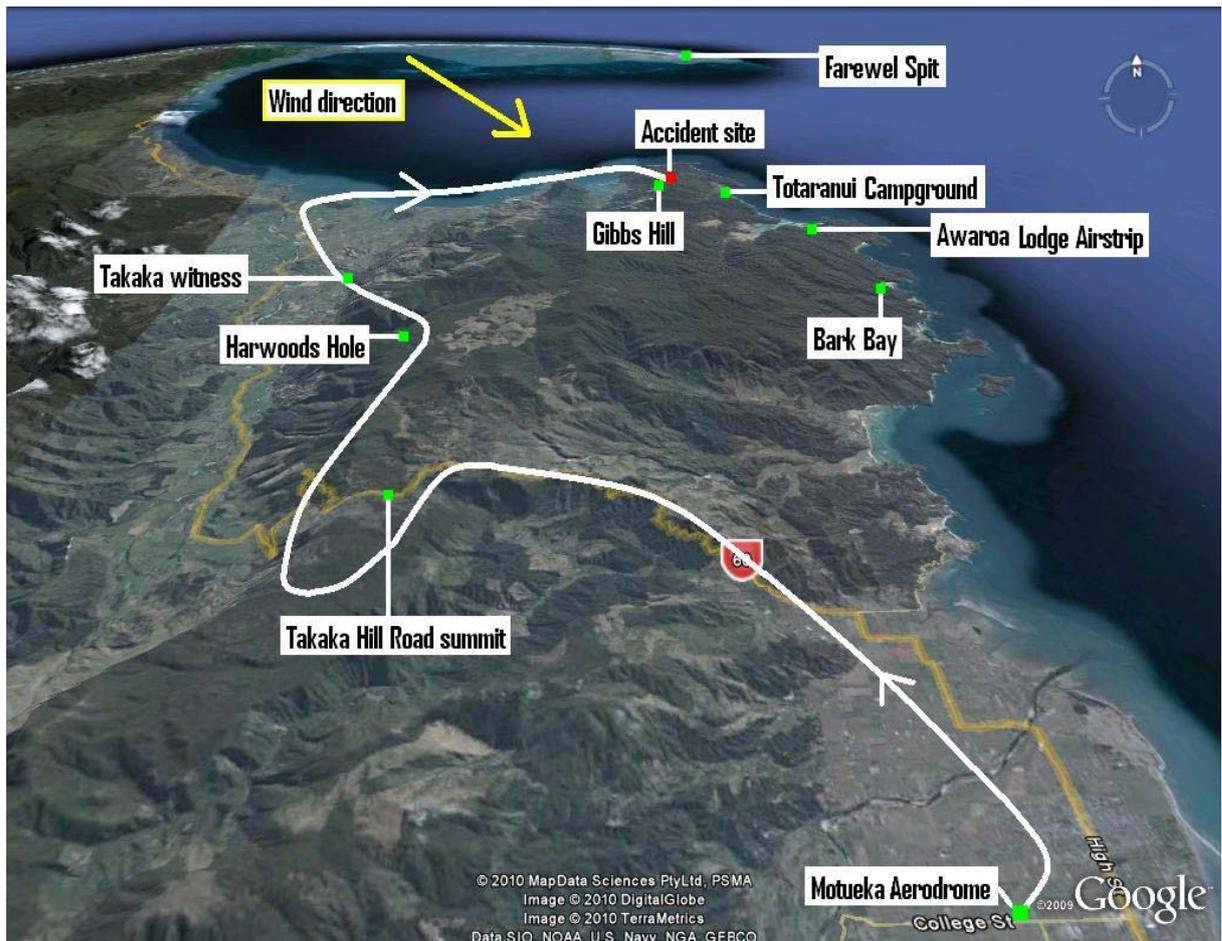
Figure 1: Map of flight route (Google Earth)

- 1.1.5 During the flight the passenger took a number of digital photographs which helped to establish the route flown. The flight approached Gibbs Hill at approximately 1356 hours approaching from the north-west at an altitude of 2000 ft amsl, and at an indicated airspeed of 65 mph. This information was obtained from a digital inspection of the photograph and its digital properties (see Figure 2). This photograph also shows a wind lane³ east of Totaranui Bay, which indicates choppy sea conditions off the coast and calm seas within the bay itself.

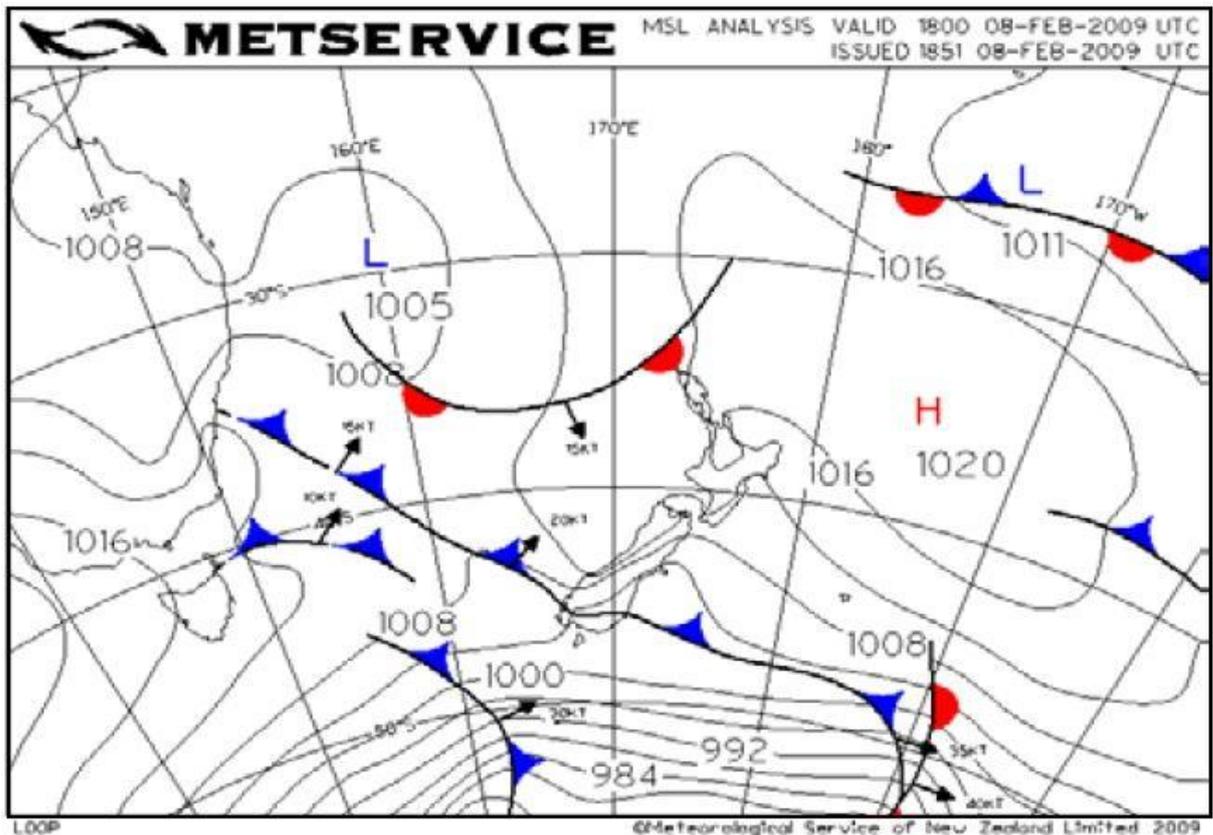
Figure 4: Meteorological Mean Sea Level Analysis Chart

- 1.7.7 Post-accident Meteorological Service analysis of the wind at approximately 1400 hours in the vicinity of Gibbs Hill, estimated it to have been 35 knots to 40 knots with a localised rotor zone of permanent and intermittent rotor winds⁶.

⁶ A rotor zone is an area of severe rotating turbulent winds found in the lee of a mountain range under certain adverse conditions. In the absence of cloud there is nothing to indicate the presence of a rotor zone.
