**CAA OCCURRENCE 14/1159**

**MD HELICOPTERS INC. 500N**

**ZK-HQP**

**Collision With Terrain Following Engine Failure**

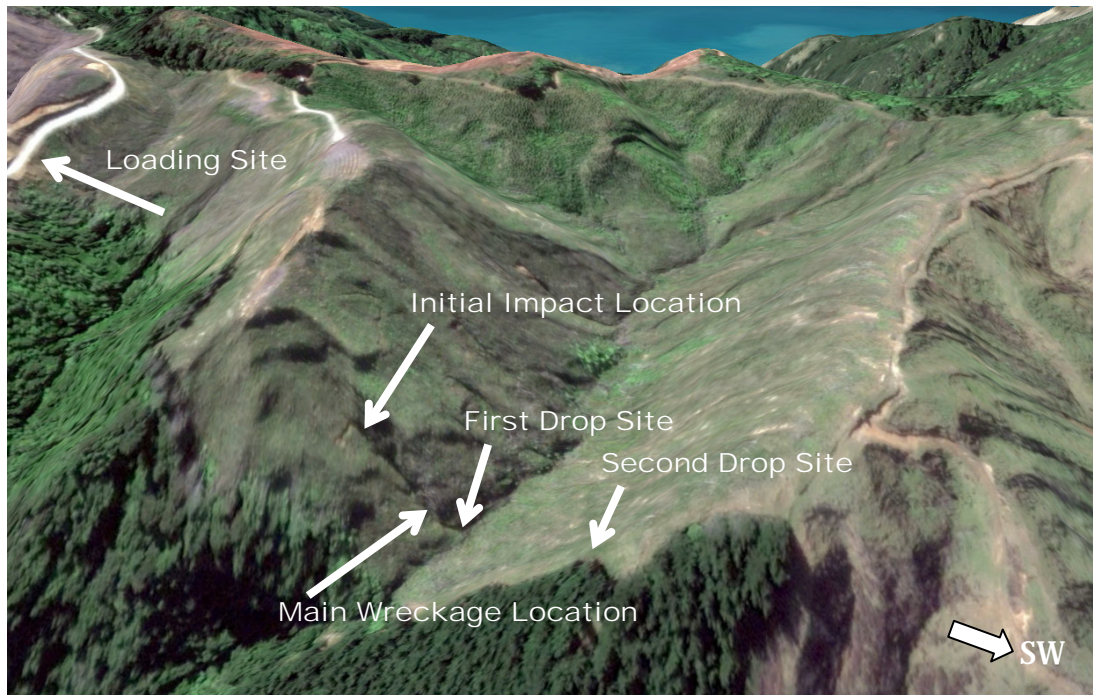
Figure 1:  
ZK-HQP approximate drop sites and wreckage locations.

- 1.1.8 Forestry contractors reported the helicopter arriving a short time later at their location in the valley, the first drop site (see Figure 1). Once this first drop had been completed the helicopter flew the rest of the equipment up to the second drop site. The second drop site was approximately 70m further to the SW, on the face of the ridge, near a tree line. A forestry contractor unloaded the rest of the equipment at this site. After the cargo net was detached from the long line the pilot maneuvered the helicopter away from the drop site so that the remote hook did not pose a hazard to the contractors on the ground.
