## Safety Information Bulletin

**SIB No.: 2019-07R1**

**Issued: 25 February 2025**

**Subject: Sailplane Rigging – Procedures, Inspections and Training**

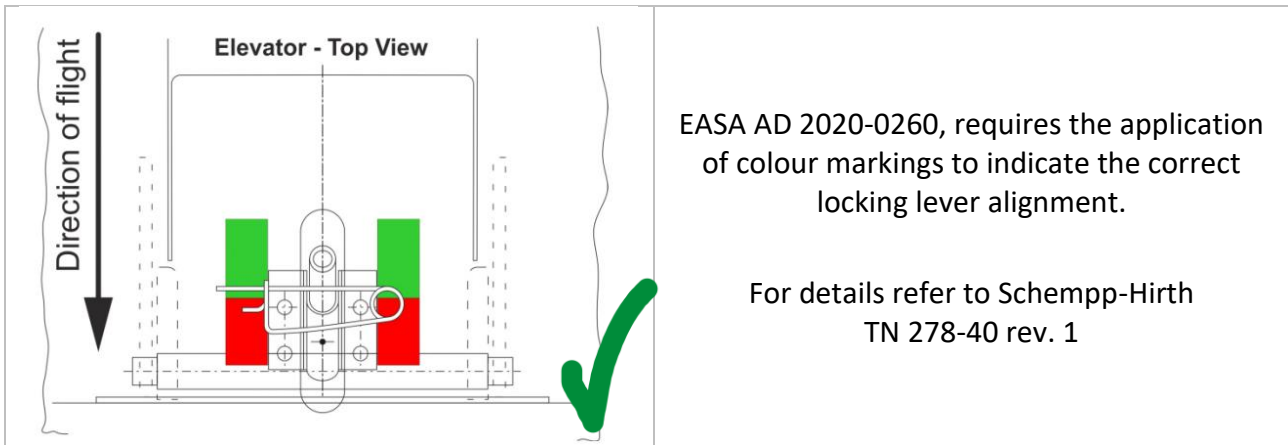
Ref.: AAIB-UK, [Bulletin 6/2020](#)

*Not all cases of unconnected controls and unconnected horizontal stabilizers can be detected by performing a positive control check. Non-interruption during the rigging procedure helps to prevent forgetting the connections in the first place. The checking of proper securing can be done by a visual inspection only.*
