Airworthiness Directive Schedule

Engines

Continental 520 Series

28 September 2023

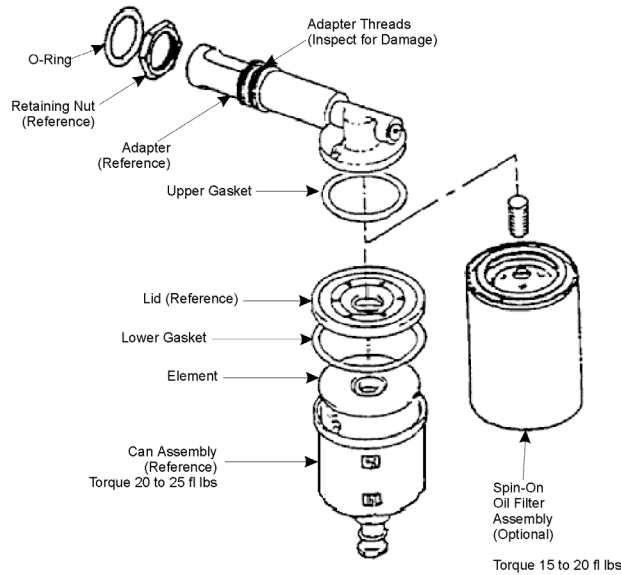
DETAIL A

2. For oil filter adapter assemblies that do have torque putty between the engine filter adapter assembly, nut, and oil pump housing, inspect the torque putty for misalignment, evidence of oil leakage, or cracks.

- (a) Inspect the adapter locking nut installation for evidence of oil leakage.
 - (b) Check the torque of the adapter nut installation and ensure that the torque value is within the limits of 50 through 60 foot pounds.
