Airworthiness Directive Schedule

Engines

Lycoming LTIO-540 and TIO-540 Series

28 November 2024

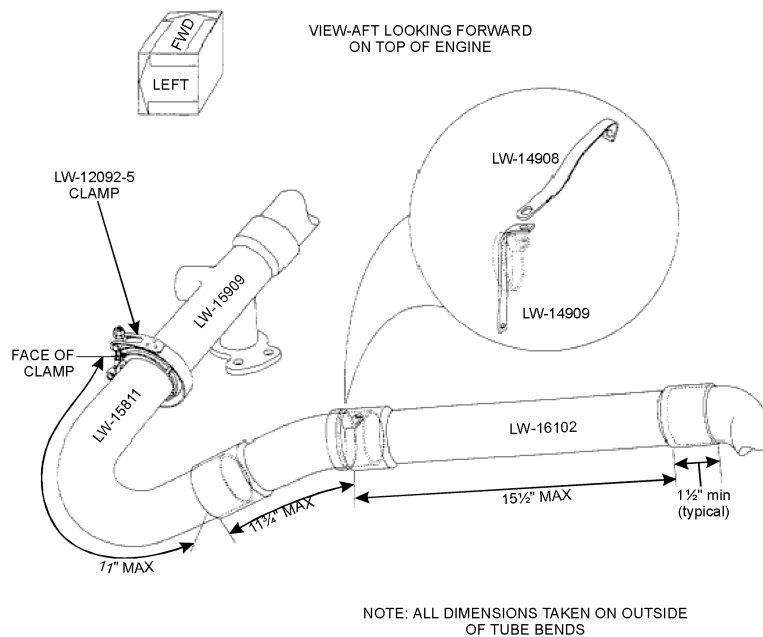
1. Inspect all exhaust system joints, flanges, couplings and brackets for heat damage, distortion, cracks or excessive wear per Textron Lycoming SB 484. Inspect the exhaust system for proper slip joint engagement by measuring distances between pipe end points of LW-16102 (RH) and LW-16103 (LH) per the diagram. If damage is found in the exhaust system or measurements which exceed allowable dimensions, repair or replace damaged parts with serviceable parts as necessary, before further flight.
