**AIRCRAFT ACCIDENT REPORT**  
**AEROTEK INCORPORATED S-2B**  
**ZK-MAD**  
**LOSS OF CONTROL**  
**STRATFORD, TARANAKI**  
**15 NOVEMBER 2009**

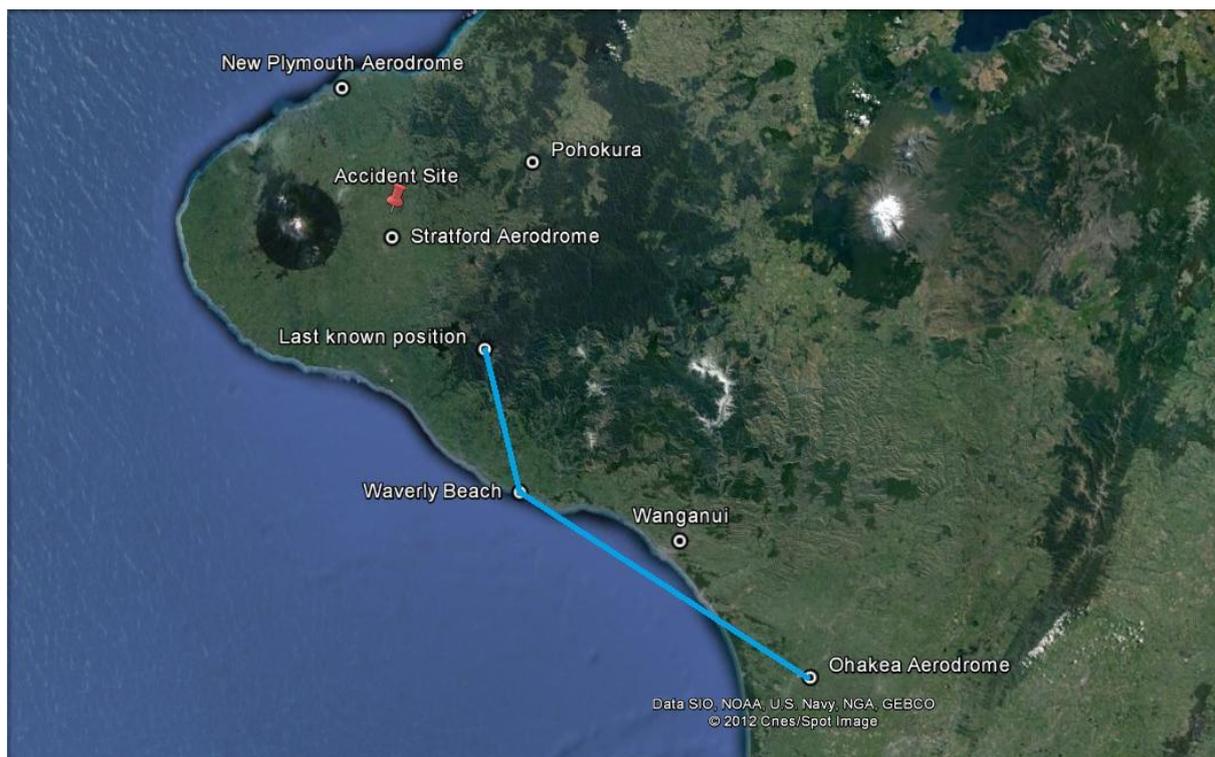
Figure 1: Map of Flight route.

- 1.1.5 After completing the Sunday morning aerobatic flight the pilot refuelled the aircraft and departed Ohakea Military Aerodrome at 1108 hours. The Air Traffic Controller on duty advised the pilot he was clear of controlled airspace at 1118 hours. This was the last known recorded transmission from the aircraft.
- 1.1.6 The aircraft was transmitting a Secondary Surveillance Radar code of 1200 and examination of the radar position plots revealed the aircraft had tracked from Ohakea Military Aerodrome up the coast passing seaward of Wanganui. This track continued along the coast until abeam Waverly Beach where the aircraft turned northwards. The last known position was at Lake Rotorangi at 1150 hours. See figure 1.

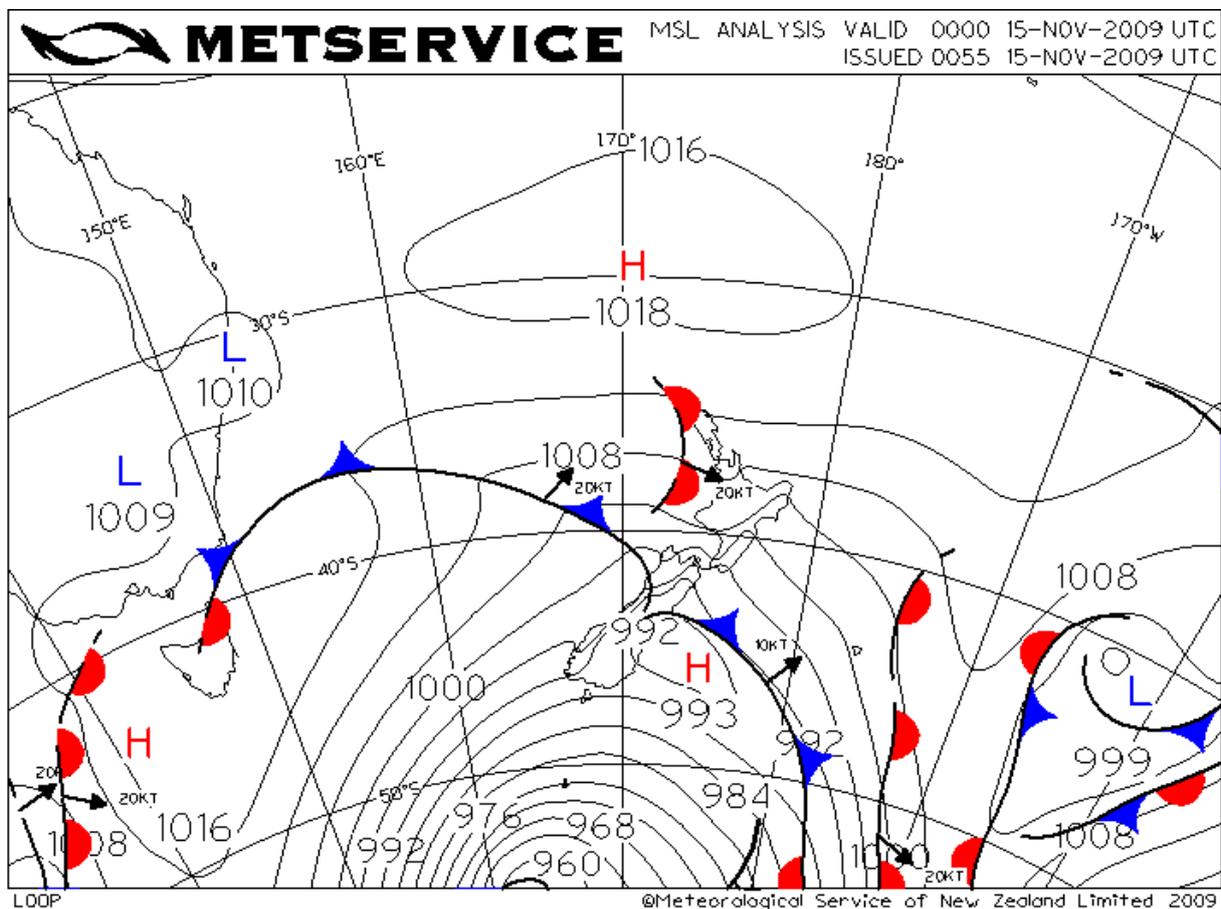
Figure 2: Mean Sea Level Analysis Chart

1.7.1 The investigation procured an extensive report from a Metservice meteorologist. A warm front, part of the frontal system associated with a depression, was moving eastwards across the North Island with forecast deteriorating conditions. See figure 2.
