VECTOR

Pointing to Safer Aviation

MICROLIGHT ACCIDENTS
AND INJURIES

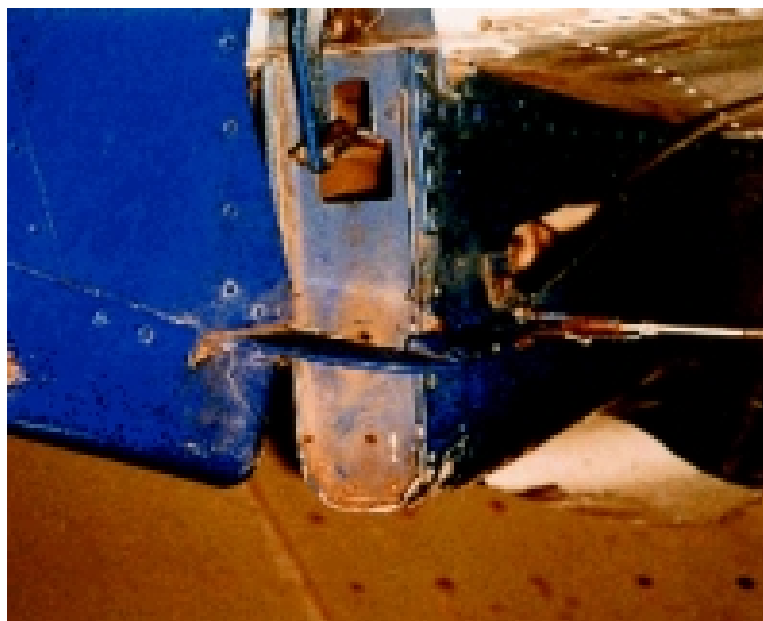
It was found that the rudder stop-plate on the righthand half of the rudder horn was firmly jammed behind its stop-bolt on the fuselage. The rudder was deflected 34 degrees measured perpendicular to the hinge line, whereas the maximum allowable deflection for setting the stops is 23 degrees. It required 36 pounds of steady pull on the trailing edge of the rudder to break the rudder out of its jammed position. This steady pull of 36 pounds equated to 180 pounds if the force was applied to the rudder pedal. However, given that the direction of cable pull tended to increase the jamming by closing the horn, it would not have been possible to break the rudder jam with the application of right rudder.

During a 50-hour check engine inspection carried out the day before the accident, the right pedal rudder bar return spring and a spring attachment bracket for this spring, which was welded to the rudder bar assembly, were found to be broken. The return spring supplied a tension force of about 10 pounds per inch of stretch and balanced the force exerted by the matching left rudder bar return spring.

The two return springs maintain tension in the rudder cables that connect to the right and left halves of the rudder horn. Without the right rudder pedal return spring, the right rudder cable slackens. The left rudder pedal return spring will then tend to pull the right pedal toward the pilots, which facilitates deflection of the rudder to the left.

After conducting tests on the accident aircraft and another C 152, investigators determined that, under certain conditions, the design and condition of the stop-bolt and rudder horn stop-plate allowed the stop-plate to over-travel the stop-bolt and jam.

The tests showed that the absence of the return spring, in combination with other factors such as incorrect rudder rigging, condition of the rudder, and rudder horn or stop-plate condition and alignment, set the stage for irreversible jamming of the rudder during application of controls for spin entry.
