July / August 2001

# VECTOR

*Pointing to Safer Aviation*

# Ways to **HURT** Your Aircraft

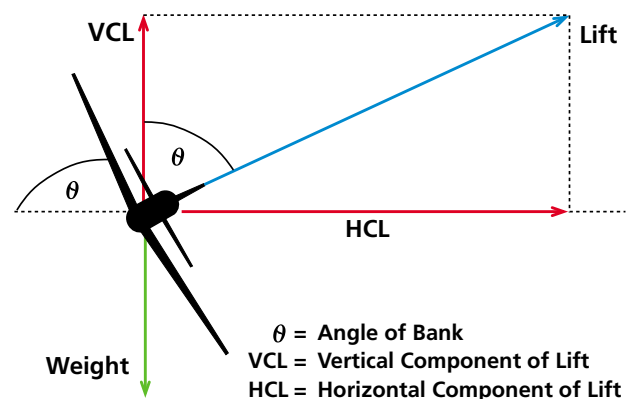
changes. For example, in a level turn at 60 degrees angle of bank, the lift required to maintain a level turn would be twice the aircraft weight – irrespective of that weight. If the aircraft weighs 1000 kg, the wings will be producing 2000 kg worth of force (kgf). Note that if the aircraft weight is increased to, say, 1500 kg and the same level turn flown, then the wings will have to produce 3000 kg of force, but the pilot will still only feel +2 G. The pilot may be quite unaware that a much greater load is being imposed on the airframe. The extra lift required at higher weights means that more drag will also be generated, so the aircraft will tend to slow down much faster the heavier it gets. This may be the only direct indication the pilot has of increased loading. A heavier aircraft flying in turbulence will also tend to ride better, since that aircraft will respond less to a given gust, again giving the impression of a smoother ride and less stress to the airframe. This is quite wrong. While the response to turbulence is reduced, the actual loads on the airframe will increase.

$\theta$  = Angle of Bank  
VCL = Vertical Component of Lift  
HCL = Horizontal Component of Lift

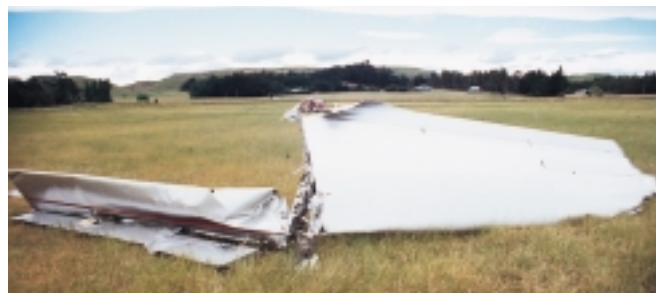
The remains of a L-13 Blanik glider wing after it suffered a complete in-flight break-up at 1000 feet. Over stressing prior to the event was thought to be a contributing factor.

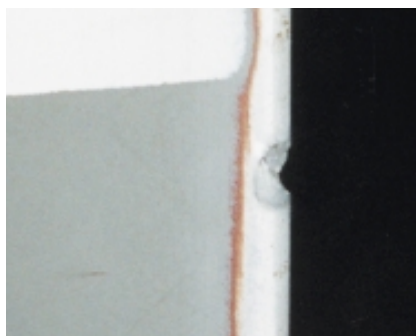
*Stone-chip damage such as this should be referred to a LAME immediately.*

Any mechanical damage to the prop creates an opportunity for blade failure. Nicks, cuts, or corrosion pits can set up stress points by interrupting lines of force. For this reason, aircraft engineers (LAMEs) are required to 'dress' or 'blend' any damage determined to be unacceptable, in accordance with strict criteria laid out in the propeller manufacturer's Maintenance Manual.

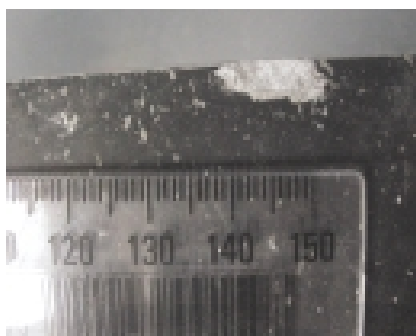
*Watch for signs of corrosion, such as those pictured above, and seek the advice of a LAME if in any doubt.*
