# VECTOR

*Pointing to Safer Aviation*

## Dangers of Static

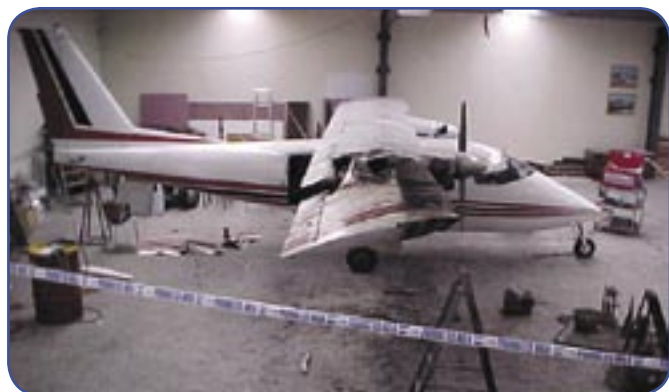
The aircraft was extensively damaged by explosion and fire.

He proceeded to pour 10 to 12 litres of fuel into the tank when a huge explosion occurred inside the tank, blowing the top and the bottom out of the tank and the wing. A fireball erupted in both directions and the explosion blew the engineer off the ladder. He fell into the fire now burning on the floor. The fireball severely damaged the 6 metre high roofline and 75 square metres of roofing had to be replaced.

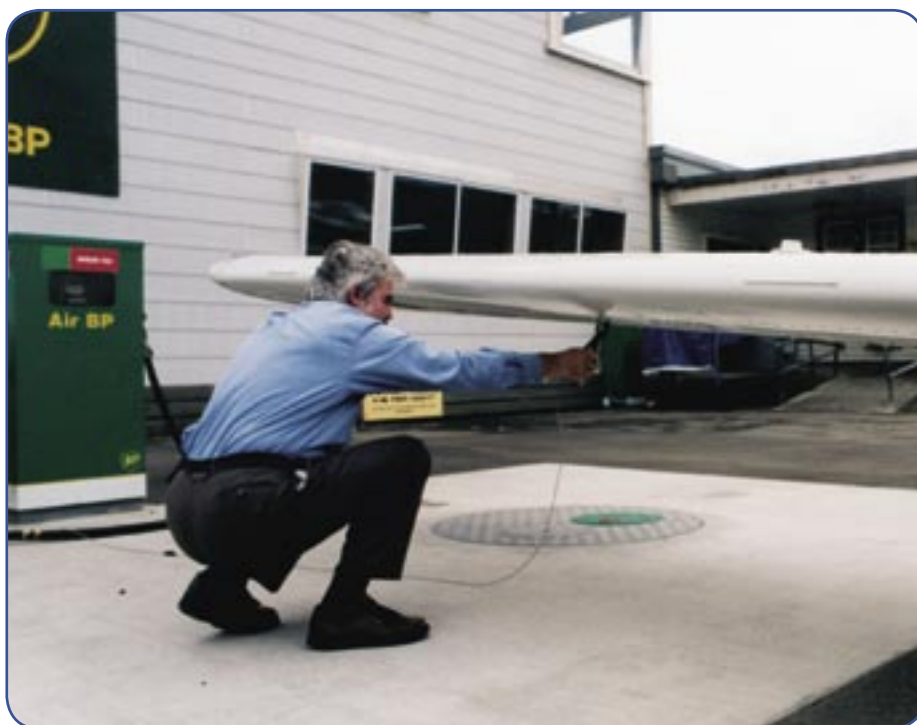
Attaching the bonding lead is the first action when refuelling, and removing it the last.

All pilots will be familiar with the routine bonding when an aircraft is refuelled at the pumps – the bonding cable is reeled out and attached to a convenient metal part of the aircraft. When refuelling from drums, always ensure there is a bonding lead connected to both the aircraft and the drum in use. Make the necessary connections before removing **any** fuel caps. Additionally, it is safe practice to keep the fuelling nozzle in physical contact with the filler orifice at any time fuel is being pumped.

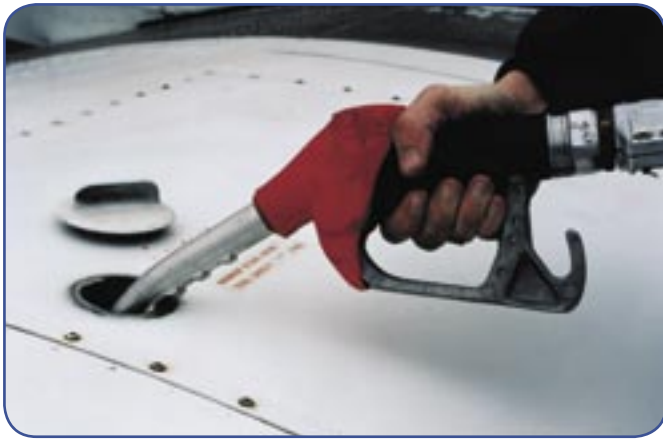
Keep nozzle in contact with orifice while fuel is flowing.

This also applies to the filling of portable containers – place the container on the ground, and maintain contact between the fuel nozzle and the container. Approved containers (these comply with Australian and New Zealand Standard 2906:2001) have this instruction on the label.

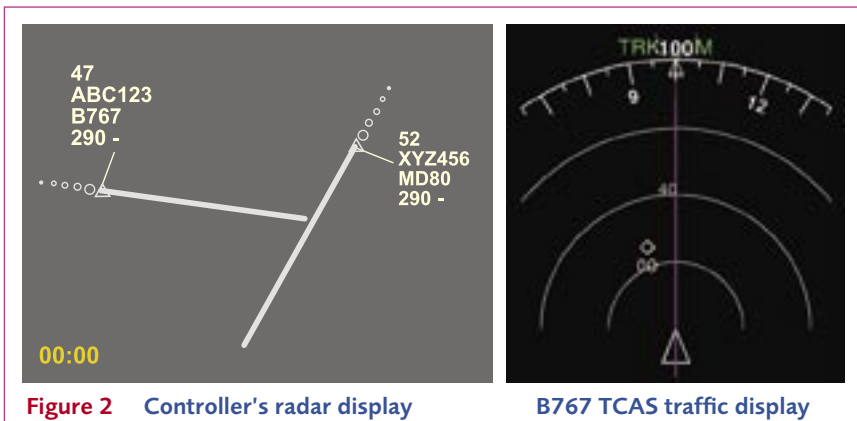
**Figure 2** Controller's radar display

B767 TCAS traffic display

Figures 2, 3, 4 and 5 illustrate how the situation was represented on the controller’s radar display and the B767 TCAS traffic display during the 90 seconds of this event.

In Figure 2, the controller’s display, the 3-minute speed vector (magnetic track and speed) clearly shows that the B767 was going to pass behind the MD80 (which was faster, 520 knots vs 470 knots ground speed for the B767). This is not obvious on the TCAS II traffic display. Due to the relative motion of the symbol and the lack of speed vector, it is extremely difficult to anticipate the evolution of the situation based solely on the TCAS traffic display.

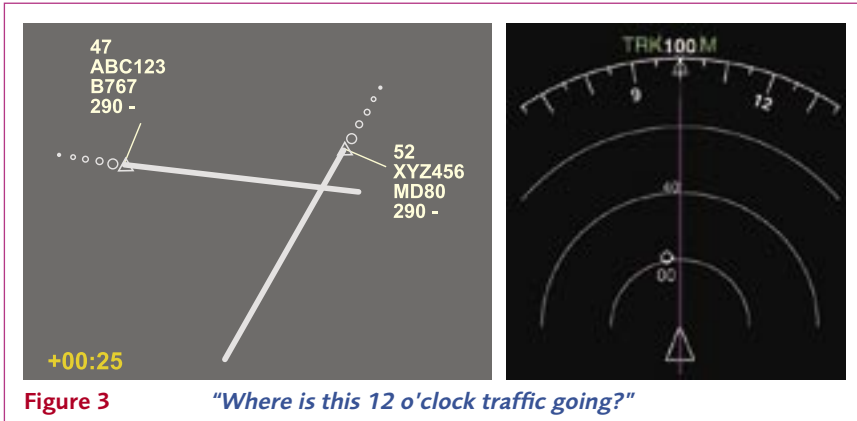
**Figure 3** “Where is this 12 o'clock traffic going?”

The B767 pilot, however, related a target on the TCAS II traffic display to the initial traffic information. The pilot saw a target moving apparently on opposite track, slightly on the left (Figure 3). Consequently, he started to question the controller.

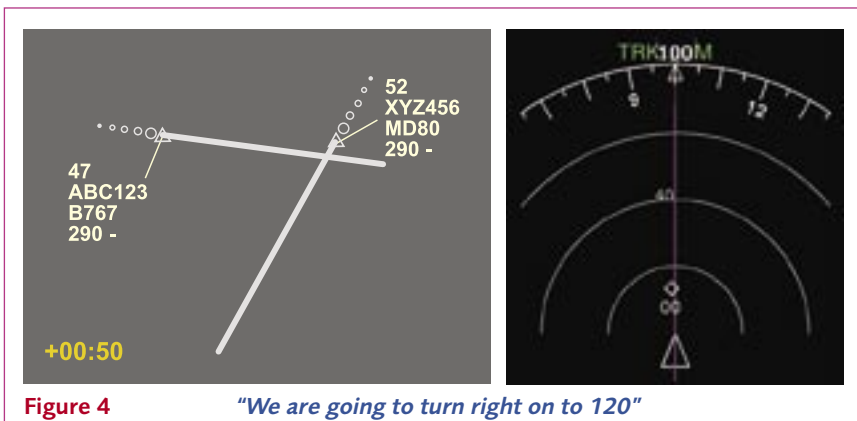
**Figure 4** “We are going to turn right on to 120”

When the target was at a 12 o'clock position and less than 20 NM, the B767 pilot decided to turn right to avoid the target on the TCAS display. The pilot could not relate the direction of the traffic contained in the controller's information to the information provided by the TCAS traffic display, so he did not take it into account. To the controller, however, it was obvious that this turn to the right would create a loss of separation.

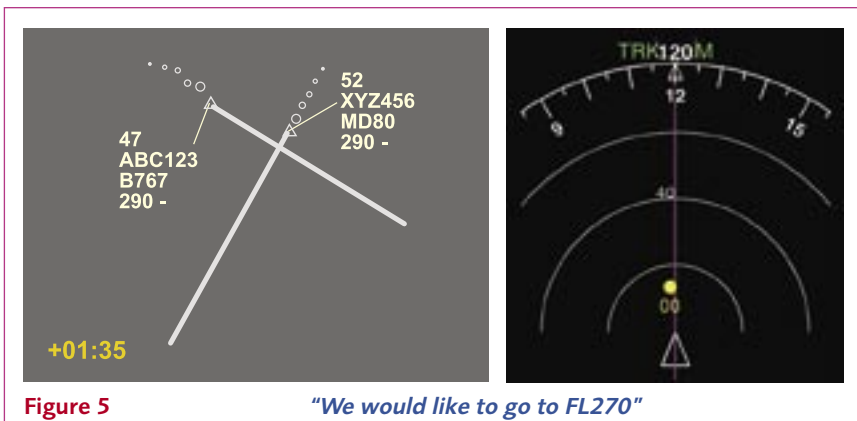
**Figure 5** “We would like to go to FL270”

The controller responds with updated traffic information. The B767 pilot, however, says, “We are going to turn right on to 120” and begins a right turn. Due to this turn, which is the wrong direction, the horizontal separation reduces quickly and a TA is triggered on both aircraft. The B767 pilot says, “We would like to go to FL270”. This turn reduced the separation to only 2 NM.
